**THE
ACCIDENT AT
THREE MILE
ISLAND**

*Reports Of The Technical
Assessment Task Force, Vol. IV*

QUALITY ASSURANCE
CONDENSATE POLISHING SYSTEM
CLOSED EMERGENCY FEEDWATER VALVES
PILOT-OPERATED RELIEF VALVE DESIGN AND PERFORMANCE
CONTAINMENT: TRANSPORT OF RADIOACTIVITY FROM
THE TMI-2 CORE TO THE ENVIRONS
IODINE FILTER PERFORMANCE
RECOVERY: TMI-2 CLEANUP AND DECONTAMINATION

QUALITY ASSURANCE

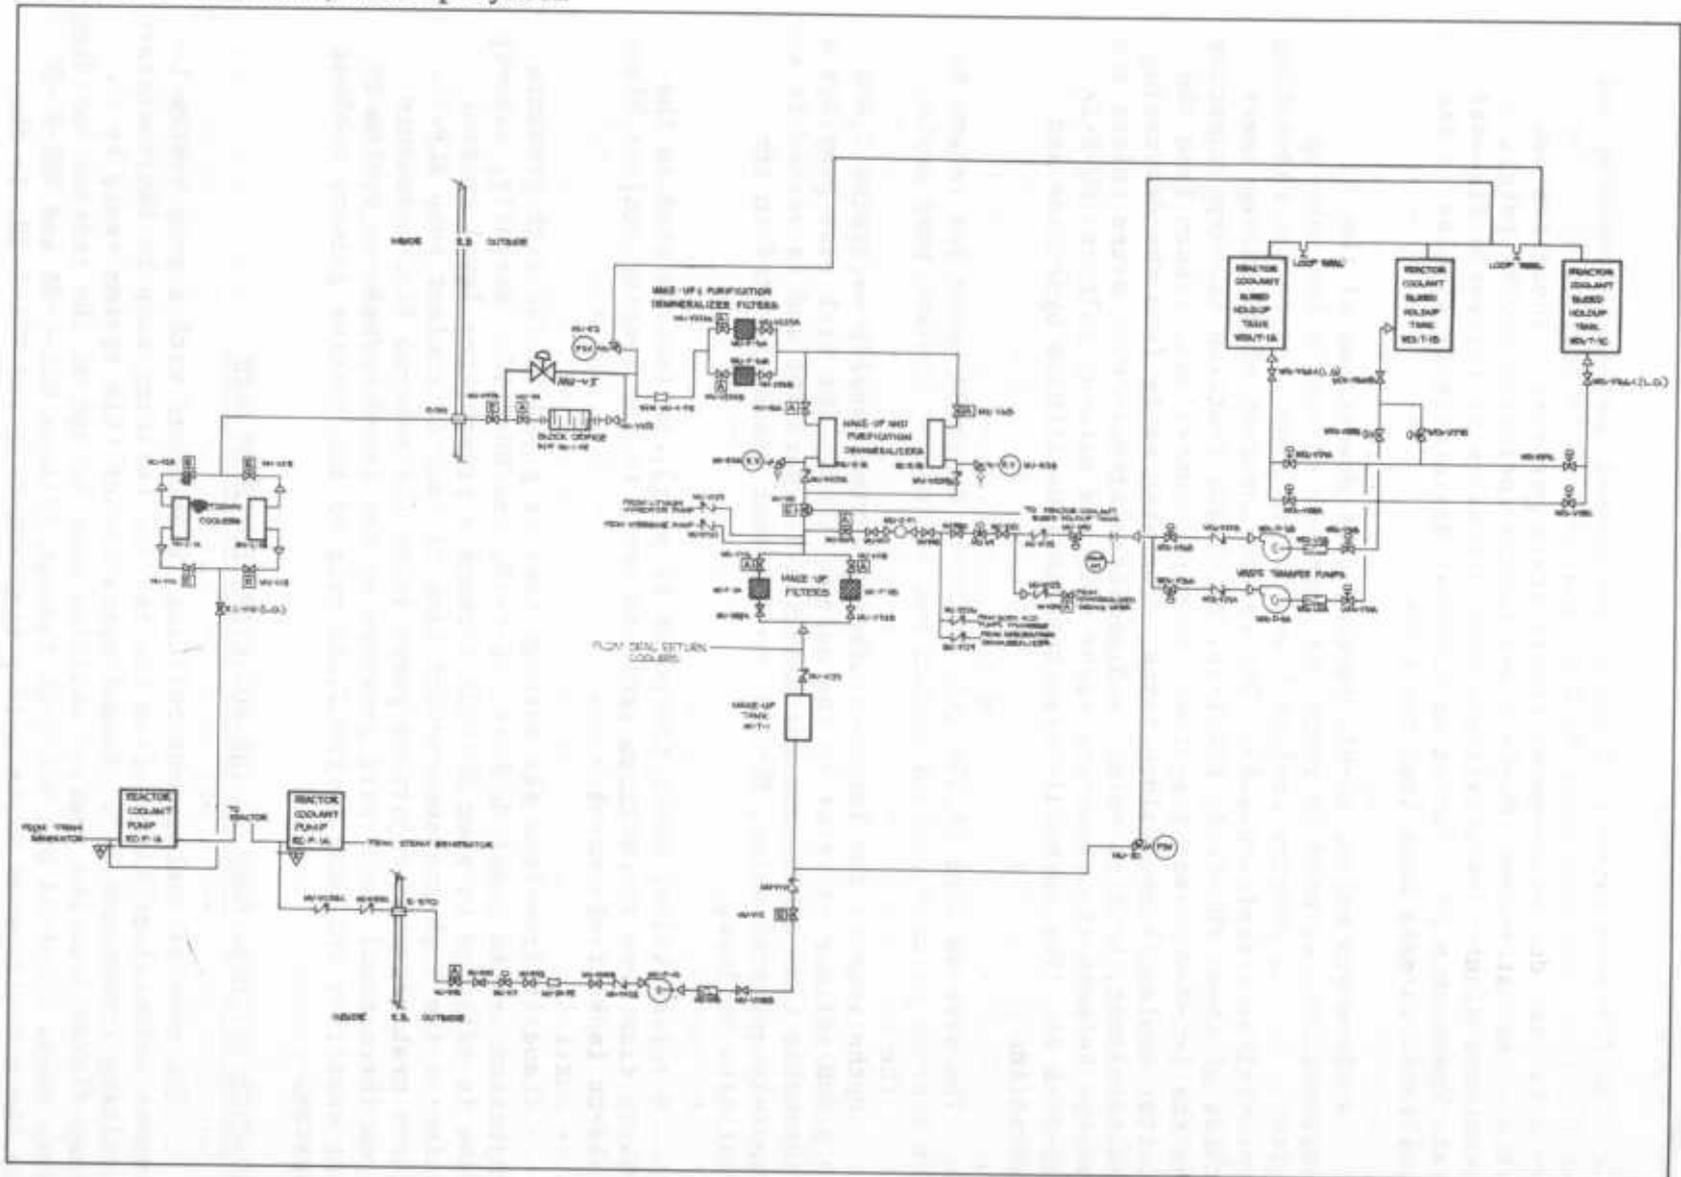
FIGURE 1: Let-Down/Make-up System

It is important to note that if the let-down/make-up system is in operation with the valves open upstream of the block orifice valve and a block or obstruction is effected downstream, this pressure relief valve MU-R3 relieves pressure by venting to the reactor coolant bleed holdup tanks (reference 6). The same relief is provided if the overpressure is caused by dissolved gases.

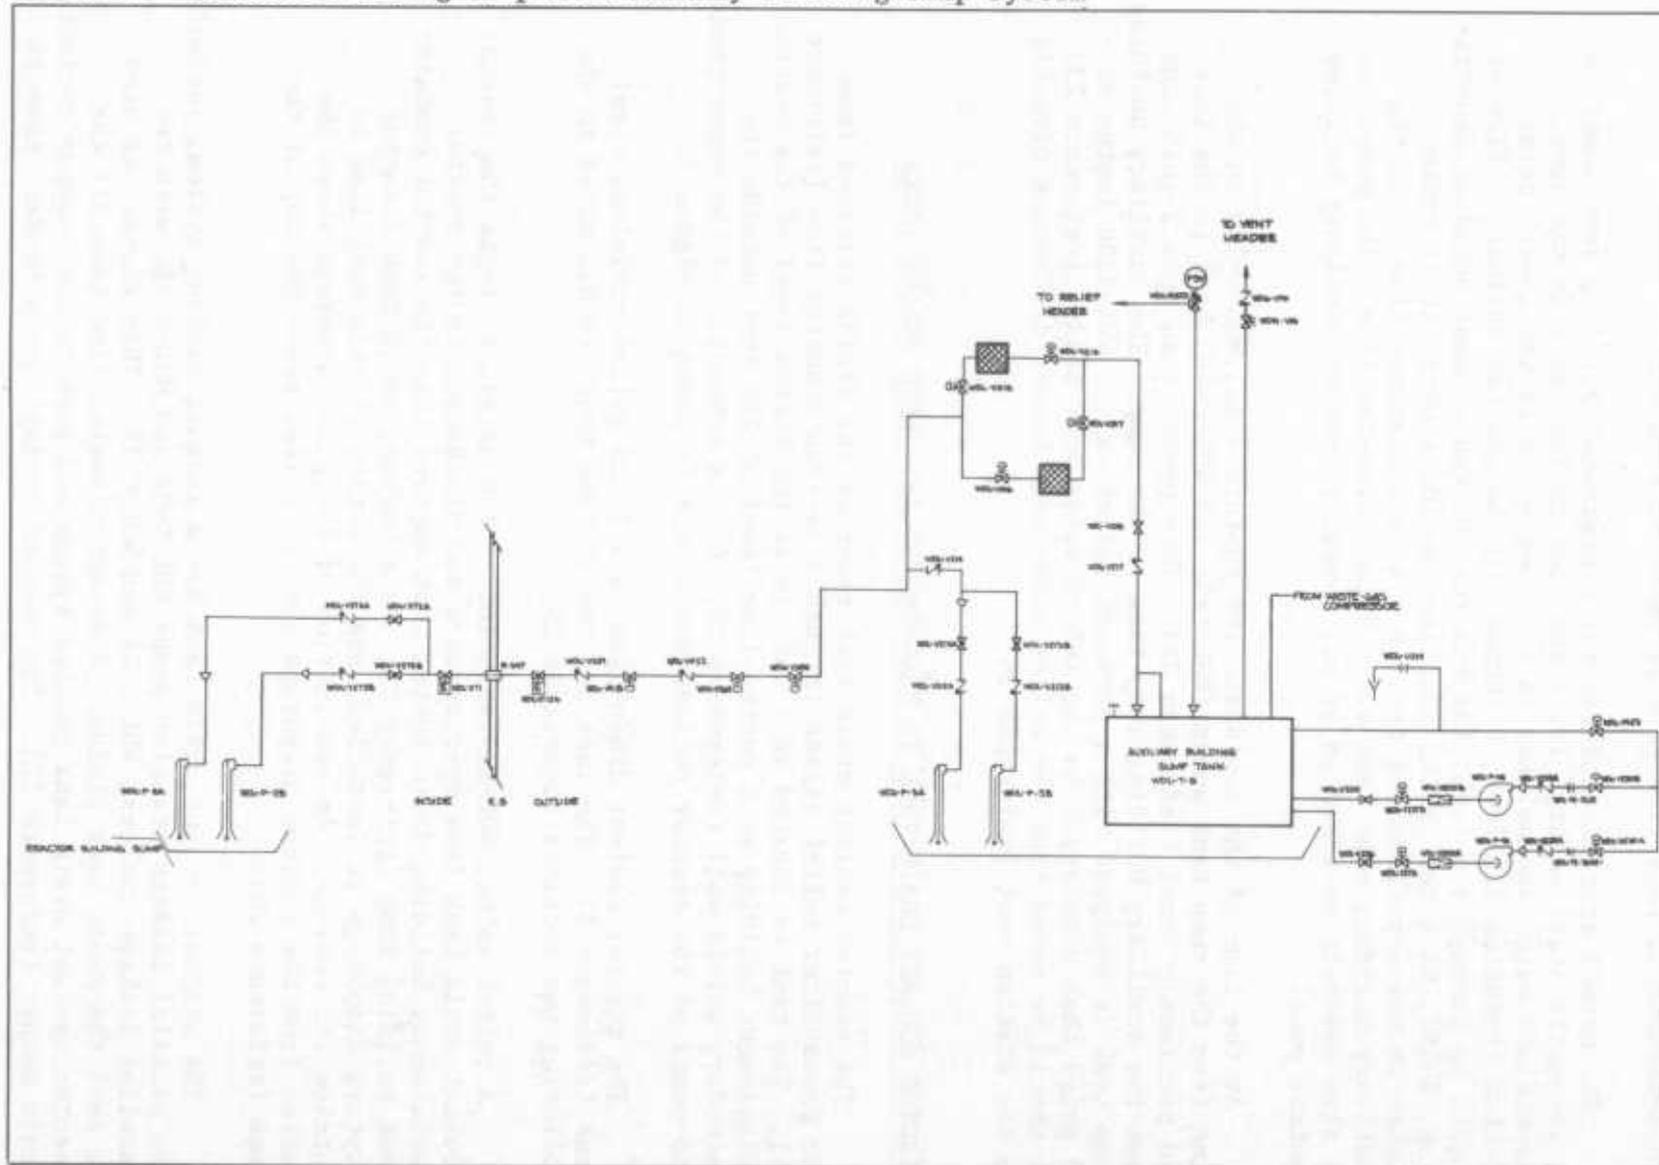
FIGURE 2: Reactor Building Sump to Auxiliary Building Sump System

auxiliary building sump tank. Consensus of operating personnel and level readings of the miscellaneous waste holdup tank before and after the event indicate the valve line-up was to the auxiliary sump tank. The schematic of this flow path is shown in Figure 2.

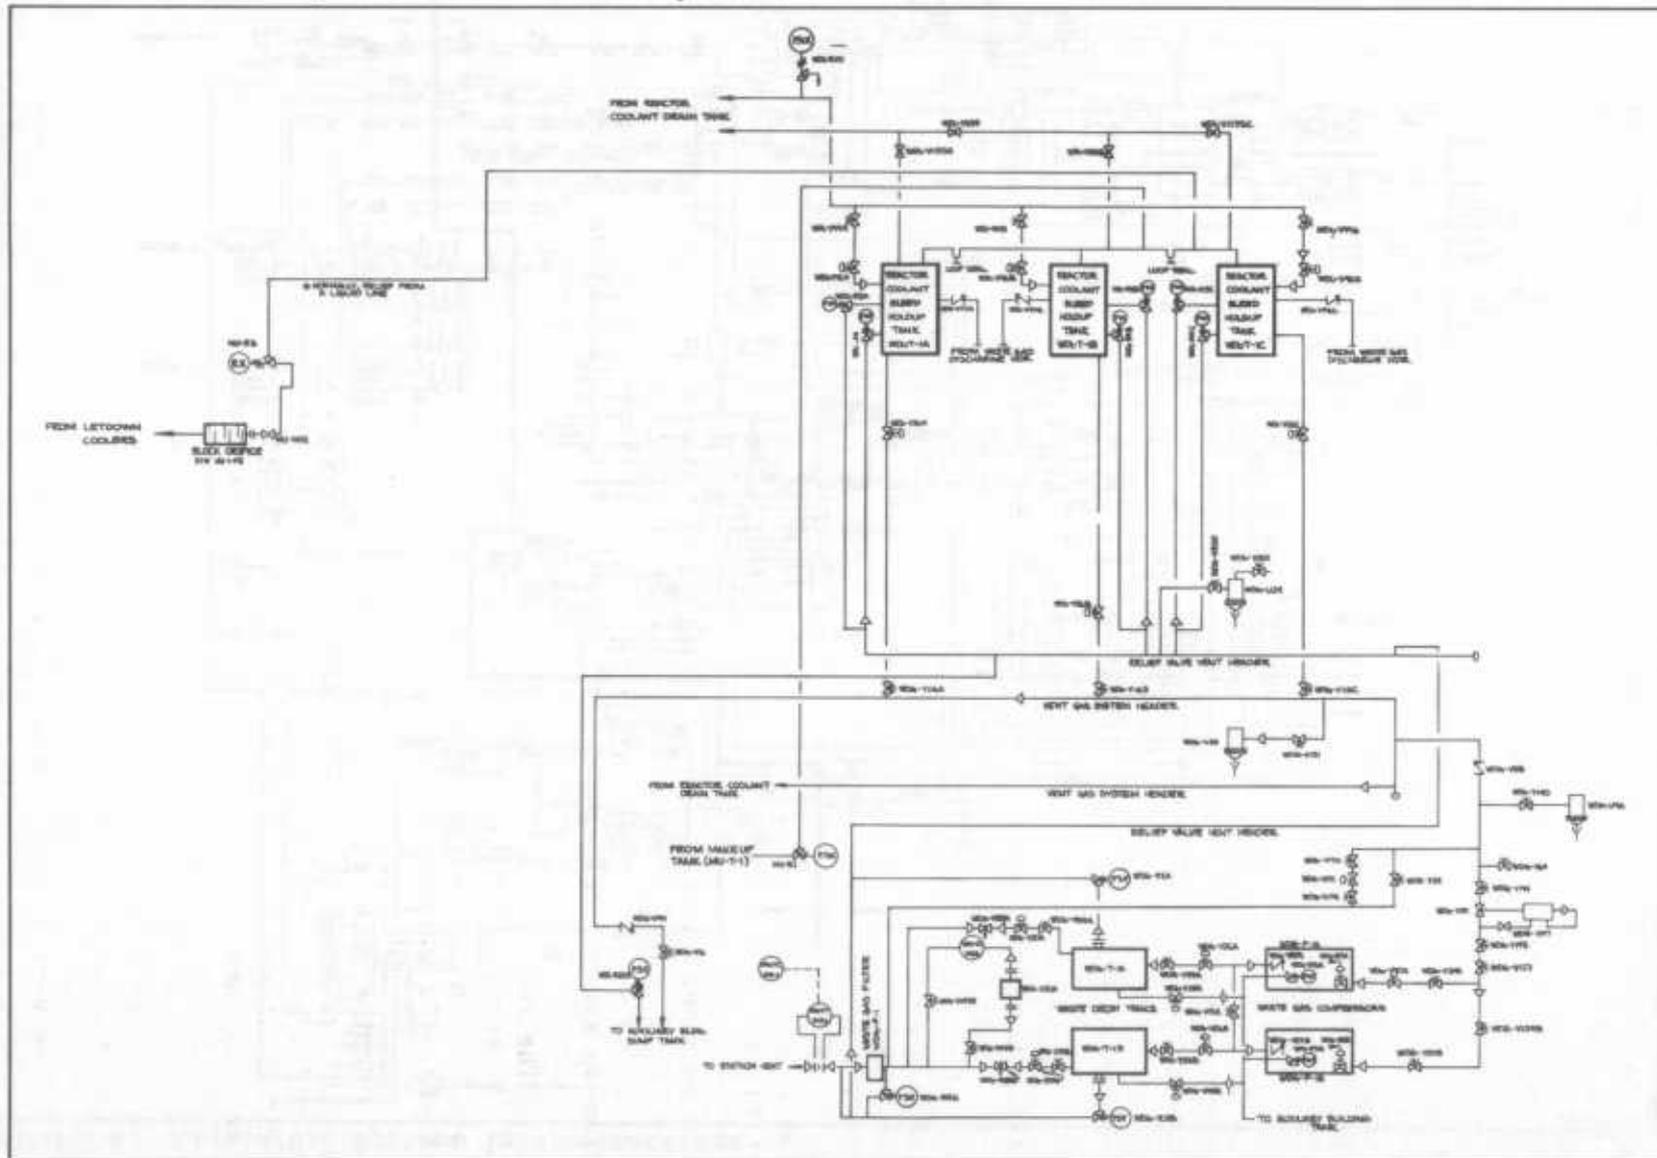
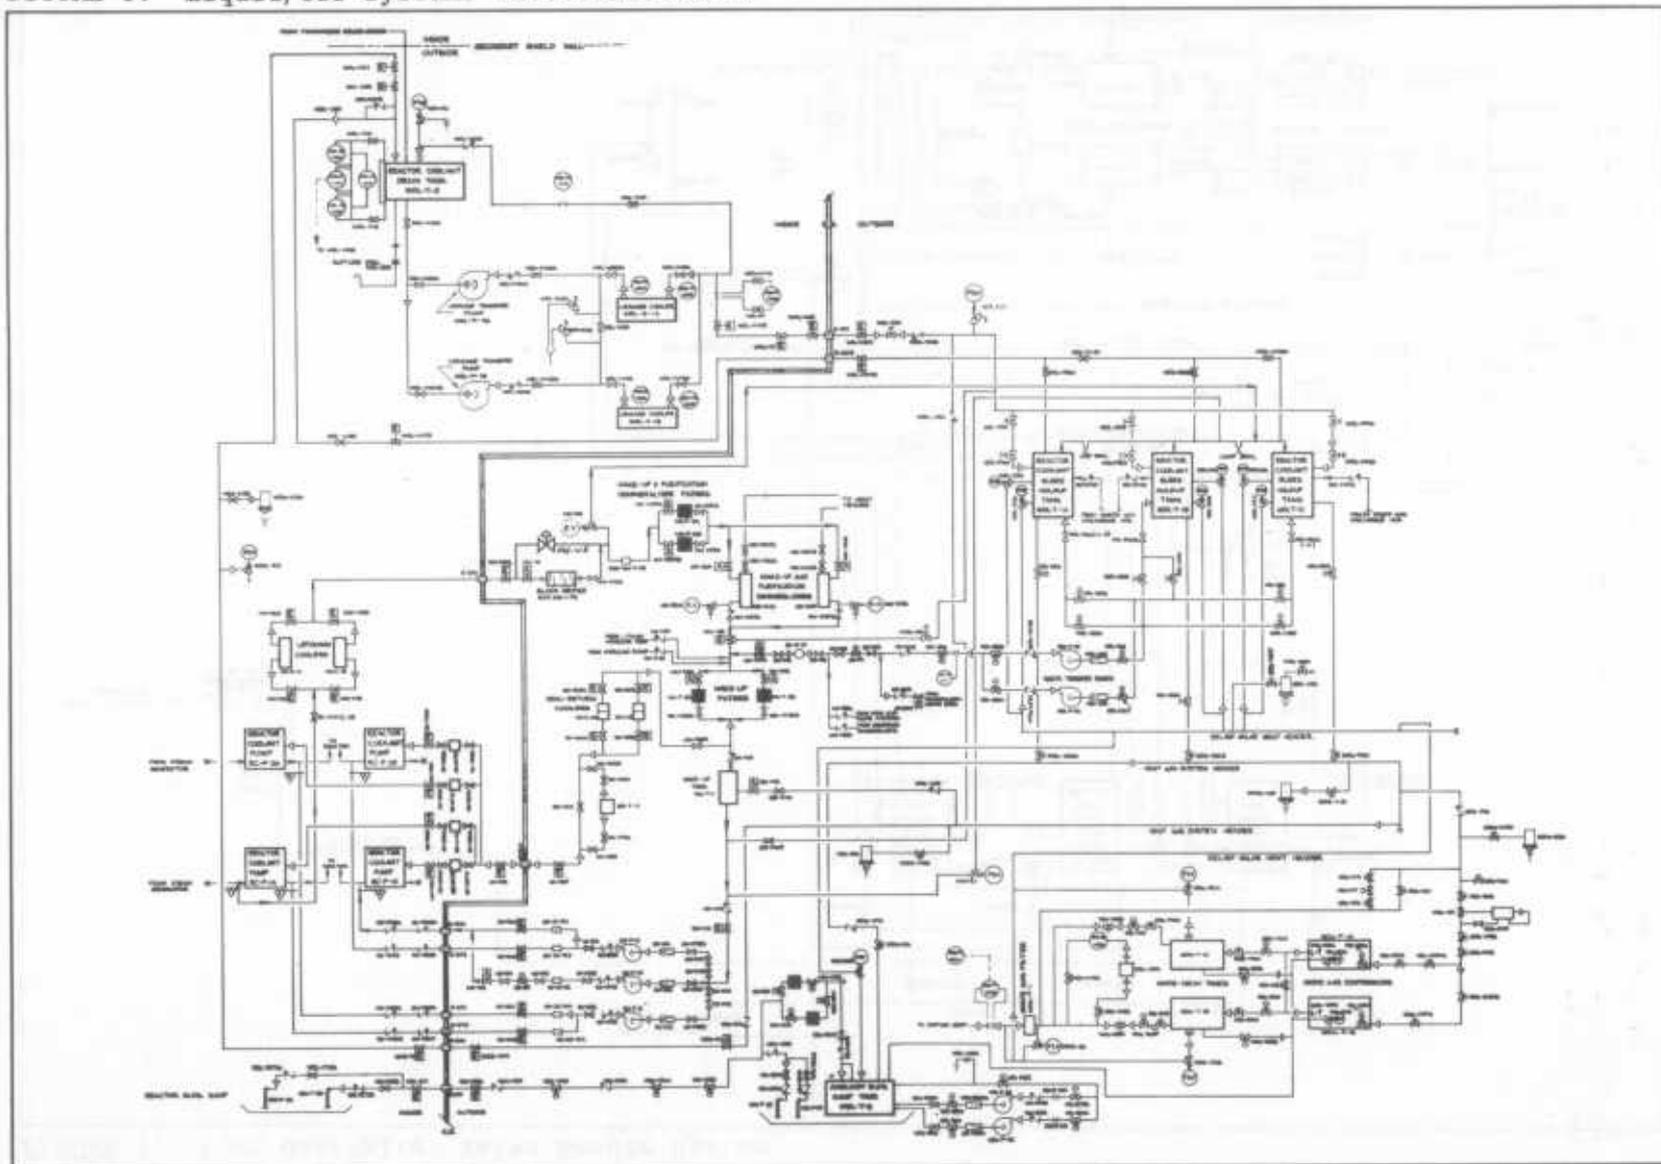
relief valves. There are at least two of these traps, WDG-U8A and WDG-U9A, in the auxiliary buildings.

The interconnections of the liquid system with the gas systems make it difficult to diagnose the release points of the radioactive gas from the auxiliary building.
