VOLUME **II** Part 2

three mile island

A REPORT TO THE
COMMISSIONERS
AND TO THE
PUBLIC

NUCLEAR REGULATORY COMMISSION
SPECIAL INQUIRY GROUP

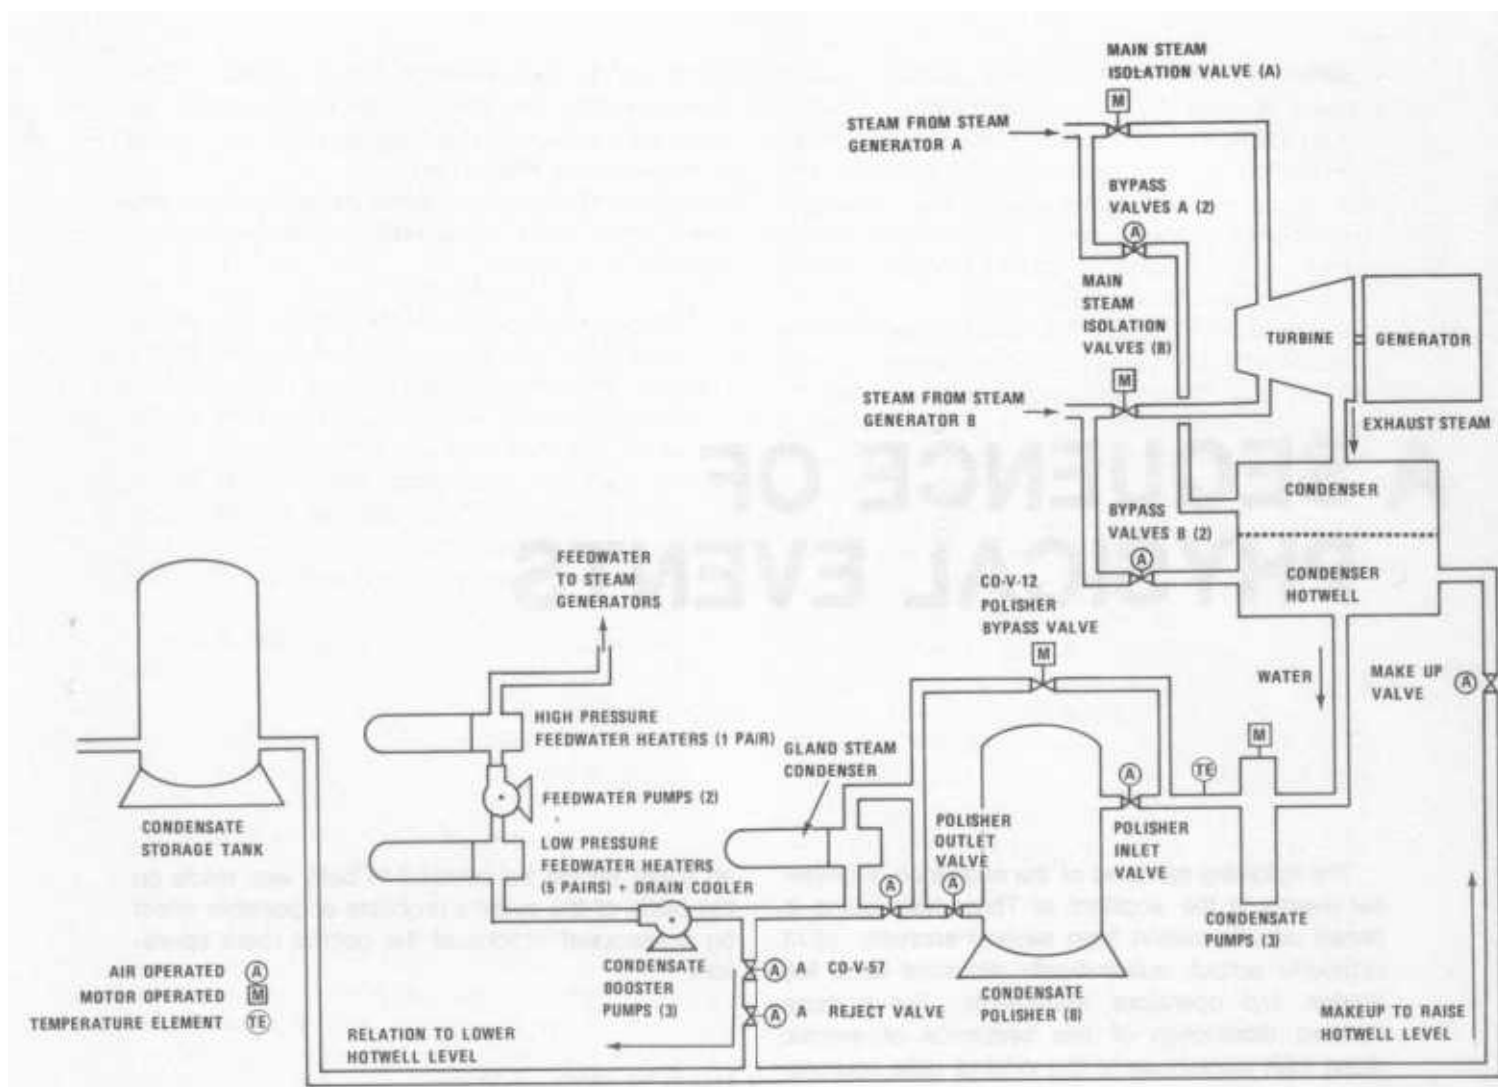
FIGURE II-1. The Condensate and Feedwater System

It has been postulated that the water in the air piping caused the polisher inlet or outlet valves, or both, to close.' [Problems with the valves in the

polisher system are discussed in Section II.C.1.d.] Closure of either the inlet or outlet valves would interrupt the flow of feedwater and cause the condensate pumps and condensate booster pumps to trip, that is, to be automatically shut down. Tripping of these pumps causes tripping of the main feedwater pumps, which in turn, causes tripping of the main turbine and electrical generator.

In the accident at TMI-2, it has not been definitely determined what caused the condensate pump to trip, although it is a reasonable inference that the operations on the polisher were somehow involved. It has been established that condensate pump 1A tripped and that both main feedwater pumps then tripped almost simultaneously. Approximately 1 second later, the turbine and generator tripped.

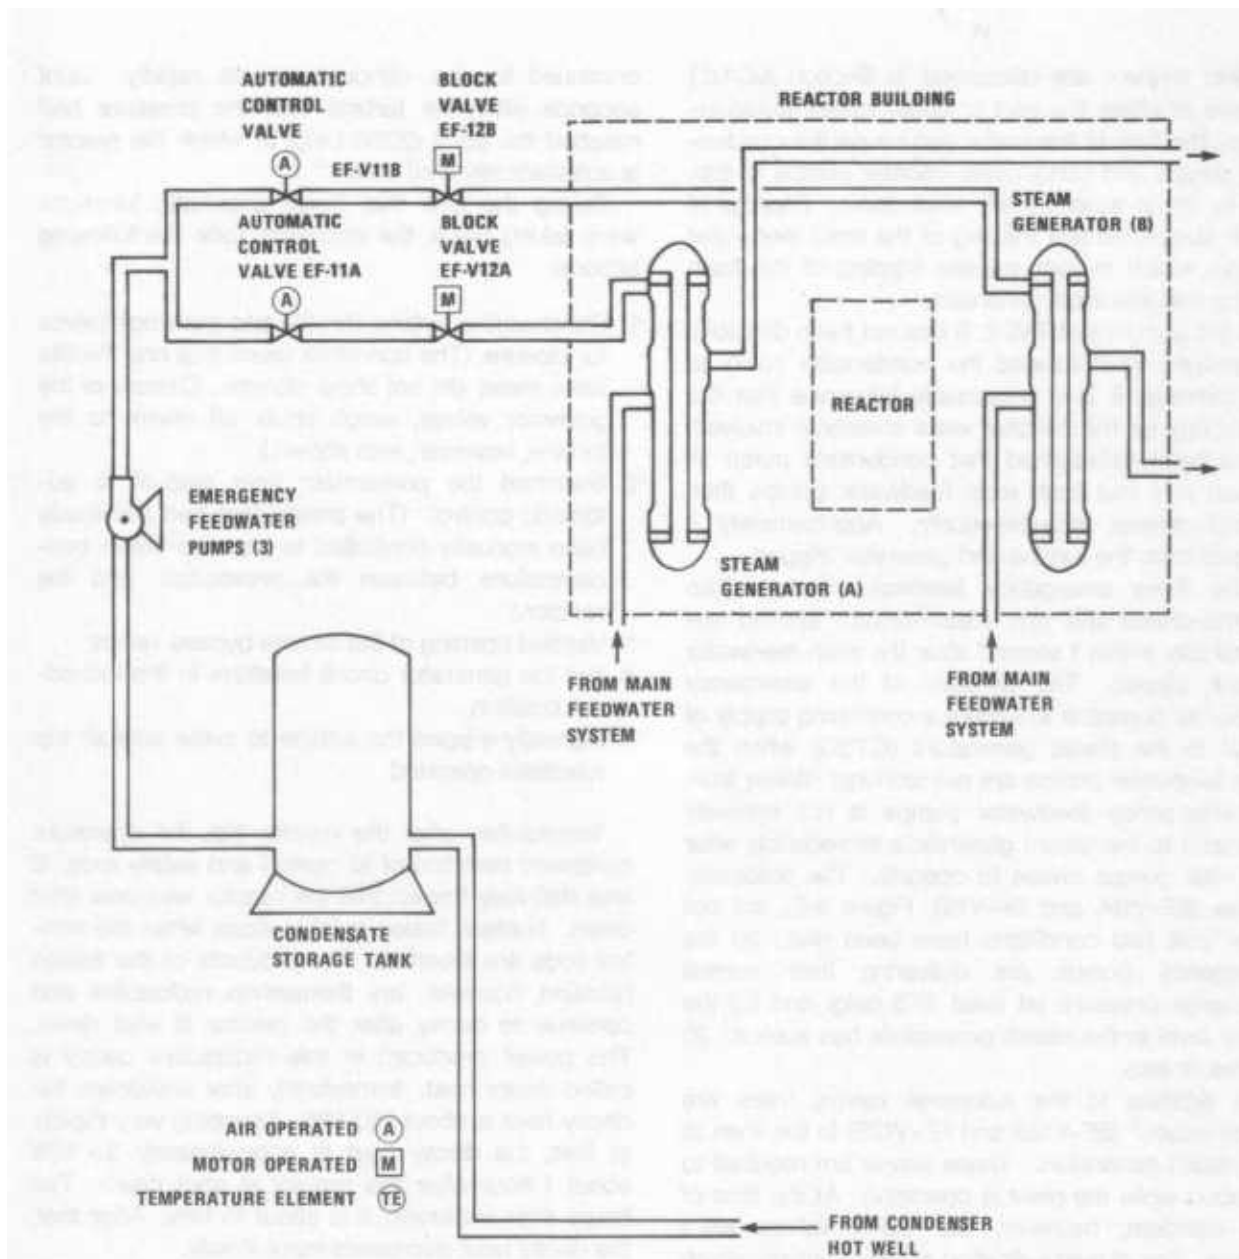
FIGURE 11-2. The Emergency Feedwater System

Three emergency feedwater pumps (two electric, one steam driven) are started automatically on loss of the main feedwater pumps (Figure II-1). The emergency feedwater pumps take suction from the condensate storage tank; in an emergency, they can also take suction directly from river water. The automatic control valves will open (a) when the discharge pressure of the emergency feedwater pumps is high enough and (b) when the water level in the steam generators falls to 30 inches or less. Until both conditions are satisfied, the control valves remain closed. The block valves should have been open at all times; however, at the time of the accident these valves were closed. When the conditions were met, the control valves slowly opened, but no water was admitted to the steam generators because the block valves were still closed. About 8 minutes after the start of the accident, the operator discovered that the block valves were closed, and opened them. This admitted water to the steam generators.

The block valves can be operated by switches in the control room, by switches in the auxiliary building, and manually at the valves. It is not known from **which point nor when the valves were closed.**

At 8 minutes after turbine trip, the operator discovered that the emergency feedwater block valves were closed and opened them. Opening these valves caused a rapid increase in steam pressure, which had previously dropped when the steam generators boiled dry, and a drop in RCS temperature. Steam generator level, however, did not recover noticeably for another 14 minutes. [The reason for the lag in recovery of the steam generator level is that emergency feedwater is sprayed directly onto the hot tubes and evaporates immediately (Figure 11-5). Evaporation raises steam pressure, but

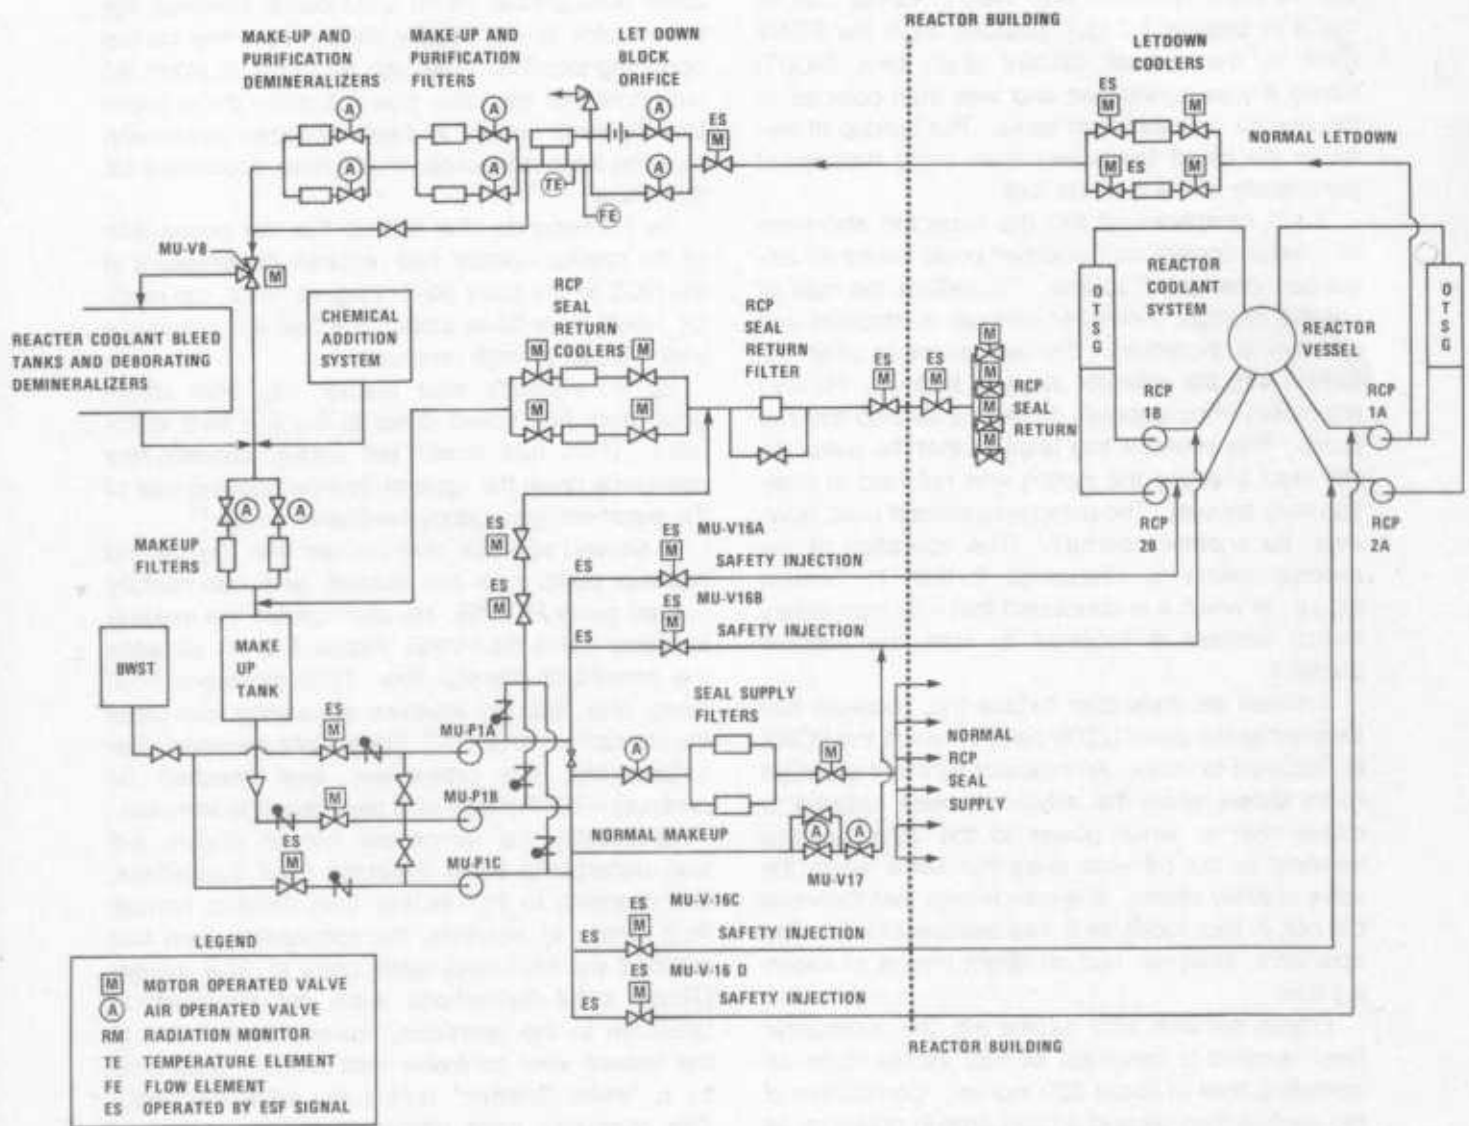
FIGURE 11-3. The Makeup and Letdown System

During normal operation, water is removed from the reactor coolant system (RCS) near the suction of the reactor coolant pump (RCP-1A). The water removed is purified and cooled and can be sent either to the reactor coolant bleed tanks or to the makeup tank. At least one makeup pump is always operating; this supplies water to the reactor coolant pump seals. A small amount of the seal water leaks out and is returned to the makeup tank through the seal return system; the remainder enters the RCS. Any additional water required to maintain the correct inventory in the RCS is regulated by valve MU-V17 and enters the discharge line of RCP-1A. In the high pressure injection mode (when the engineered safeguards are actuated), two makeup pumps (normally 1A and 1C) take water directly from the borated water storage tank, and pump through valves MU-V16A, 16B, and 16D—which are wide open—to all four RCS cold legs. Letdown is stopped during engineered safeguards operation.

sion of plant operation with leaking valves can be found in Section II.C.1.b.] Leakage from the PORV went to the reactor coolant drain tank (RCDT) where it was condensed and was then pumped to the reactor coolant bleed tanks. The buildup of water in the bleed tanks was then being transferred periodically to the makeup tank.

If not compensated for, the expected shrinkage of reactor coolant on cooldown could cause an excessive change of volume. To reduce the rate of volume change, therefore, letdown is stopped and makeup is increased. Thirteen seconds after the turbine trip, the operator stopped letdown. He also attempted unsuccessfully to start a second makeup pump. This operator has testified that the pump did not start because the switch was not held in position long enough. The pump was started later, however, by another operator. (The operation of the makeup pump is discussed further in Section II.C.1.c, in which it is concluded that only momentary switch contact is required to start the makeup pumps.)

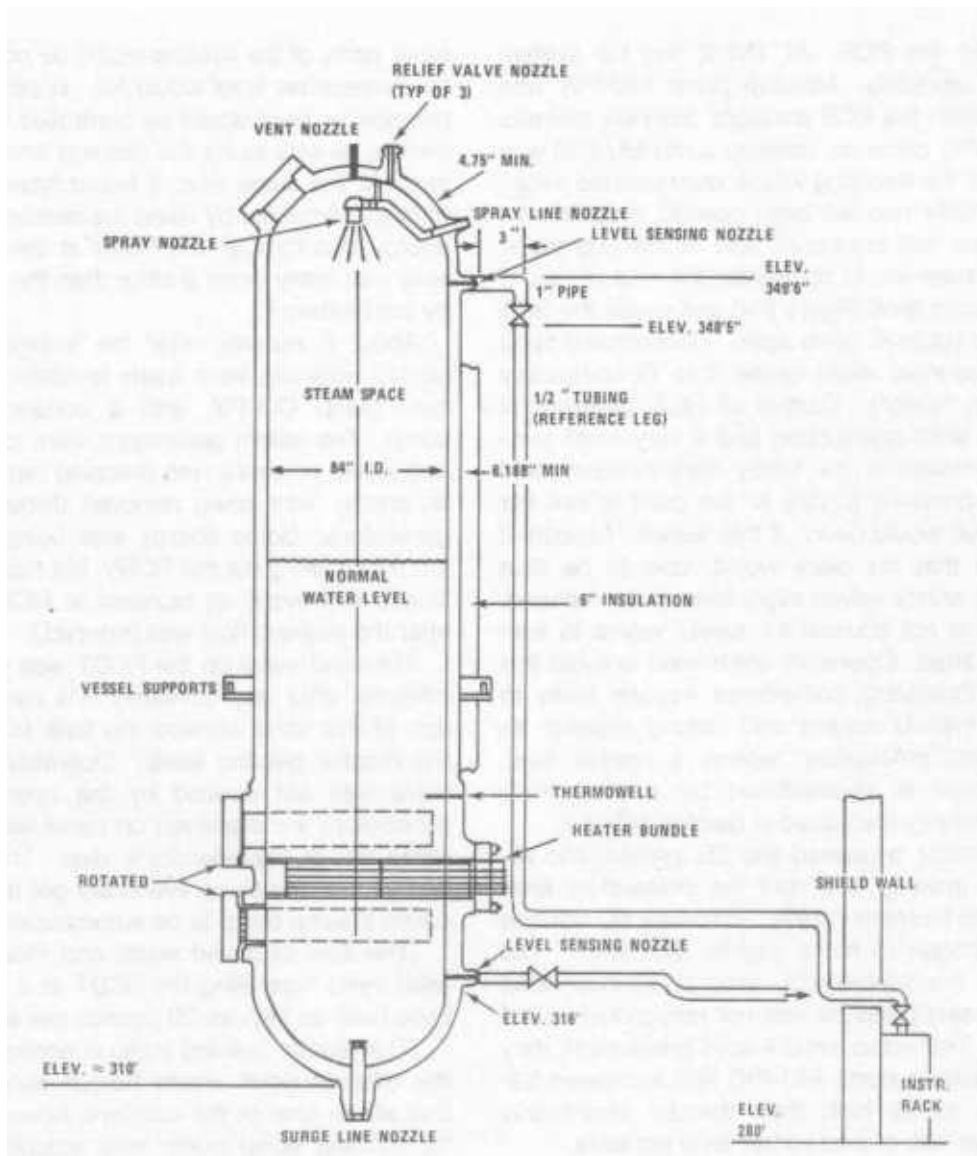
FIGURE 11-4. The Pressurizer

[If the PORV had not been opened, it could now be expected that increased flow of makeup water into the system would accelerate the rate of rise of the pressurizer level (Figure 11-4) and cause the RCS pressure to begin to climb again. Uncontrolled filling of the pressurizer might cause it to fill completely (pressurizer "solid"). Control of RCS pressure is lost with a solid pressurizer, and a very small temperature increase in the totally filled system could cause the pressure to rise to the point where the safety valves would open. If this were to happen, it is possible that the plant would have to be shut down. The safety valves might have to be repaired, because it is not unusual for safety valves to leak after being lifted. Operators are trained to avoid this situation. Operating procedures require them to switch to manual control and reduce makeup as soon as the pressurizer regains a normal level. (This practice is necessitated by a preexisting design deficiency discussed in Section II.C.1.c.)]

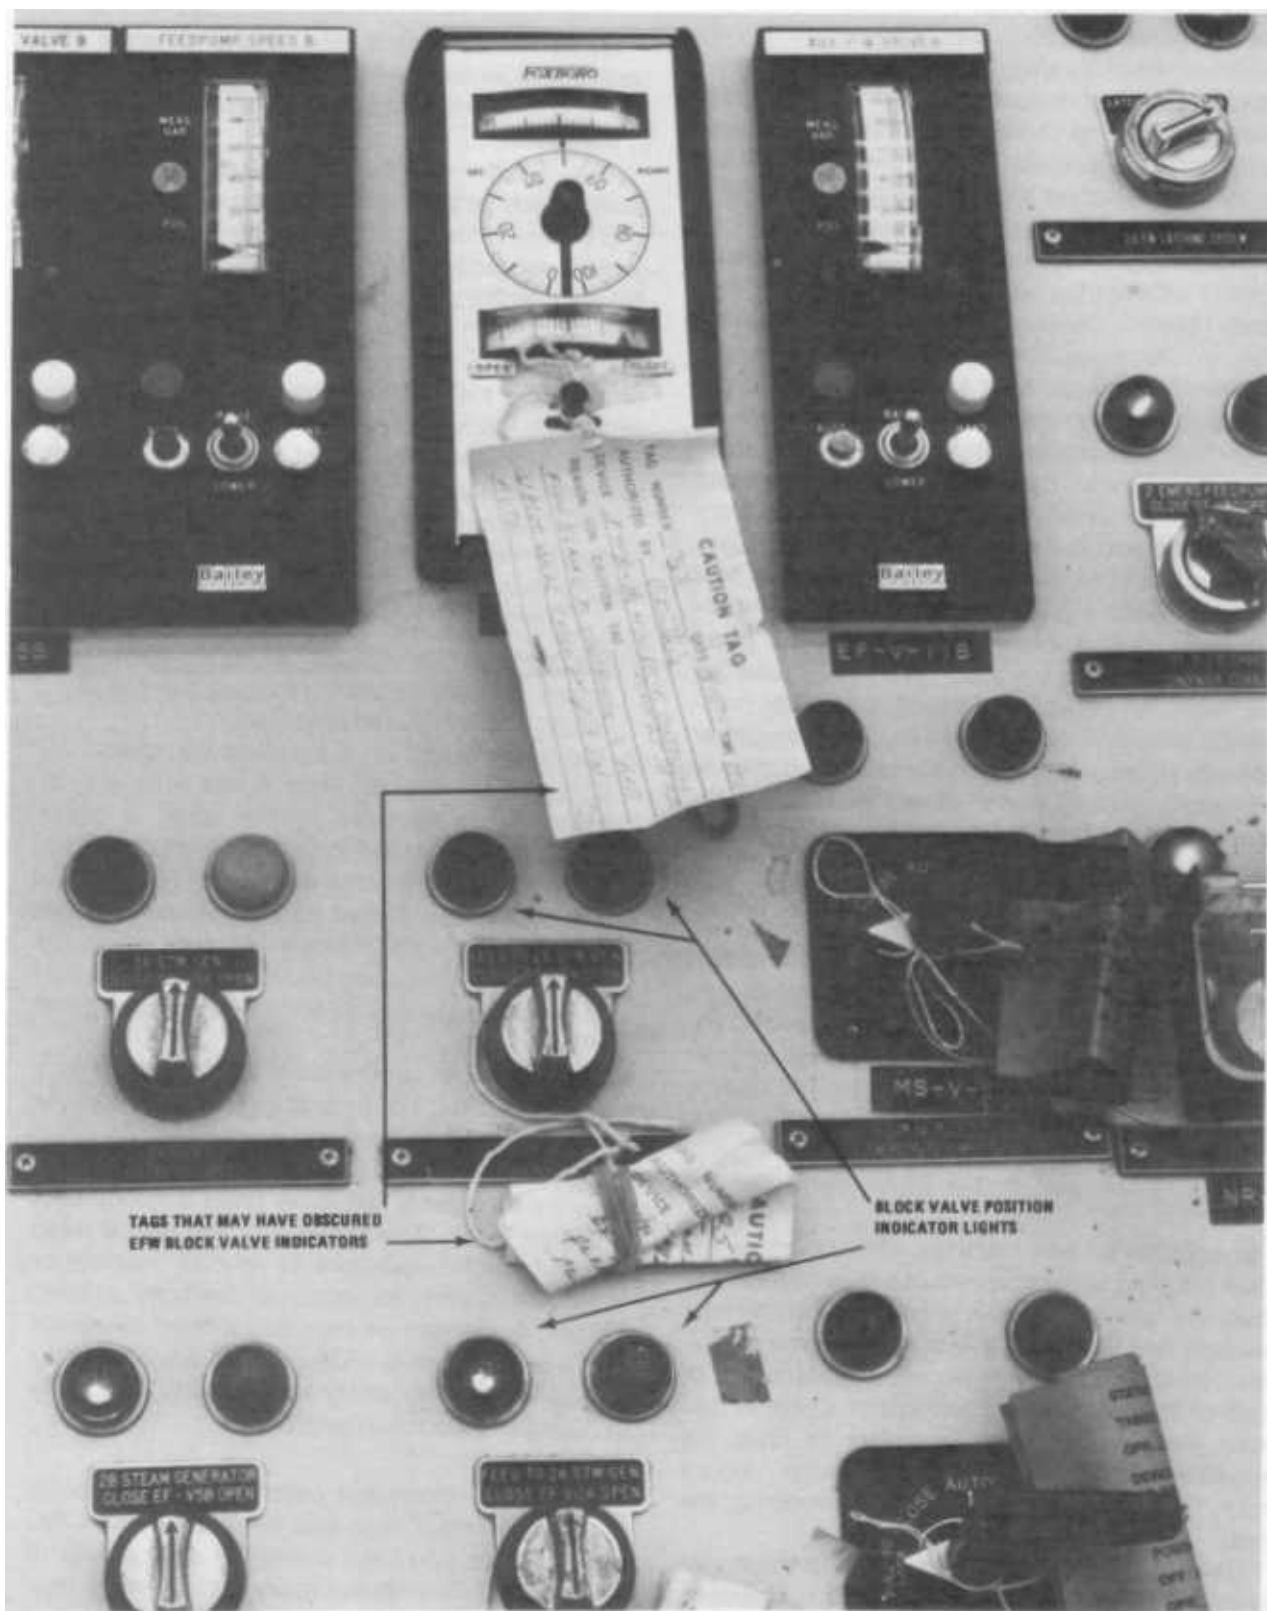
FIGURE 11-45. EFW Block Valve Controls and Indicator Lights Showing Caution Tags

Another condition that contributed to the confusion in the control room was the alarm system that hampered the operators during the early stages of the accident. The control room contains more than 750 alarms. These alarms are not prioritized, and many are difficult to read from normal operator positions. During the first few minutes, more than 100 alarms went off.²⁴

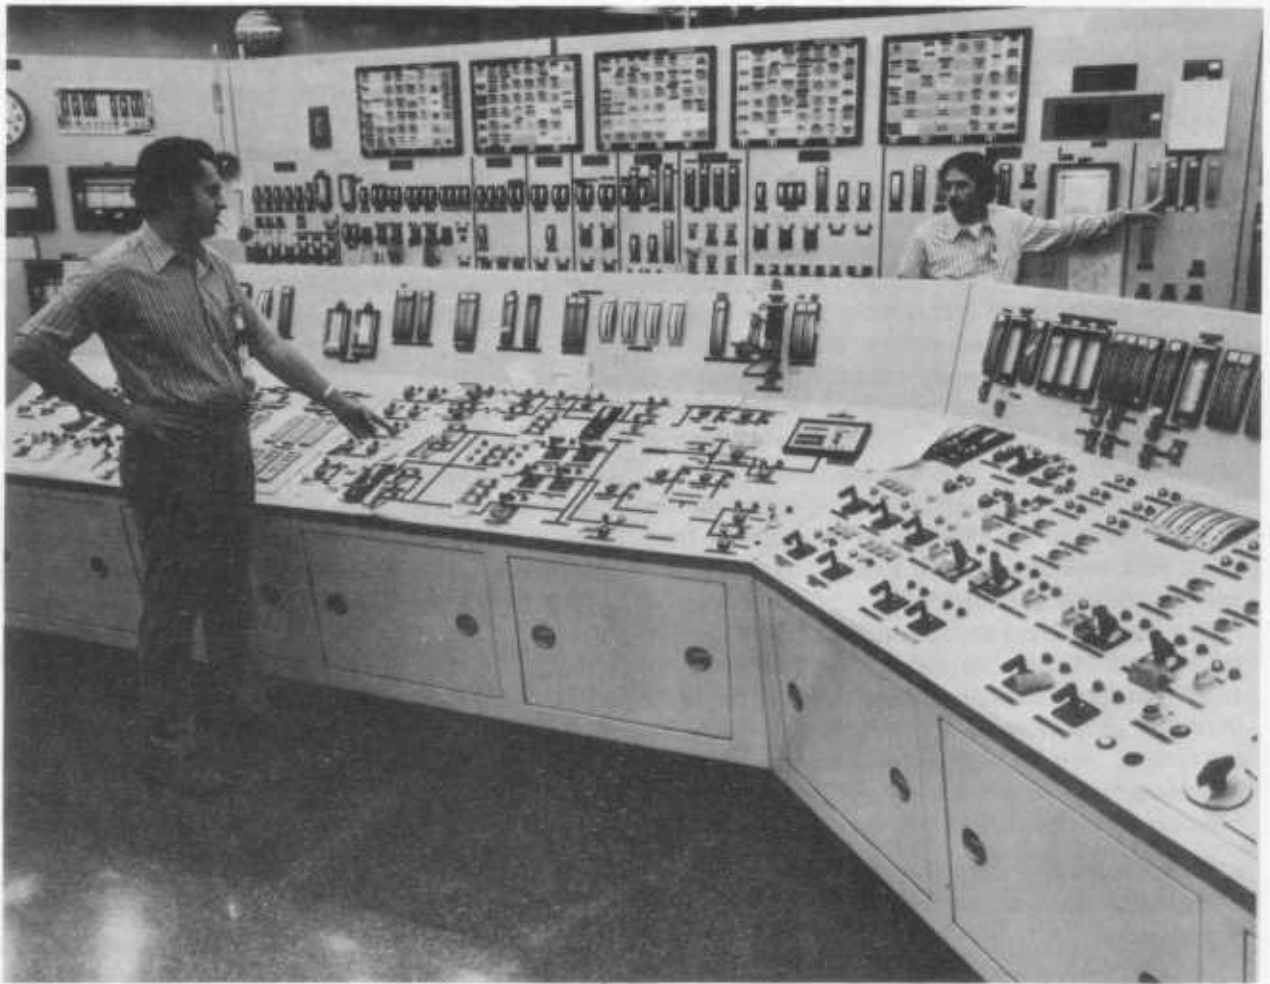
FIGURE 11-49. Visual Scan Necessary for Operator (on Left) Controlling Makeup To Monitor Makeup Flow (Operator on Right)

A critical design requirement for the nuclear powerplant control room is the effective display of information to the operator. This requirement is most pronounced during emergency conditions
