**A REPORT
TO THE MET-ED COMMUNITY**

Metropolitan Edison Company
Reading, Pennsylvania
May 30, 1979
Report Number Two

THE TMI-2 ACCIDENT

THREE MILE ISLAND UNIT TWO SCHEMATIC

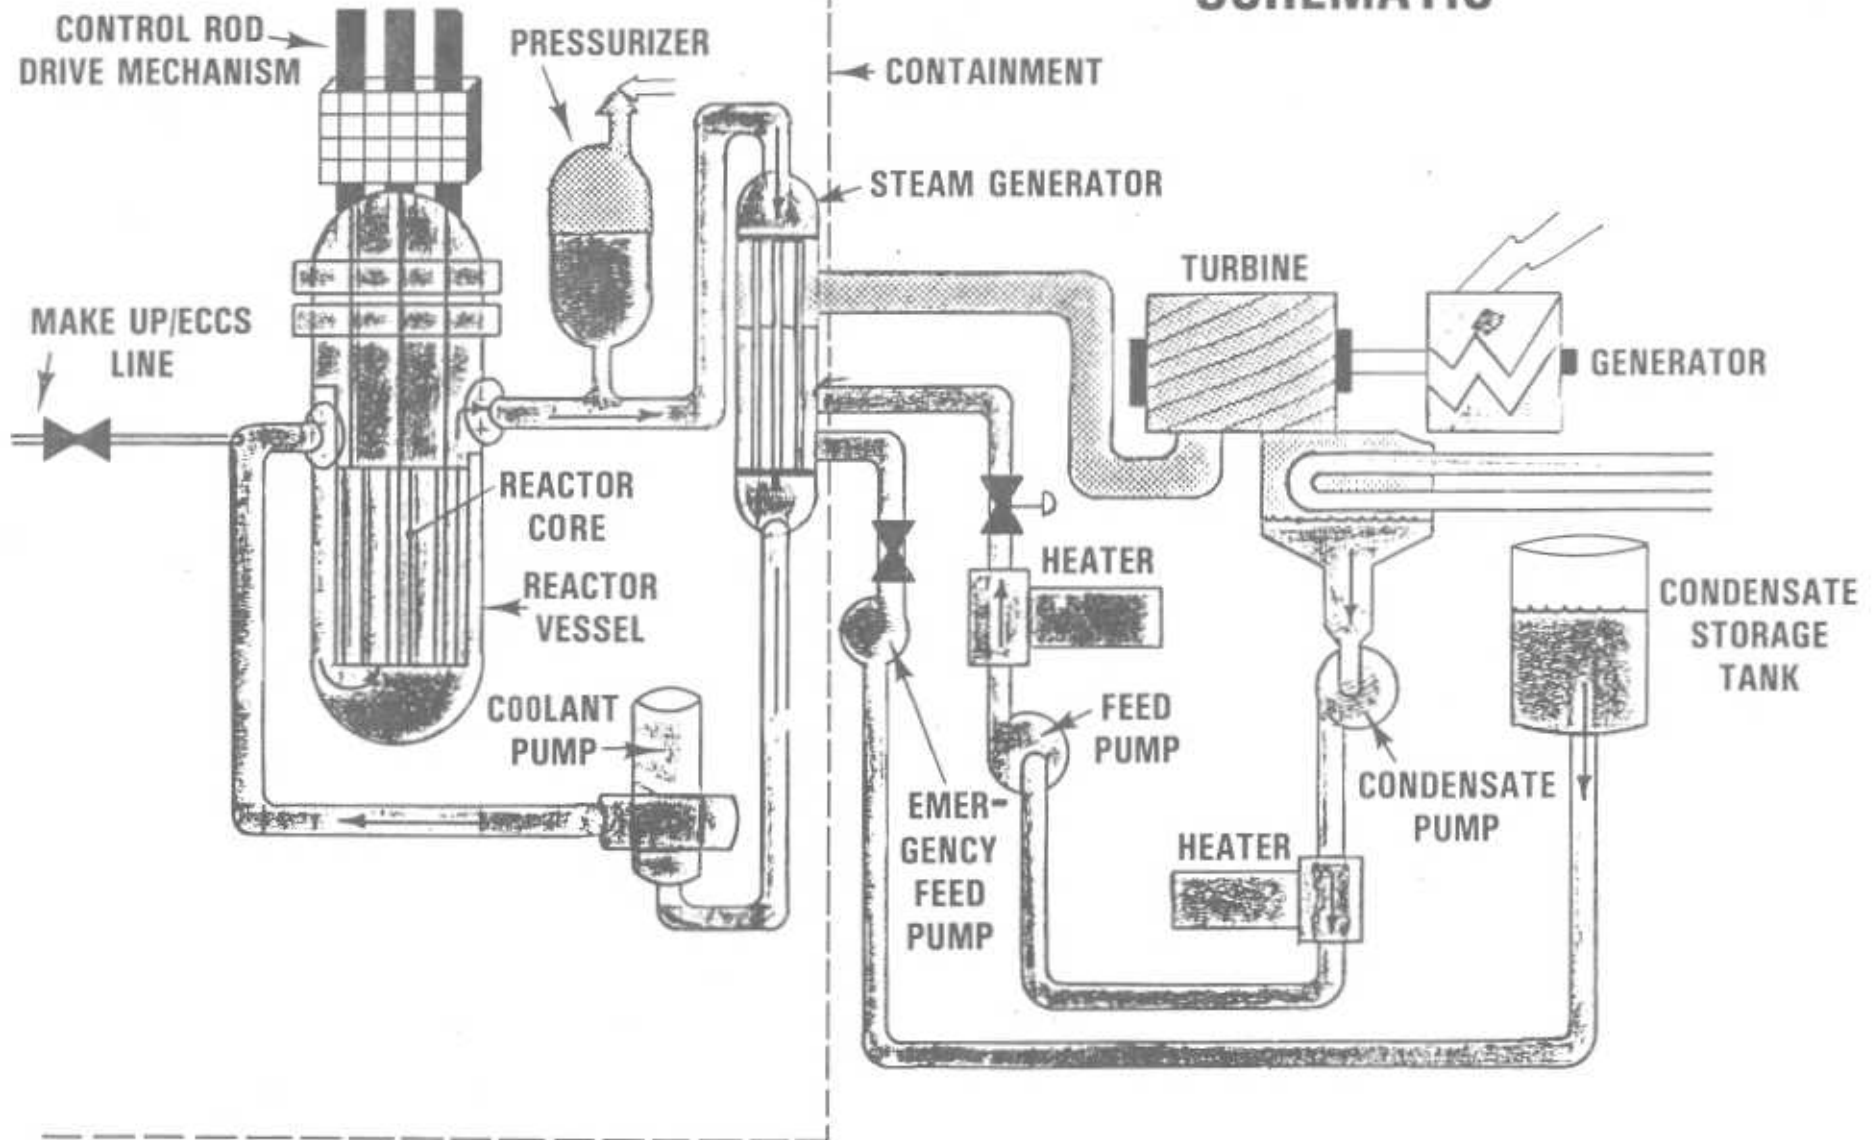
If you look to the left side of the visual aid (enclosed), you will see what we refer to as the primary coolant circuit of the plant. That portion is all contained within the reactor containment building, represented by the dashed line with the label up towards the top with the caption that says, "Containment." When you look at pictures of nuclear plants you will see generally a large cylindrical concrete structure -- that is the containment building -- of the plant.

Now let's look at some of the components within that primary cooling circuit. First let's start with the reactor core. It is there within the reactor vessel. The reactor core is a region of nuclear fuel assemblies. The core is, roughly, 10 feet in diameter and about 12-13 feet in height. The reactor itself is a heavy-walled pressure vessel that is of the order of 60 feet high and about 15 feet in diameter.

The primary system runs at about 2,000 pounds per square inch and at about 600°F. The primary coolant pump causes that water to circulate through the system. The purpose of this circulation is to transport the heat from the reactor to the steam generator.

In the steam generator, water from a separate loop (that one which starts out in the sector outside the containment building, the right hand portion of the schematic drawing) is caused to boil and absorb the heat from the reactor in the

form of high-pressure and high-temperature steam. That steam in turn then is expanded through a turbine and then is discharged from the turbine to a condenser. The steam is cooled, "condensed" and changed back to water. It then is returned by means of feed water pumps to feed water heaters and then back to the steam generator. In many ways, this secondary portion outside the containment of the plant is not at all unlike a fossil-fired power plant.

One other component that I would like to point out at this time is back in the primary loop and is the one labeled "Pressurizer." Its purpose is two-fold: 1) it is the device by which we maintain the high pressure in that primary circuit and attempt to maintain that cooling water at all times in a liquid or non-boiling state; 2) that pressurizer is used to absorb changes in volume as the primary system heats up and cools down.

Again, briefly, the heat in the reactor is transported by flowing water to the steam generator. The secondary loop of water is converted to steam in the steam generator, expands through a turbine, the turbine turns a generator and makes electricity. The discharged steam from the turbine is condensed and returned to the steam generator. The heat energy which is not converted to electricity is rejected to the environment in a third loop through the massive cooling towers that you see dominating photos of the TMI station.

At this point everything was in accordance with normal design. Immediately, however, the pressure in the primary system (the nuclear portion) began to increase. In order to prevent that pressure from becoming excessive, a valve located at the top of the pressurizer opened up. That valve (you will sometimes find it referred to as an electromatic valve) should have reclosed when the pressure decreased by about 100 pounds per square inch. However, that valve failed to reclose.

As the system pressure continued to decrease due to the stuck valve, voids began to form in portions of the system other than the pressurizer. Thus the liquid in the primary system redistributed itself and the pressurizer became full of water, but there were voids in other parts of the system. The level indicator in the pressurizer suggested that the system was full of water and caused the operator to stop adding water to the system. He was unaware that, because of the stuck valve, the indicator can, under some circumstances, become ambiguous.
