VOLUME **II** Part 2

three mile island

A REPORT TO THE
COMMISSIONERS
AND TO THE
PUBLIC

NUCLEAR REGULATORY COMMISSION
SPECIAL INQUIRY GROUP

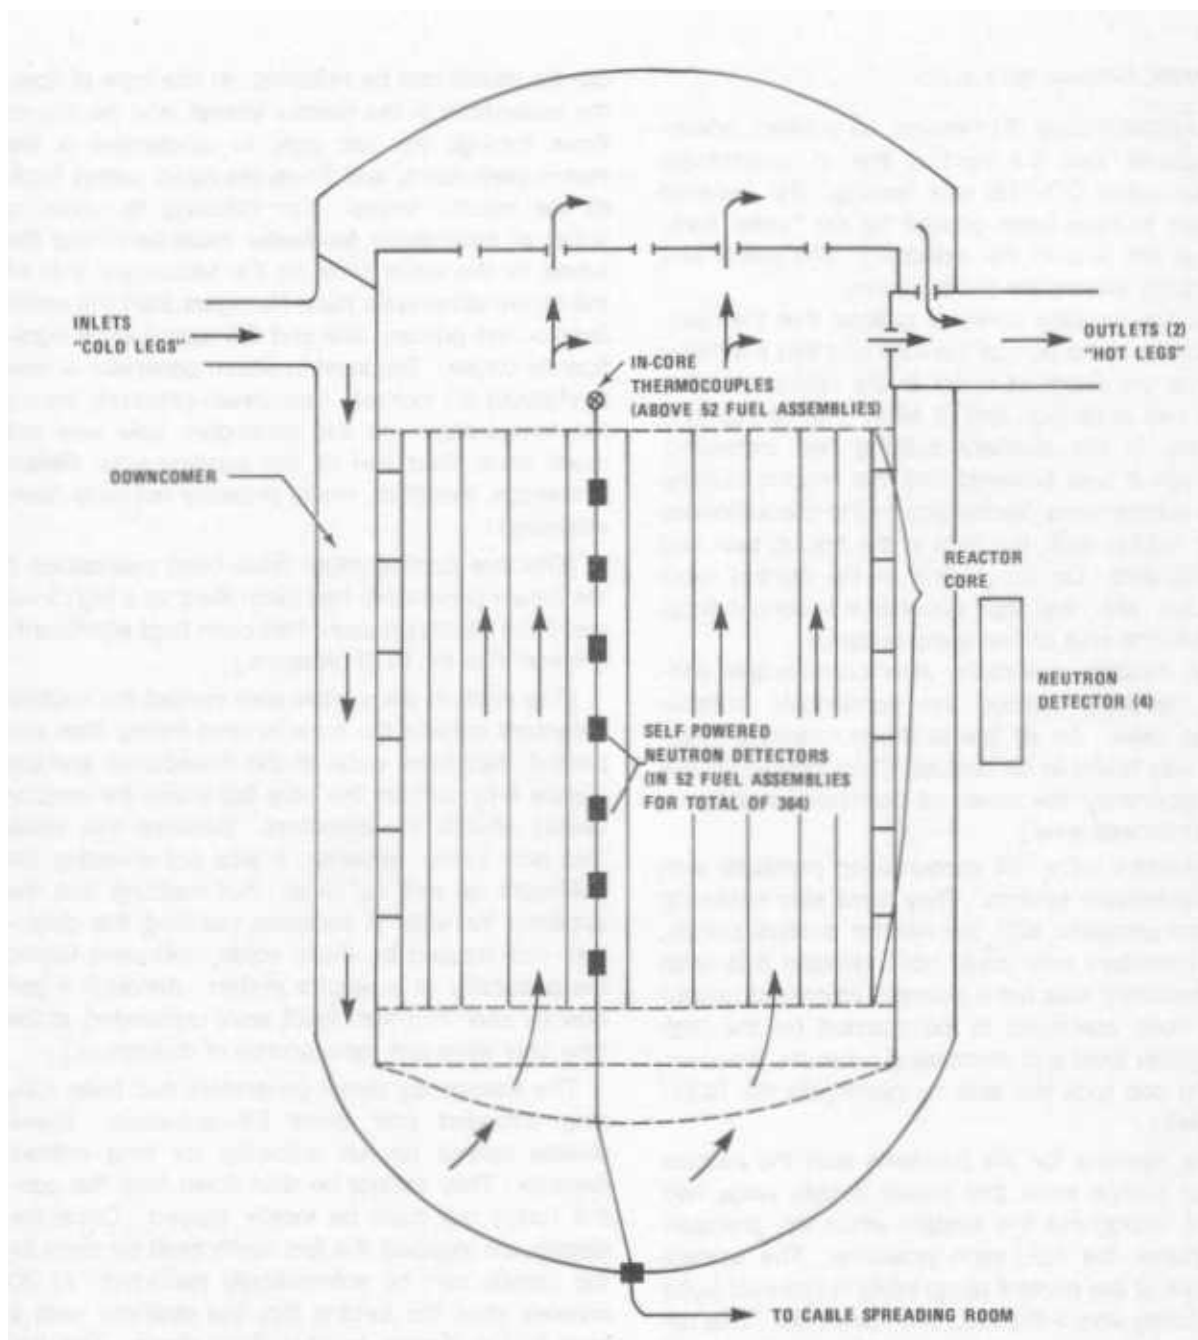
FIGURE 11-6. The Reactor and Reactor Pressure Vessel

[The voids in the system also caused the neutron detectors outside the core to read higher than expected. Normally, water in the downcomer annulus (Figure 11-6), outside the core but inside the reactor vessel, shields the detectors. Because this water was now frothy, however, it was not shielding the detectors as well as usual. Not realizing that the apparent increase in neutrons reaching the detectors was caused by these voids, operators feared the possibility of a reactor restart. Although it can now be seen that their fears were unfounded, at the time they were one more source of distraction.]

The reactor is contained in the reactor pressure vessel. Water is pumped in through the four cold legs (inlets), and flows down through the downcomer annulus. At the bottom of the vessel, the flow is reversed and the water flows upward through the core. The temperature of the water is raised as it flows past the hotter fuel rods. Thermocouples-temperature measuring devices-are installed just above the fuel rods. These devices are not in contact with the rods and, therefore, measure the temperature of the fluid that has just left the core area. Water then flows out through the two hot legs (outlets) to the steam generators. Neutron detectors are located inside the core. In addition, there are two sets of detectors outside the reactor pressure vessel. The source range detectors read relatively low neutron levels. Before the upper limit of the source range is reached, the intermediate range detectors pick up and continue recording higher levels than the source range can read. No instruments are provided for reading the level of water in the reactor vessel.

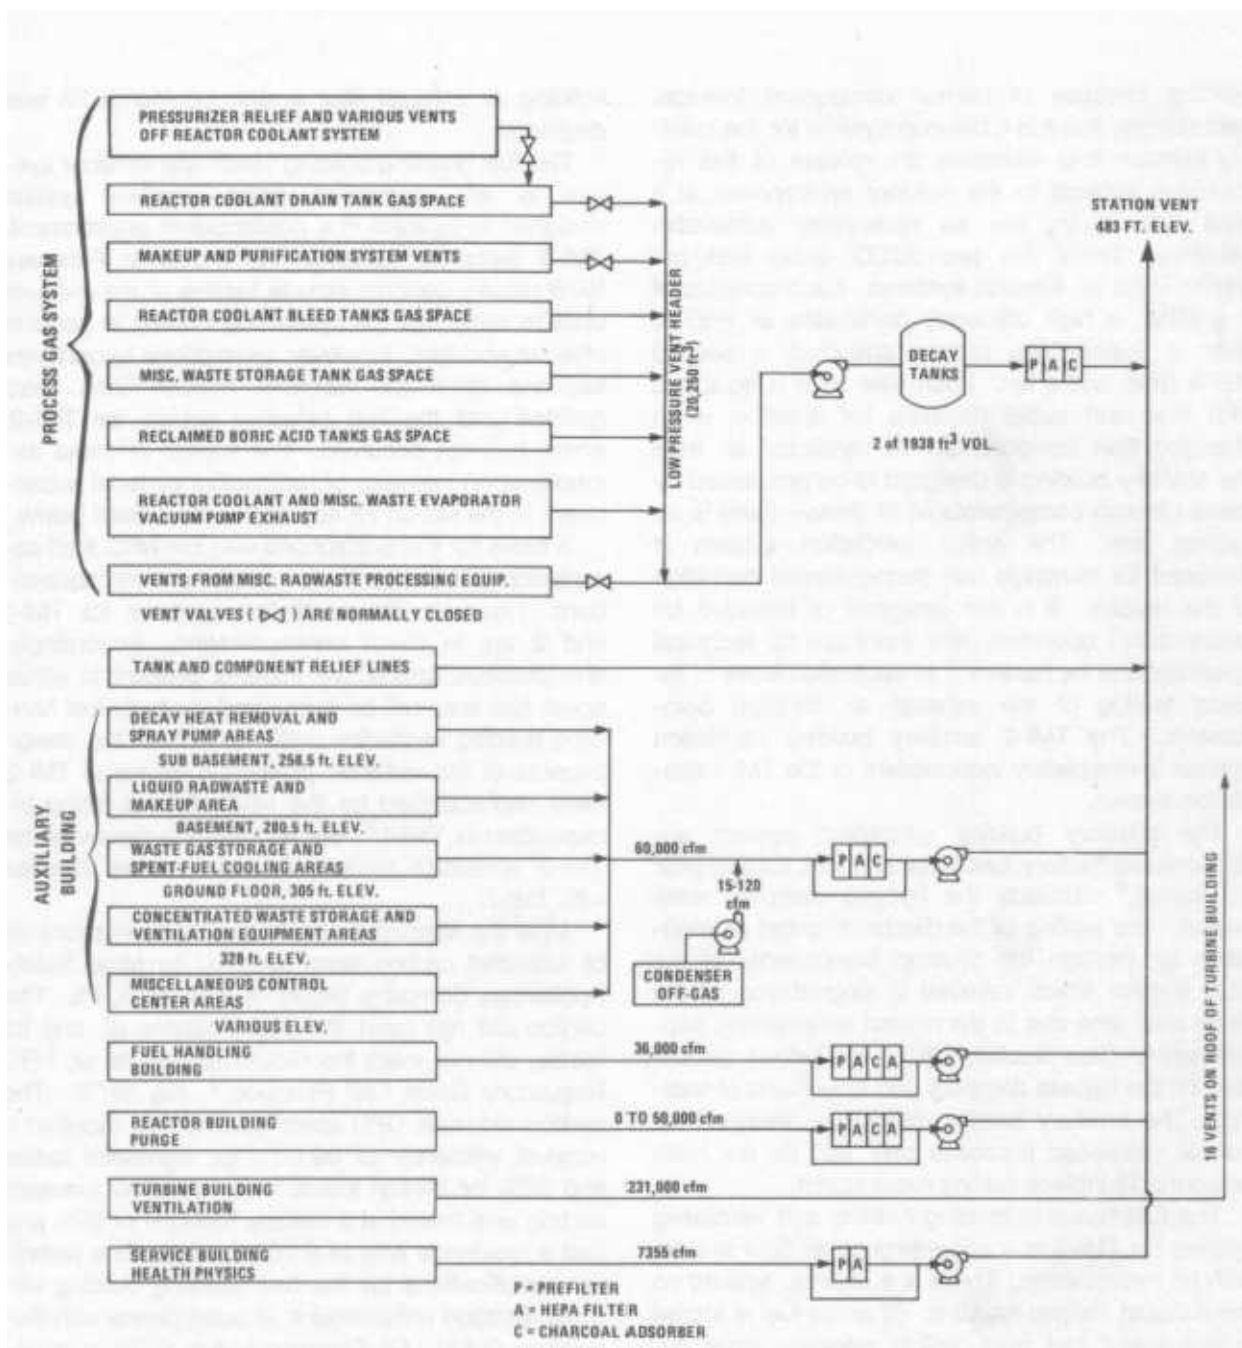
FIGURE 11-9. Ventilation and Waste Gas System Release Pathways

The process gas system collects and stores the radioactive gases stripped from the primary coolant in the letdown line and also the gases from the reactor building vent header and vent gases from equipment. The low pressure vent header collects these gases and pipes them to one of two waste gas compressors (40 scfm) for compression and storage in the gas decay tanks. This storage allows radioactive decay before release to the environment. Releases are directed through a HEPA filter, to remove particulate material, and a carbon adsorber, to remove gaseous radioiodine species.

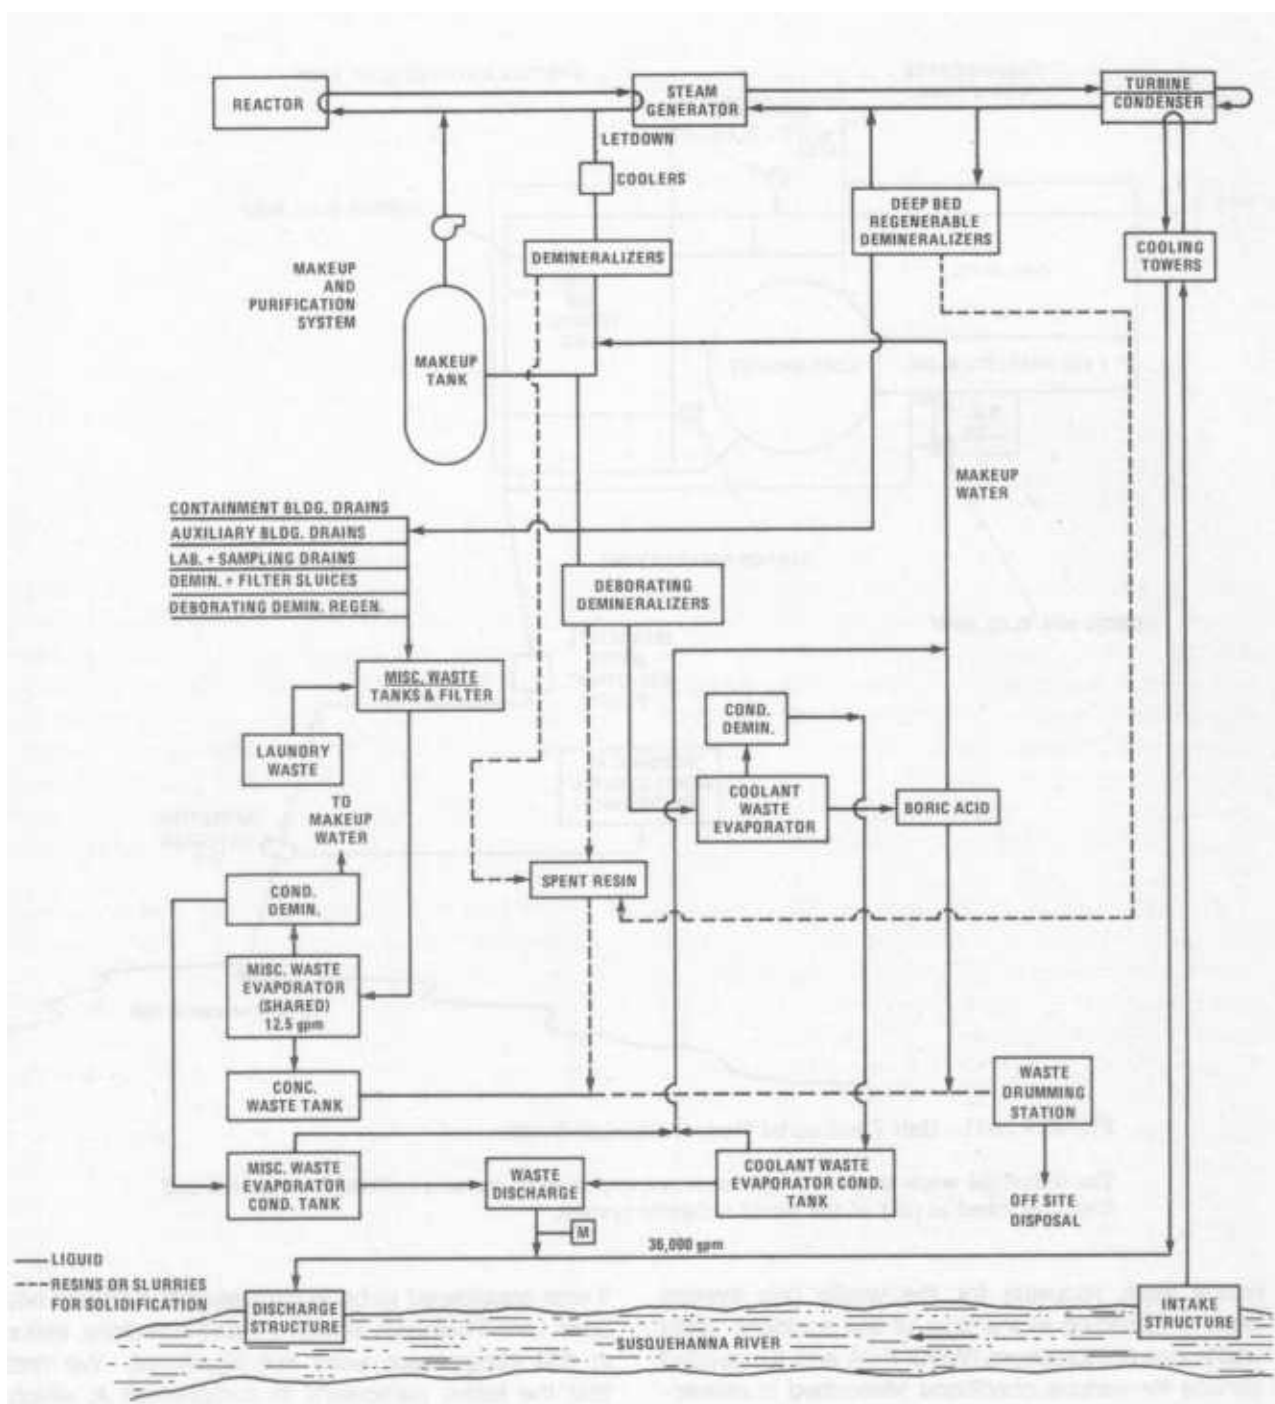
FIGURE II-10. Liquid Radioactive Waste Treatment System

The liquid radwaste treatment system treats the liquid radwaste before release to the environment. The letdown stream is a designed pathway for primary coolant to enter the cleanup components in the auxiliary building.

capacity for the site. Accordingly, we find that for normal operations the liquid radwaste storage and treatment system was marginal at best.

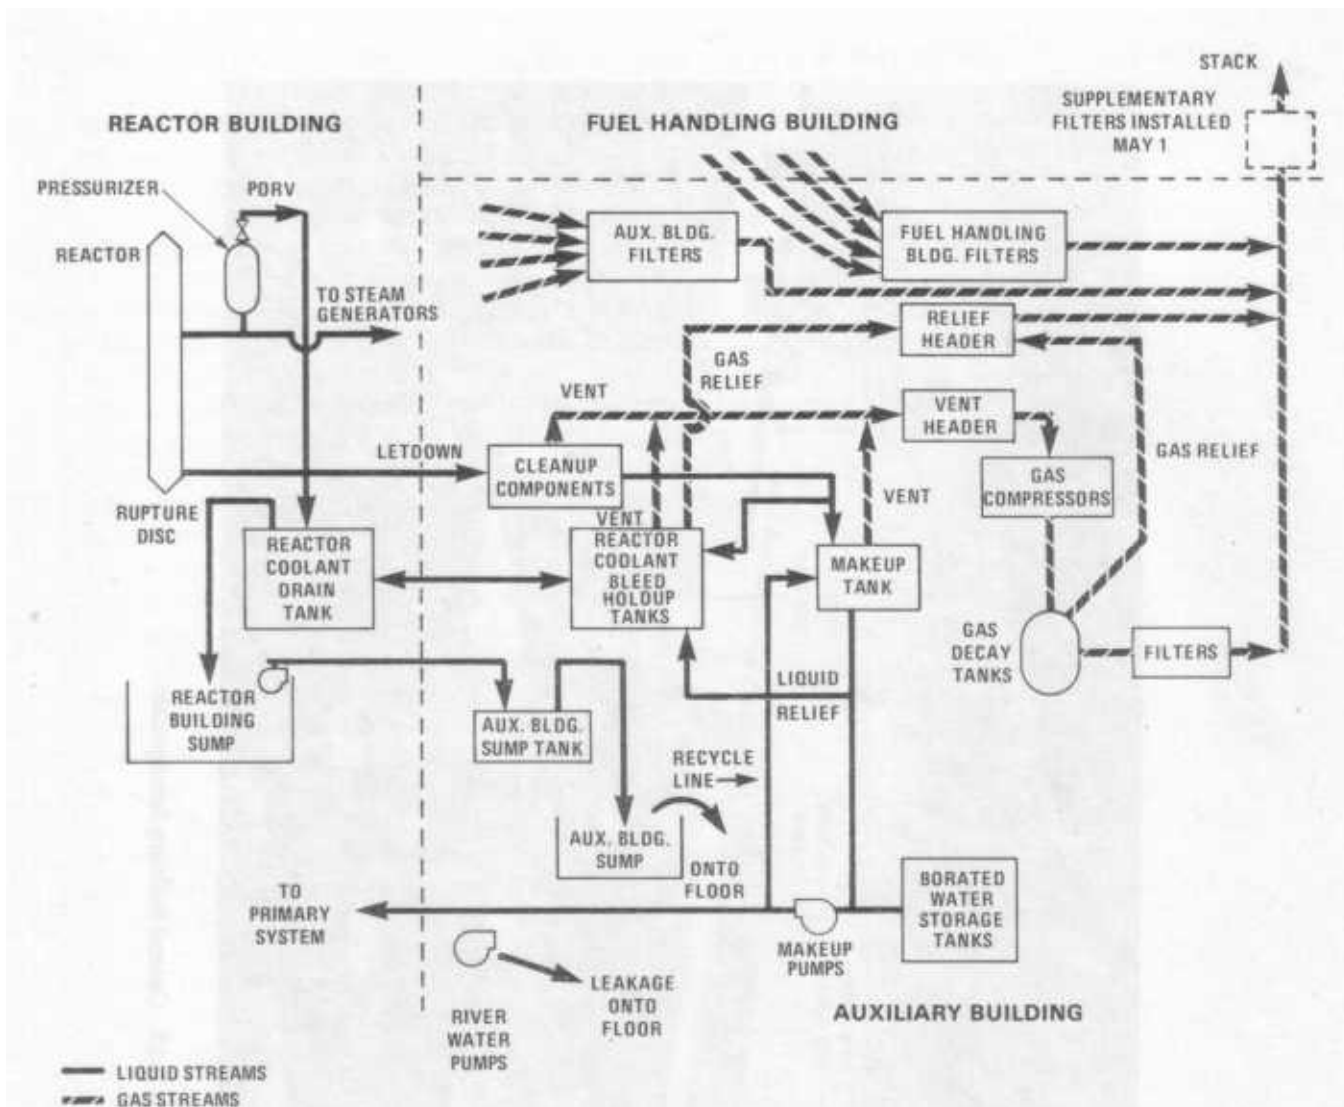
FIGURE 11-12. Release Pathways

The vent line from the reactor coolant drain tank to the vent header was open on March 28, as indicated by the open status of valves WDL-V-126 and V-127.²⁴ The high pressures in the reactor coolant drain tank forced liquid (primary coolant) through the vent line to the vent header. The vent header relief valve (WDG-R-3) is set at 150 psig, so water under pressure caused leaks in the water drains. This water also damaged some of the 10 check valves located between the vent header and connected tanks (such as WDG-V-113 to the reactor coolant bleed holdup tanks, or WDG-V-153 to the reactor coolant evaporator). These check valves are designed to permit flow only from the component to the vent header and not in the opposite direction, but are known to operate inefficiently and fail easily.²⁵ Therefore, a significant pathway existed from the vent header to a number of tanks. The relief valves on these tanks, which were set at relatively low pressures (reactor coolant bleed holdup tank at 20 psig, reactor coolant evaporator at 10 psig), opened. Lifting of these relief valves resulted in untreated releases directly to the stack via the relief valve vent header (shown in Figure 11-12). We find that the gaseous radwaste system design included "relief to atmosphere," which provided a path to the environment for untreated gas. We find, also, that the high reactor coolant drain tank pressures between 4:00 and 4:30 a.m. on March 28 damaged portions of the vent gas system and resulted in a gaseous release pathway to the vent header, through failed check valves to components with low-pressure relief valves. Once established, this release path was available whenever the vent header was used, such as in the venting of the makeup tank.

Continued operation of the letdown transferred primary coolant from the reactor to components in the auxiliary building. Pressure buildup in components due to degassing of the hydrogen and noble gases in the letdown system caused gaseous leakage to the auxiliary building and operation of relief and vent valves to release gaseous radioactivity to the auxiliary and fuel handling buildings and to the environment.

Each time the makeup tank was vented, the radiation levels inside and outside the plant increased. The pathway for the gaseous activity from the makeup tank venting process and for other component vents is shown in Figure 11-12. Cleanup components in the letdown and the makeup tank have manually operated vents that discharge to the vent header. During normal operation, vented gases are held up and filtered prior to release.

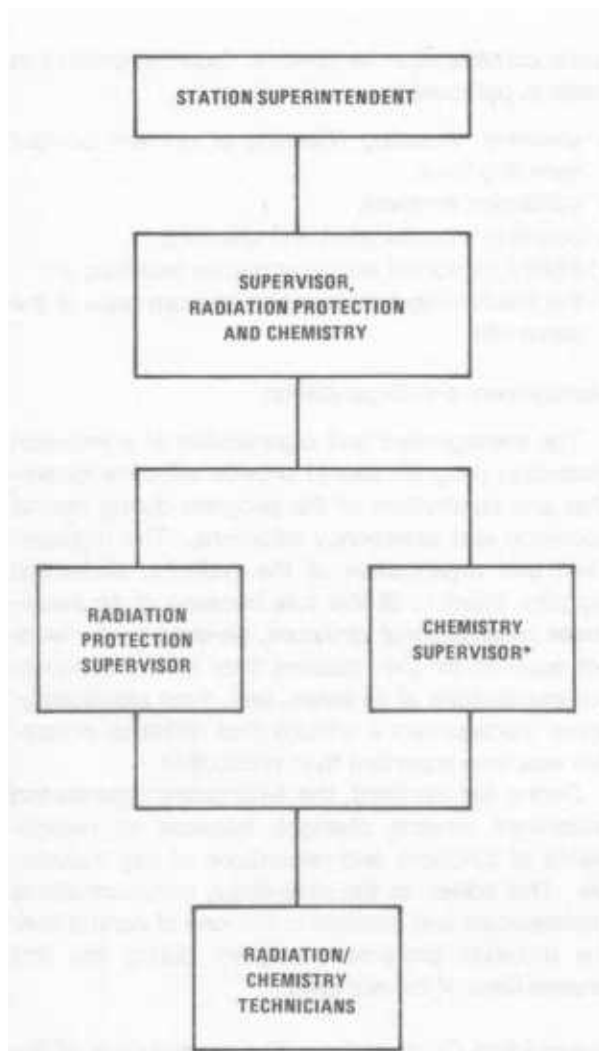
FIGURE 11-16. Organization of the Radiation Protection and Chemistry Staff as Indicated in Technical Specifications, Figure 6.2-1.

Preaccident Organization- The organization of the radiation protection staff was approved by the NRC staff and is shown in Figure 11-16. This organization has the Supervisor of Radiation Protection and Chemistry, Richard Dubiel, reporting directly to the station superintendent, the senior plant official. However, a different organization (Figure 11-17) was prescribed by Met Ed at the time of the accident, which added another level of management between Dubiel and the senior plant official. Moreover, Dubiel actually reported to the unit superintendents. ²²⁴ Dubiel's theoretical and actual reporting responsibilities ²²⁵ were inconsistent with the technical specifications.

* REMAINED UNFILLED SINCE ISSUANCE OF THE TECHNICAL SPECIFICATIONS. THE DUTIES AND RESPONSIBILITIES OF THIS POSITION WERE BEING FULFILLED BY THE SUPERVISOR, RADIATION PROTECTION AND CHEMISTRY AND THE CHEMISTRY FOREMEN.

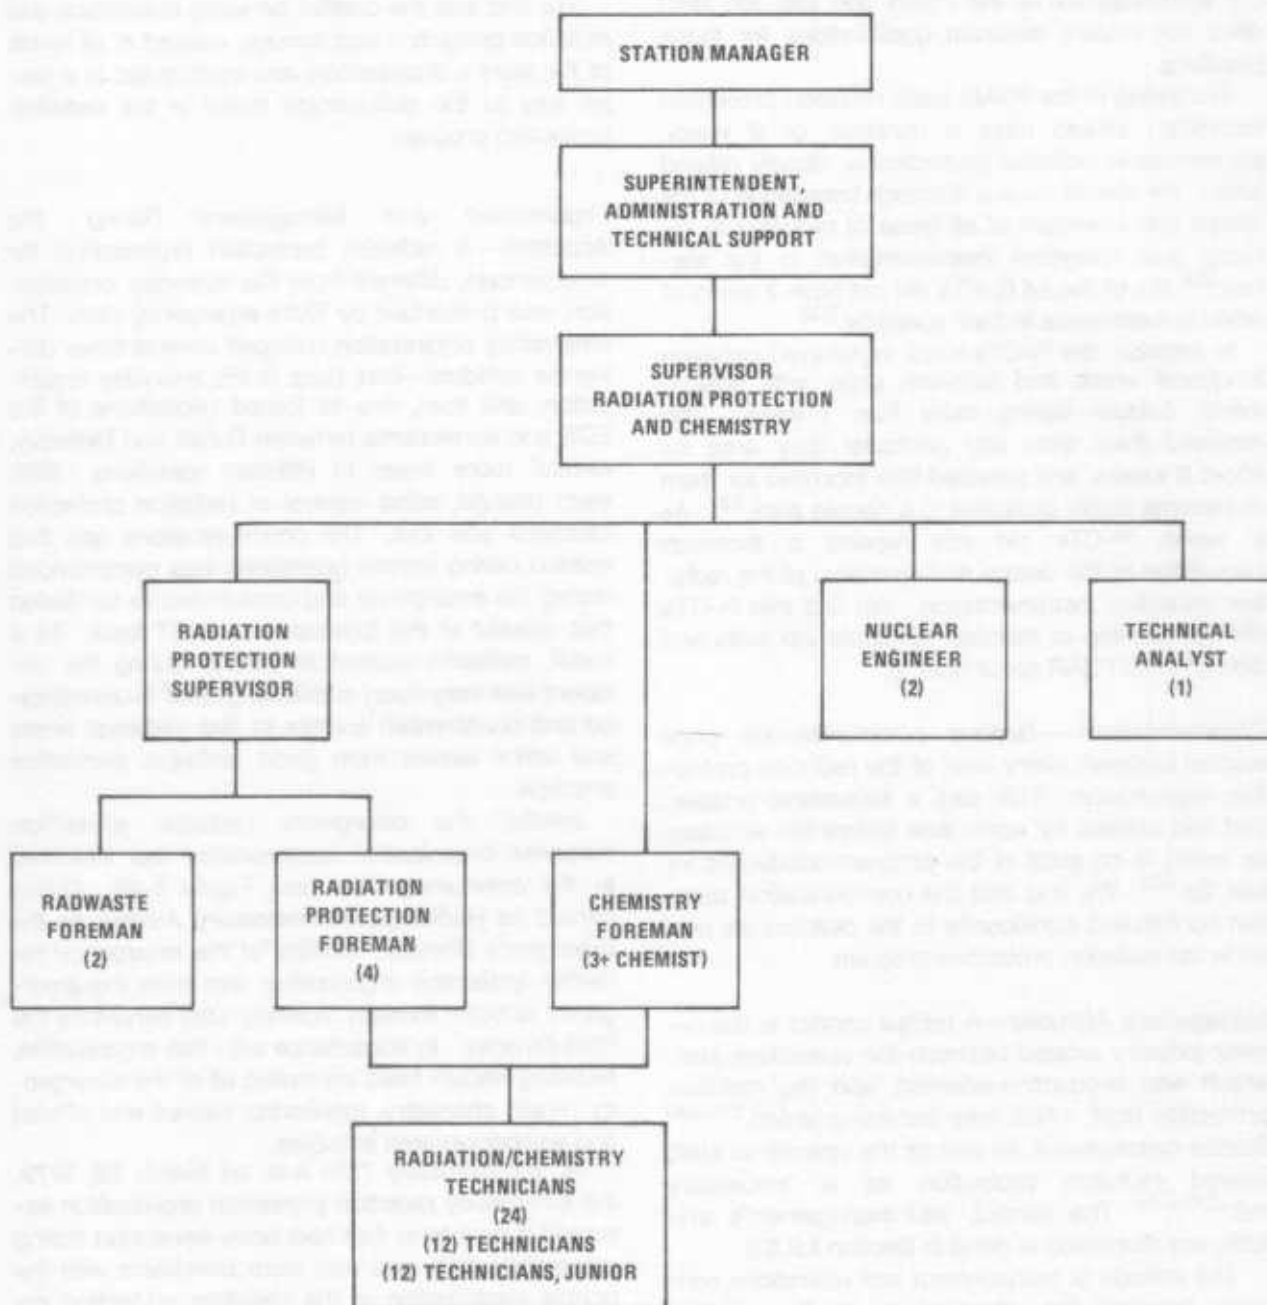
FIGURE 11-17. Actual Organization of TMINS Radiation Protection and Chemistry Staff Before March 28, 1979 (NUREG-0600, P.II-1-2)

Dubiel's time and attention were spread much too thinly because: (1) he was acting (in conjunction with the chemistry foremen) as chemistry supervisor, (2) he had the additional burden and responsibilities of running the radiation protection program for a two-unit station, and (3) he had too many people reporting to him.²²³ As a result, we find that Dubiel did not function as the RPM as defined in

Regulatory Guide 1.8, and that the role fell, by default, to Mulleavy, who was not qualified for this position.

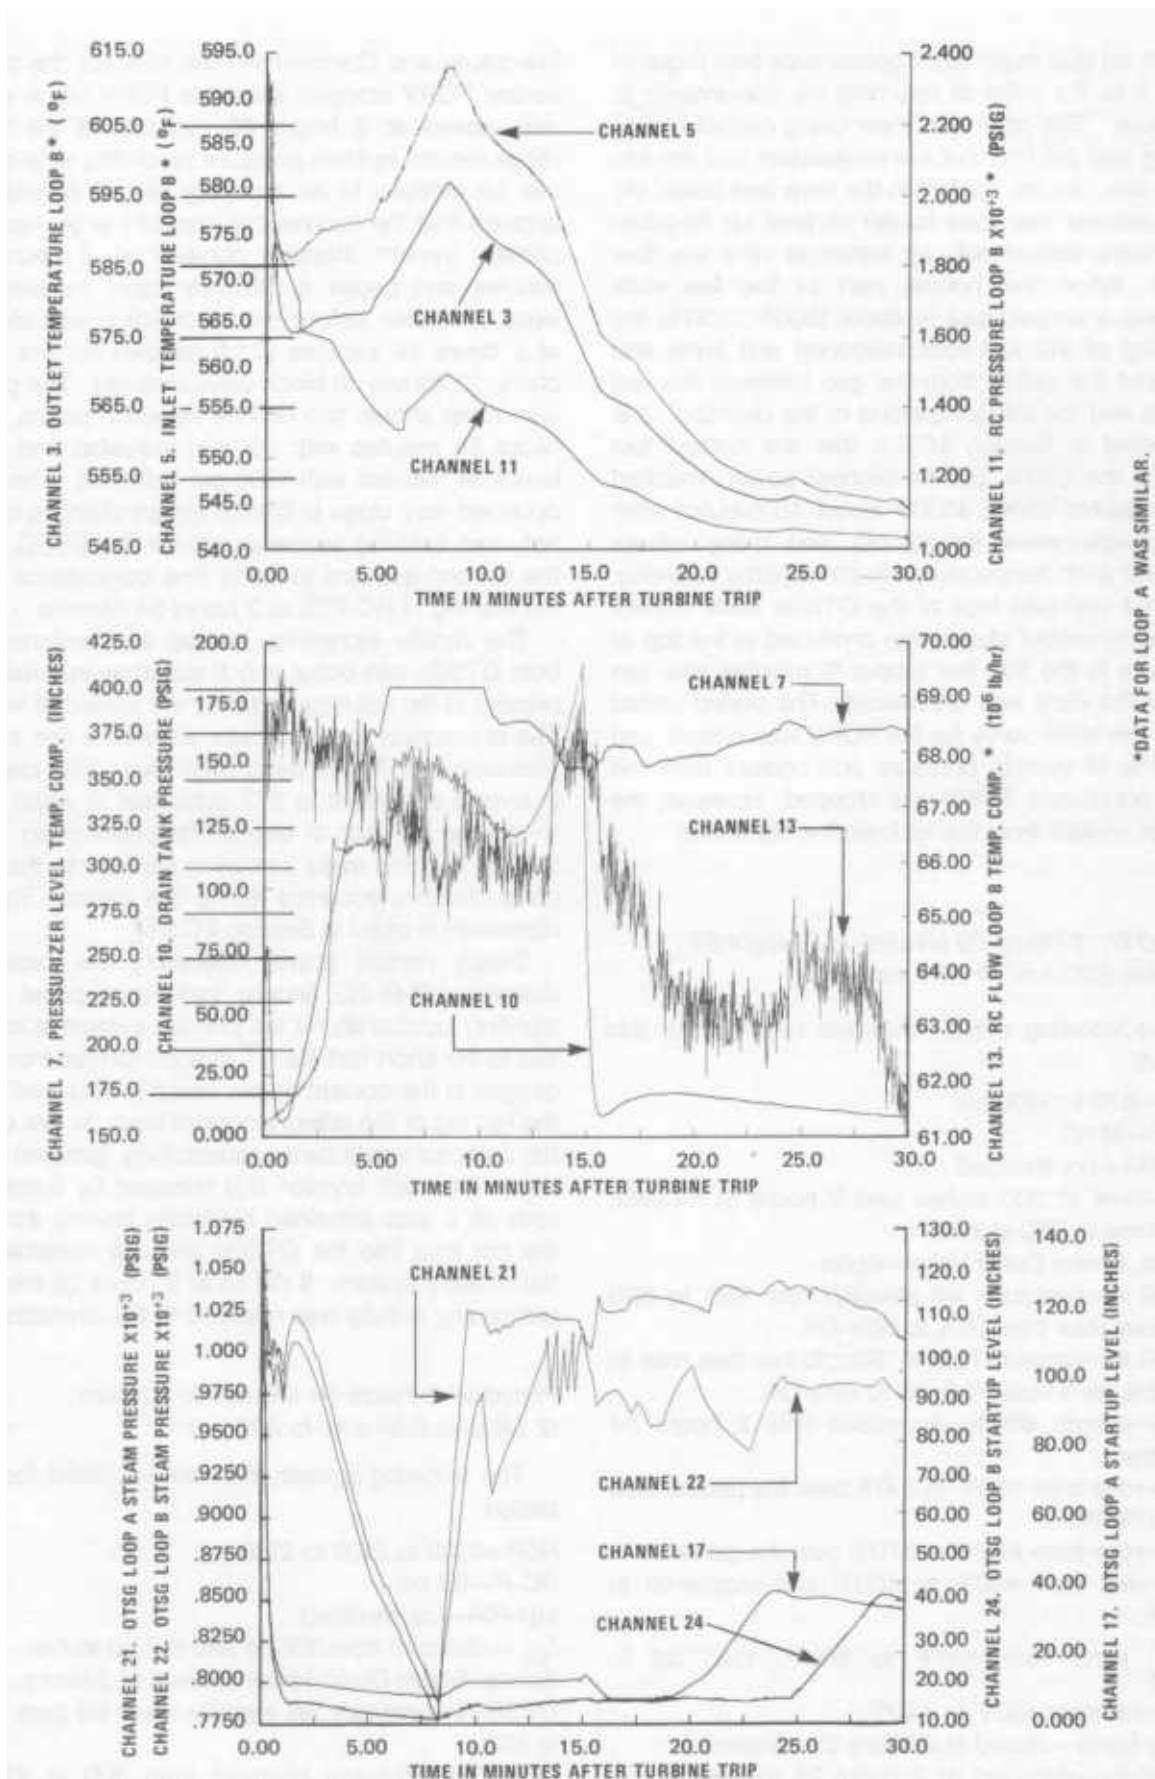
FIGURE 11-26. System Parameters for the First Thirty Minutes of the TMI-2 Accident

range. (This may be a minimum reading for the instrumentation, rather than a "zero" on the scale used.) System parameters for the first 30 minutes are shown in Figure 11-26.

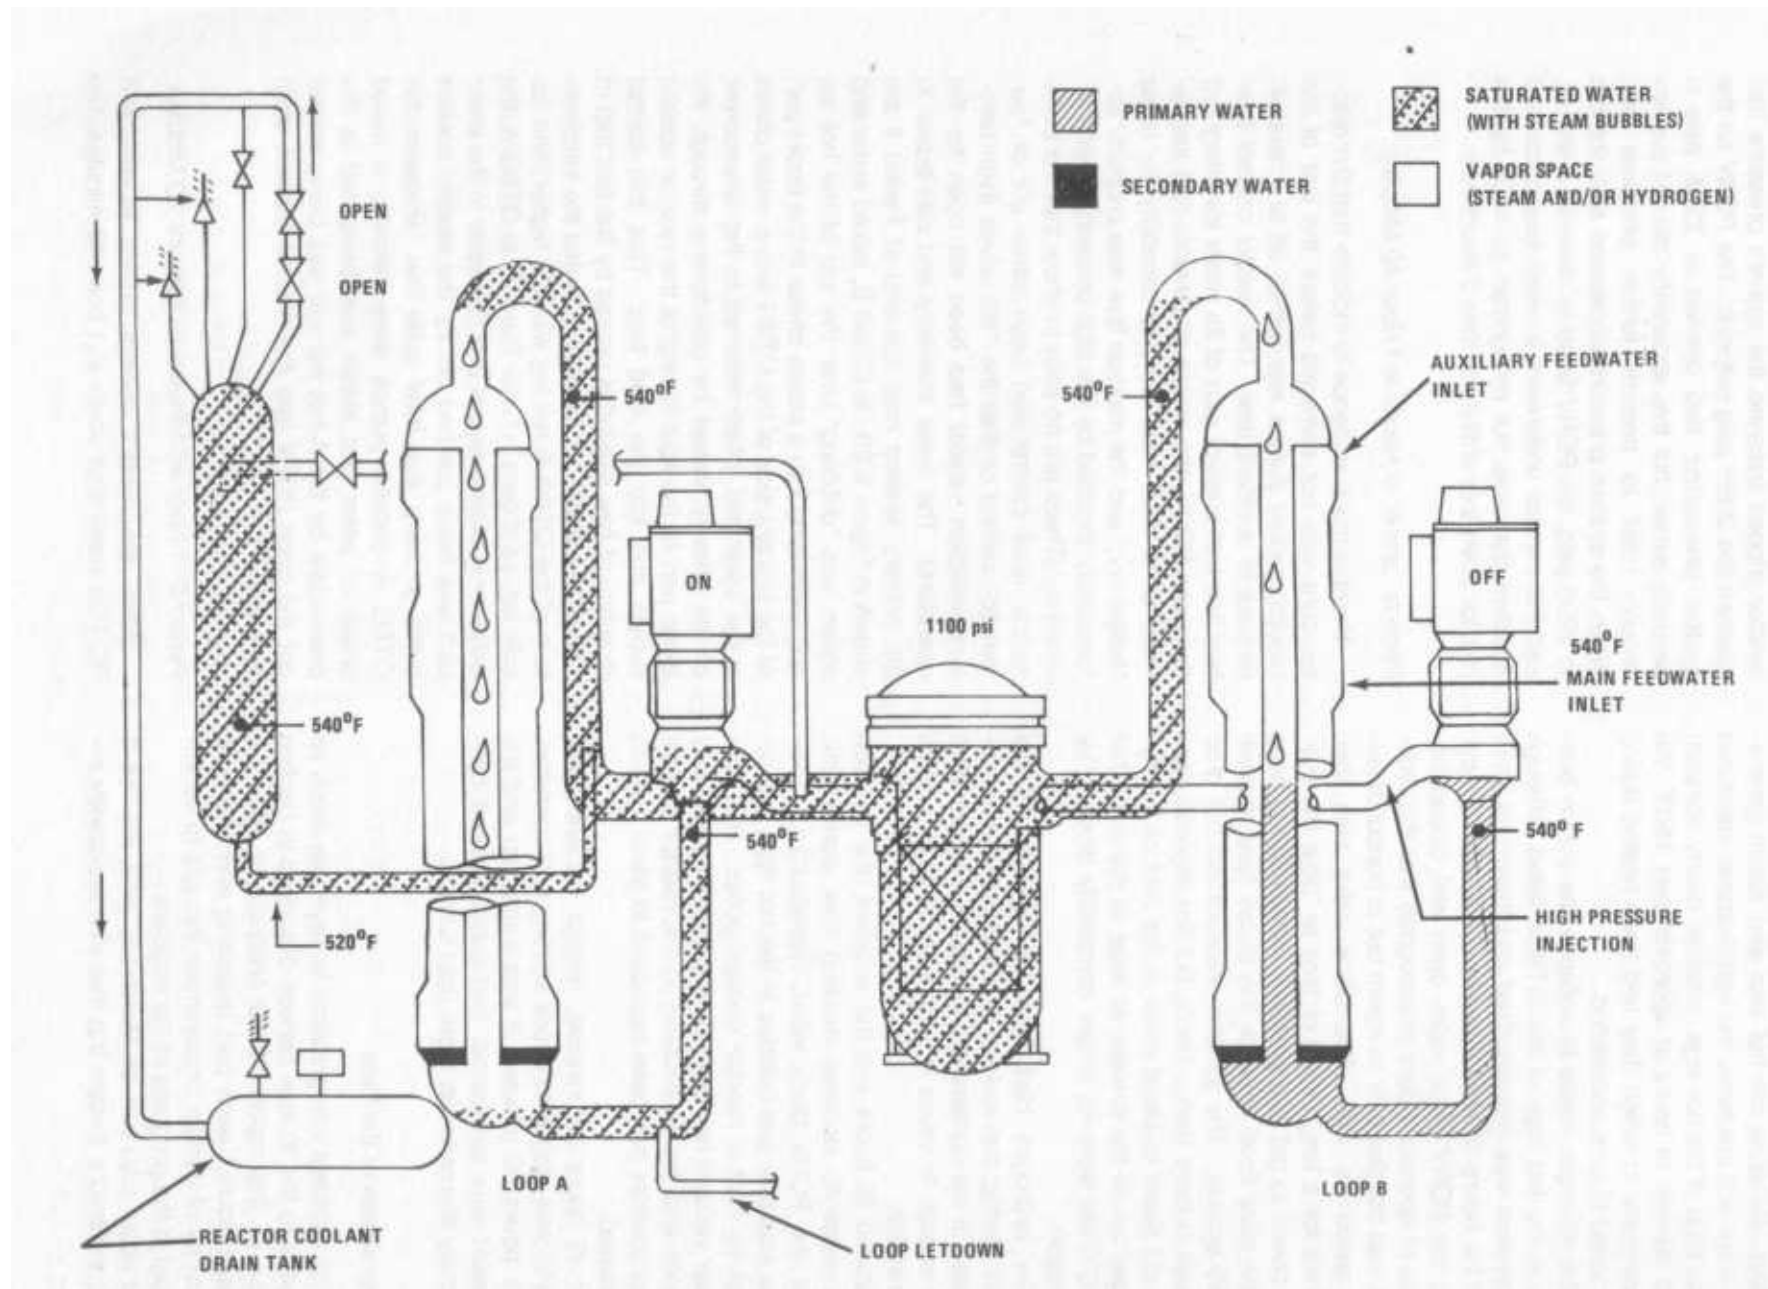
FIGURE 11-29. Reactor Primary System at 90 Minutes

two-phase mixture of water and steam that had been circulating separated into a steam phase in the upper parts of the reactor primary system and a water phase in the lower parts.

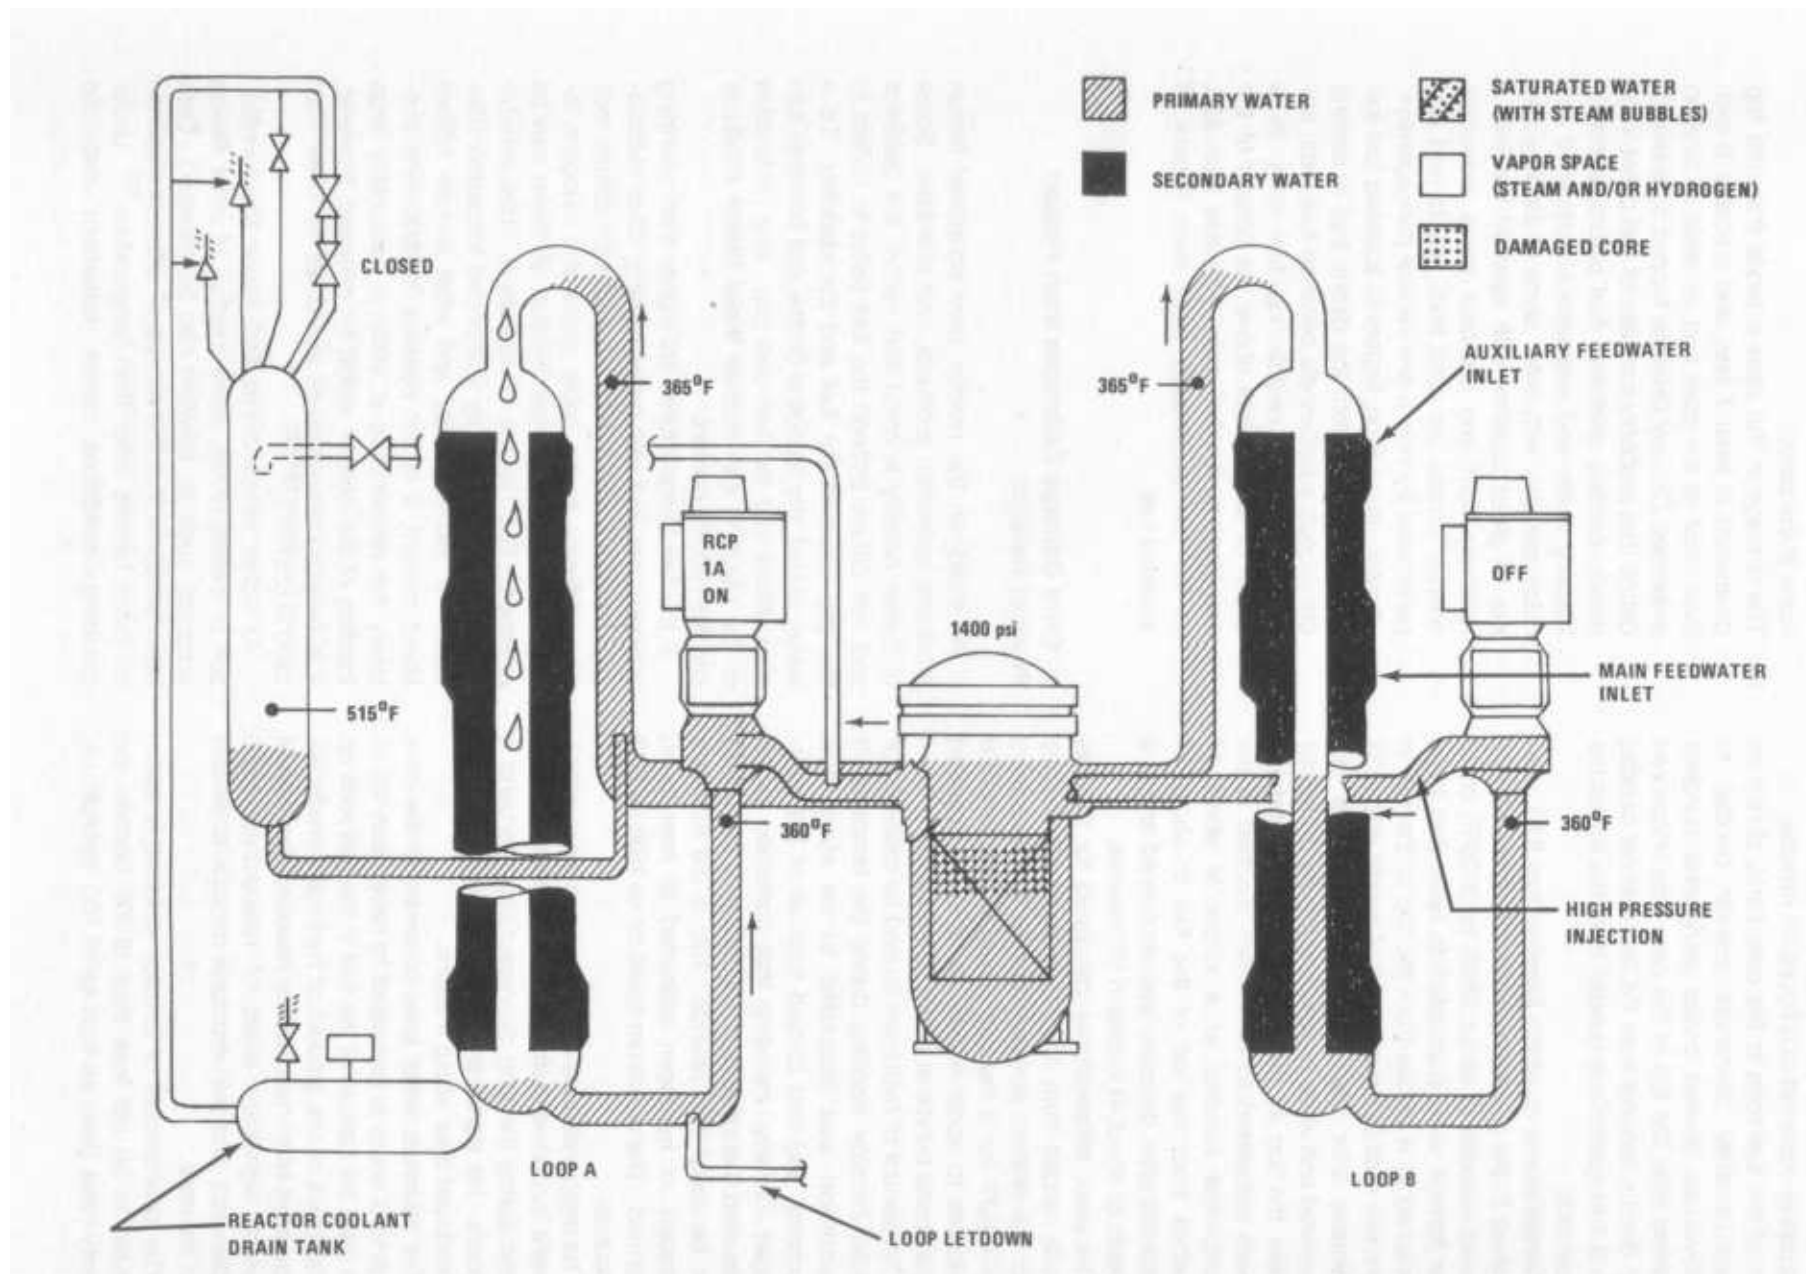
FIGURE 11-32. Reactor Primary System at 16 Hours

The distribution of the water and gas inventory of the primary system at 16 hours is shown in Figure 11-32. At that time there were four gas bubbles in the system, one in the top of each OTSG, one in the top of the pressure vessel, and one in the pressurizer. Coolant water was being pumped through the hot leg of OTSG A, flowed over the top of the candy cane, and dropped through the gas bubble to fill the lower part of the OTSG and be recirculated by the pump. The reactor pressure vessel was filled above the hot-and cold-leg nozzles, and hydrogen was trapped in the pressure vessel head.

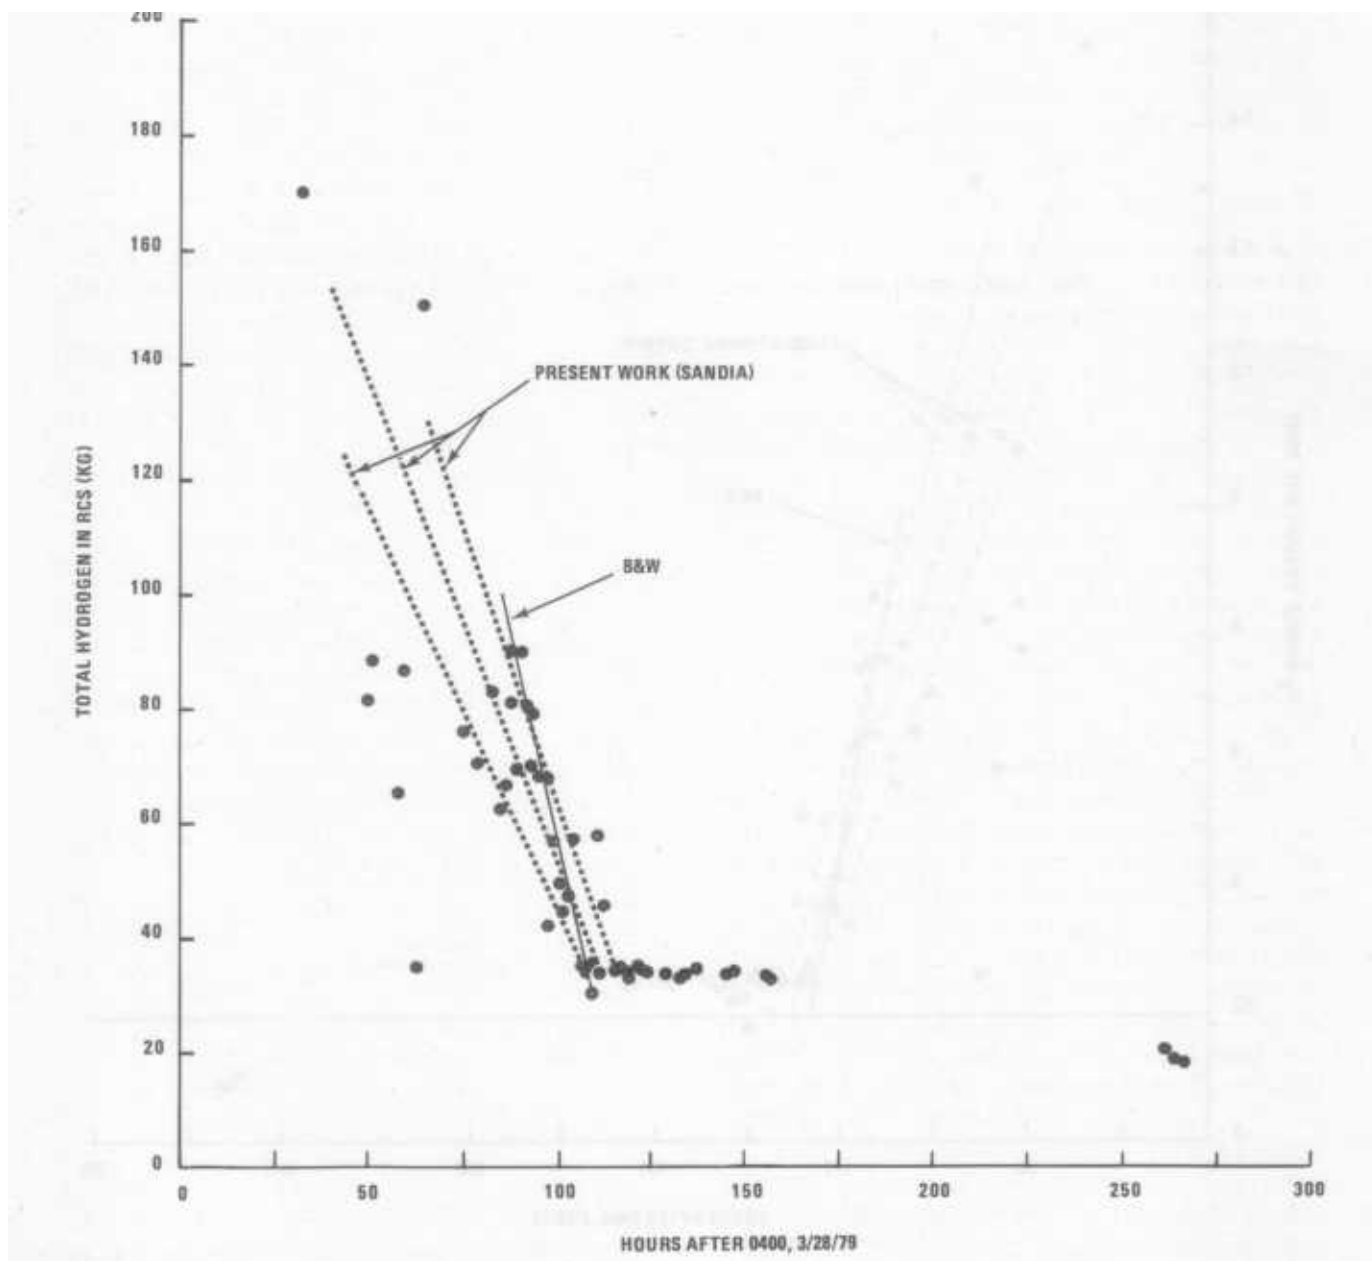
FIGURE 11-33. Total Hydrogen in RCS

principle-the compliance of a liquid containing a gas bubble-was used by each organization. After the accident, Sandia carried out an independent investigation²⁰⁷ at the request of the TMI Special Inquiry Group. The results of the latter study, as given in Figures 11-33 and 11-34, show that the bubble was about 1470 ft³ at 2:00 p.m. on March 28 and was completely gone by 6:00 p.m. on April 1.

taken to be the intercept with the horizontal axis in Figure 11-33. The data show that the bubble had disappeared between 3:00 and 9:00 p.m. on April 1.

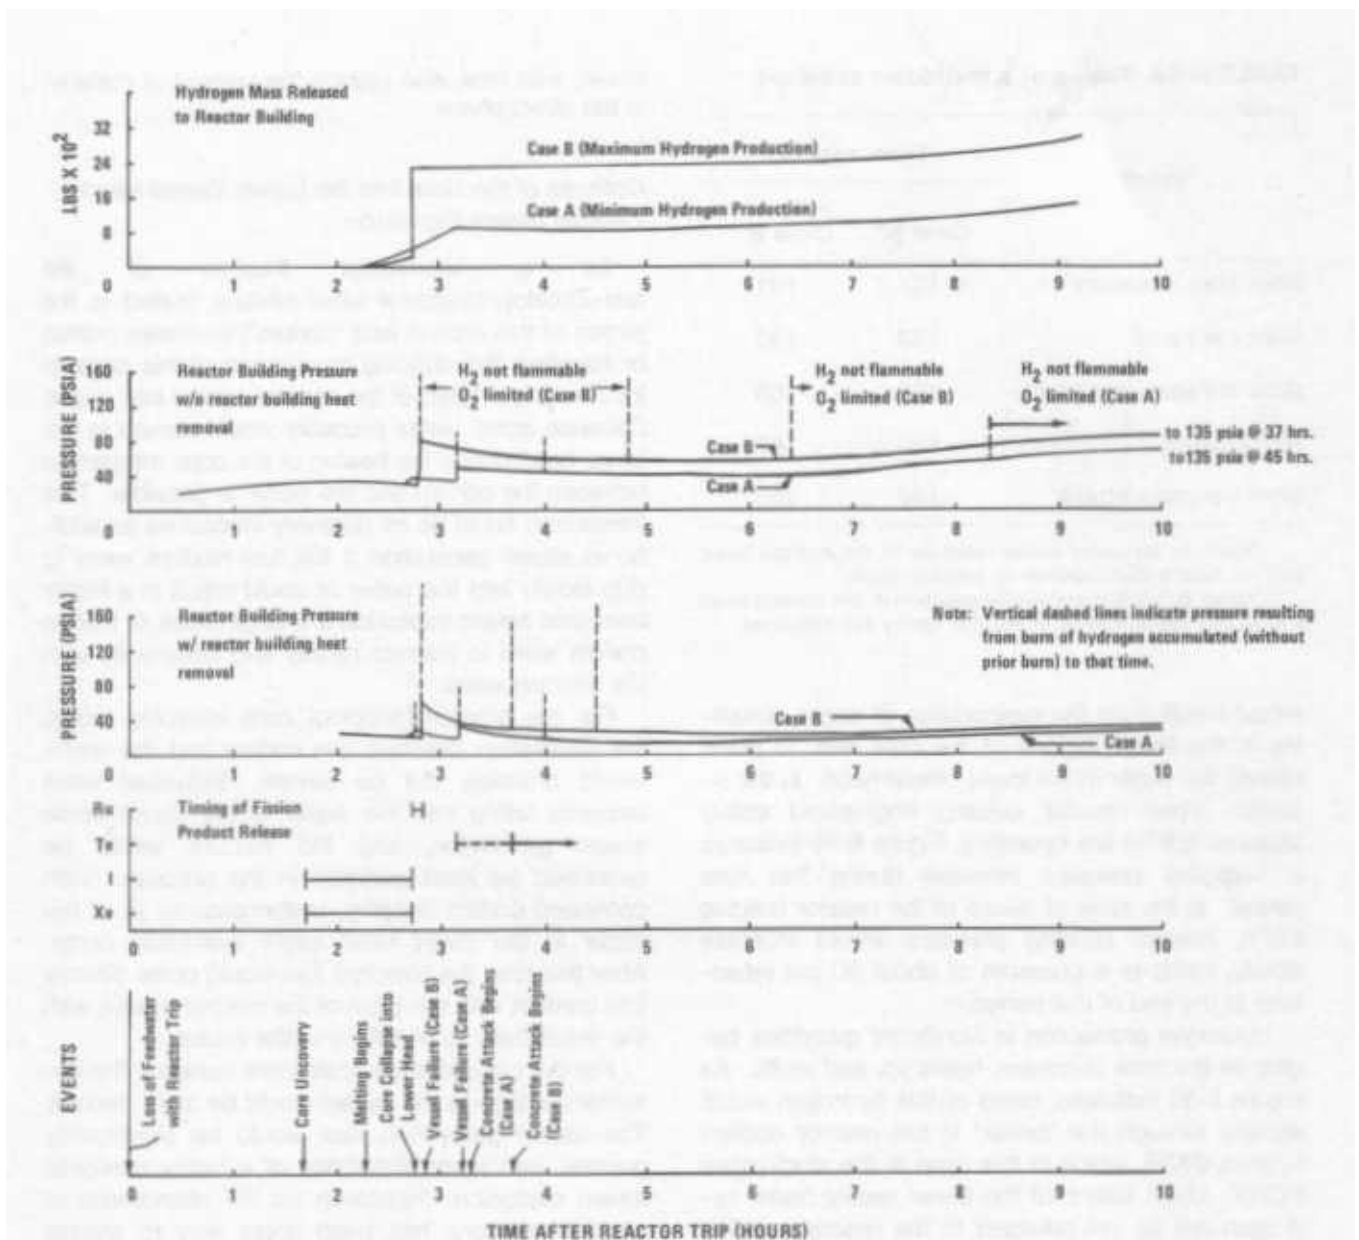
FIGURE 11-36. Reactor Building Response

In Figure 11-36, reactor building pressure resulting from minimal fragmentation and fragmentation into roughly 2-inch diameter fragments are shown; pressures just after the collapse into the cavity are indicated as about 31 and 65 psia, respectively. Neither of the pressures by itself would be expected to result in reactor building failure.

Figure 11-36 shows the calculated reactor building response to two particular combinations of hydrogen burning and steam generation. Case A in the figure represents a lower bound to the combined effects; that is, no metal-water reaction is presumed to occur as the core collapses into the lower vessel head, and no significant fragmentation of the corium mixture is assumed as it falls into the reactor cavity. Case B represents an upper bound for combined effects of these phenomena. Total reaction of the Zircaloy is assumed, as is significant fragmentation of the corium as it falls into the reactor cavity.

Figure 11-36 indicates that the operation or failure of the reactor building ESFs does not significantly affect the likelihood of building failure in the period up to and including the time of vessel failure. However, in the longer term, failure of the building air cooling system could lead to failure of the building by overpressurization. For the particular accident discussed, failure of the building coolers is predicted to result in building failure about 1 1/2 to 2 days after the beginning of the accident (presuming no restoration of building cooling is possible). Natural deposition processes could be expected to reduce the amount of radioactive material in the building atmosphere over such long time periods, so that a long term overpressurization would be expected to result in greatly reduced consequences compared with building failure early in the accident. The differing outcomes from having or not having the reactor building ESFs are therefore shown in Figure 11-35 to demonstrate the effect that the features can have on the integrity of the reactor building and the resulting consequences of the accident. During the first day of the TMI-2 accident, these safety features were known to have automatically actuated and operated successfully;²²⁷ as such the "most likely" accident path in Figure 11-35 indicates that the features would be available.

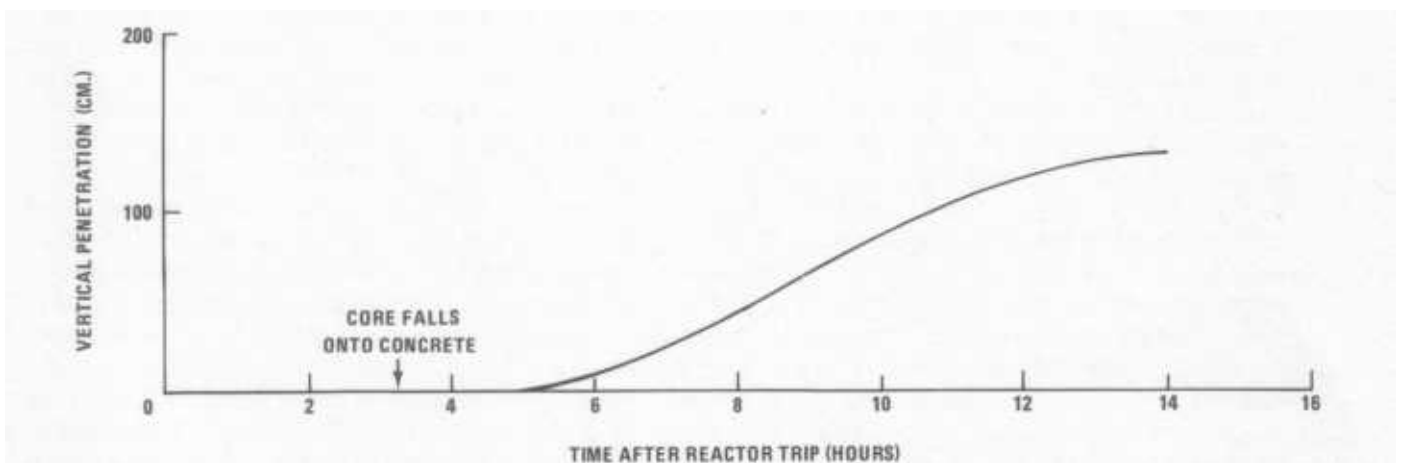
FIGURE 11-37. Penetration of the Reactor Building Base Mat (Timing Related to Case A in Figure 11-36)

As the corium-concrete interaction continues, the decomposition of additional concrete would result in further noncondensable gas generation and dilution of the corium mixture. The combined effect of the reduction in the corium power density (caused by the dilution effect), the expenditure of energy to decompose the concrete and other energy losses (such as radiative and convective cooling) would result in a gradual cooling of the corium mixture. Thus, as the interaction continues, the rate of base mat penetration and the mixture temperature would decrease. This effect is apparent in Figure 11-37, which shows that as time progresses the rate of penetration would gradually decrease.
