VOLUME **II** Part 2

three mile island

A REPORT TO THE
COMMISSIONERS
AND TO THE
PUBLIC

NUCLEAR REGULATORY COMMISSION
SPECIAL INQUIRY GROUP

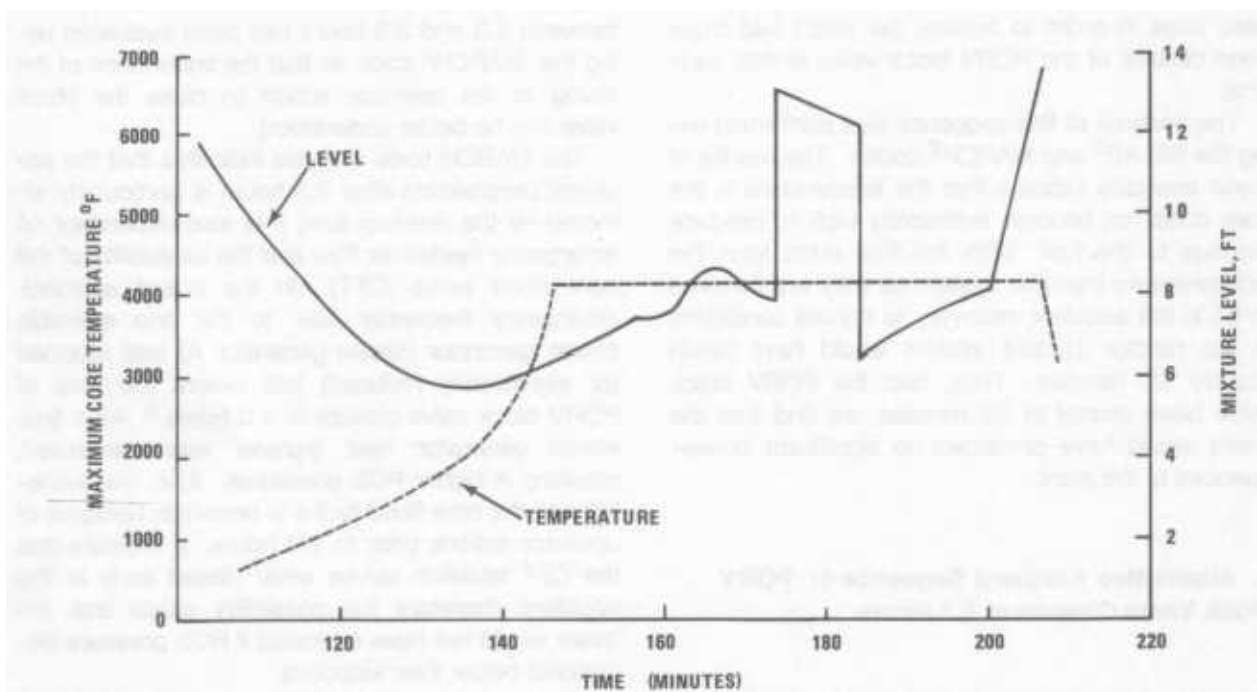
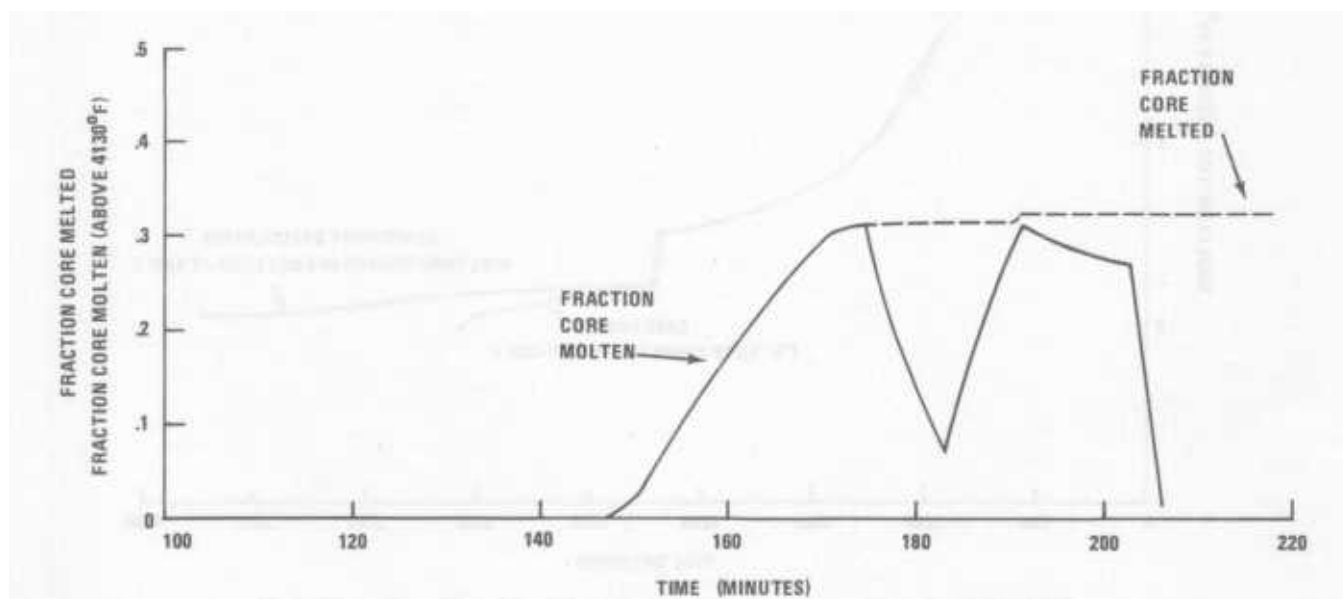
FIGURE II-41. Effect of Delay in PORV Block Valve Closure Until 3.3 Hours (Ref. 2)

Based on the MARCH results shown in Figure II-41, it appears likely that the failure to close the PORV block valve until 3.3 hours would have resulted in a substantial fraction of the fuel achieving temperatures where fuel-clad eutectic formation, i.e., fuel liquefaction, would occur. Thus, it appears that the TMI-2 accident could have been within an hour of becoming what is called in general terms a core meltdown accident. It should be noted that the likely consequences of such a meltdown would not necessarily be catastrophic because of the likely ability of the reactor building to maintain its integrity and retain a great majority of the radioactive material released during the accident. Discussion of the physical events expected to occur in such a meltdown accident may be found in greater detail in Section II.C.

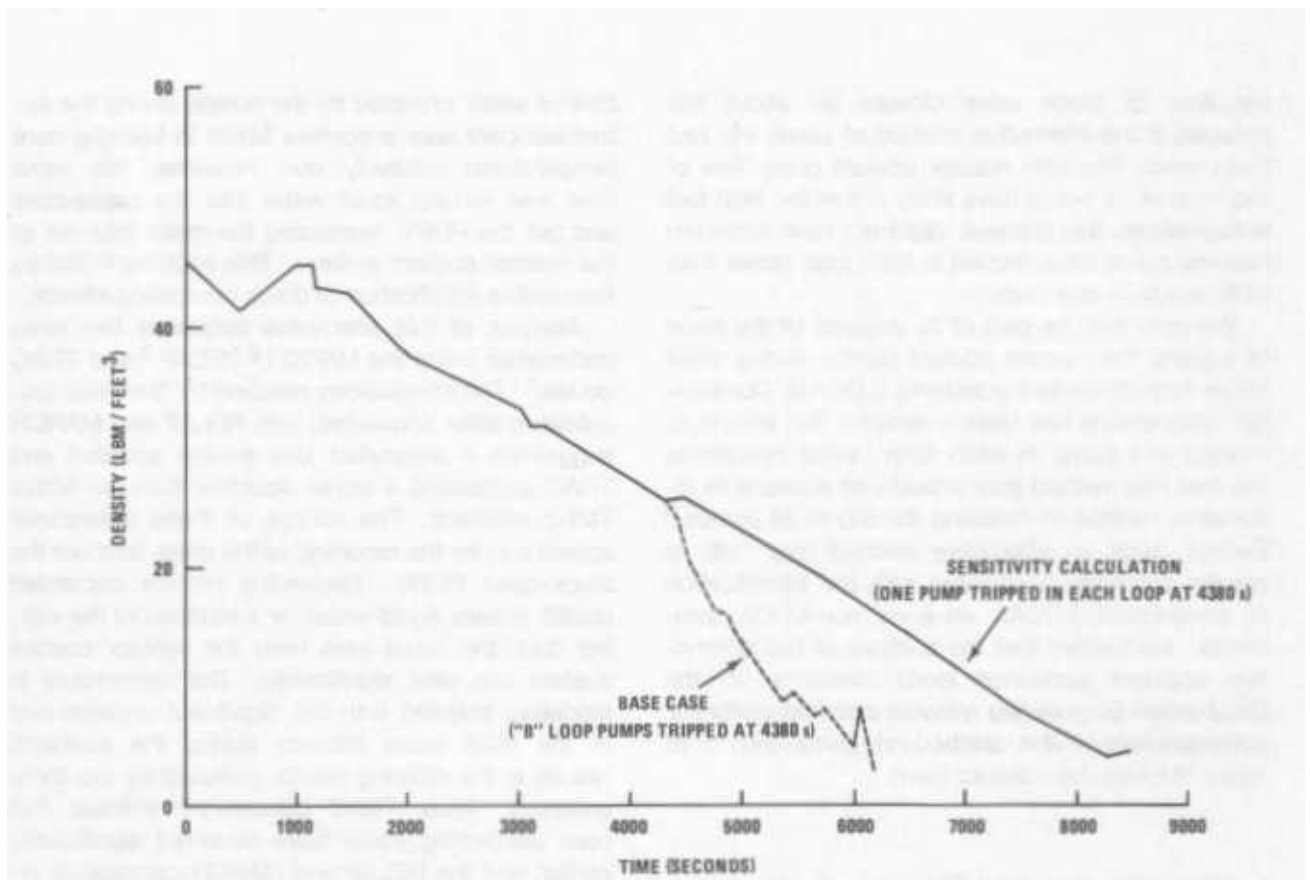
FIGURE 11-42. Effect of Pump Trips on Fluid Density in the A-I Loop Pump (Ref. 3)

The calculated pump suction fluid densities and core inlet flow rates discussed above suggest that relatively good flow could have been sustained until

the time of block valve closure (at about 138 minutes) if the alternative method of pump trip had been used. Because reactor coolant pump flow of this magnitude would have likely prevented high fuel temperatures, fuel damage might not have occurred had one pump been tripped in each loop rather than both pumps in one loop.

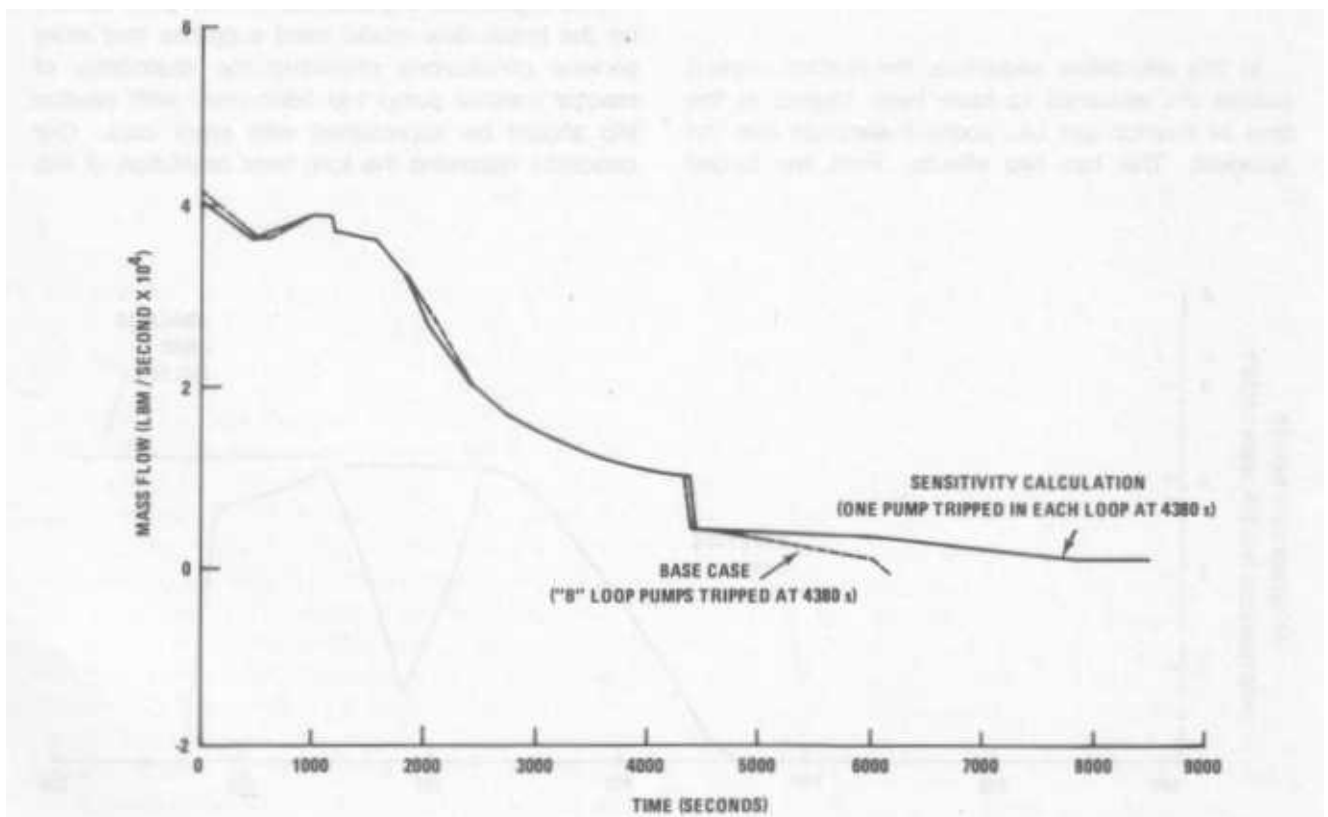
FIGURE 11-43. Effect of Pump Trips on Core Inlet Mass Flow Rate (Ref. 3)

Also obtained in the RELAP calculations is the core inlet mass flow rate, shown in Figure 11-43. This figure indicates that in the alternative sequence case the inlet flow rates decrease at a slower rate than in the actual accident and remain almost constant after the trip of the first two reactor coolant pumps.

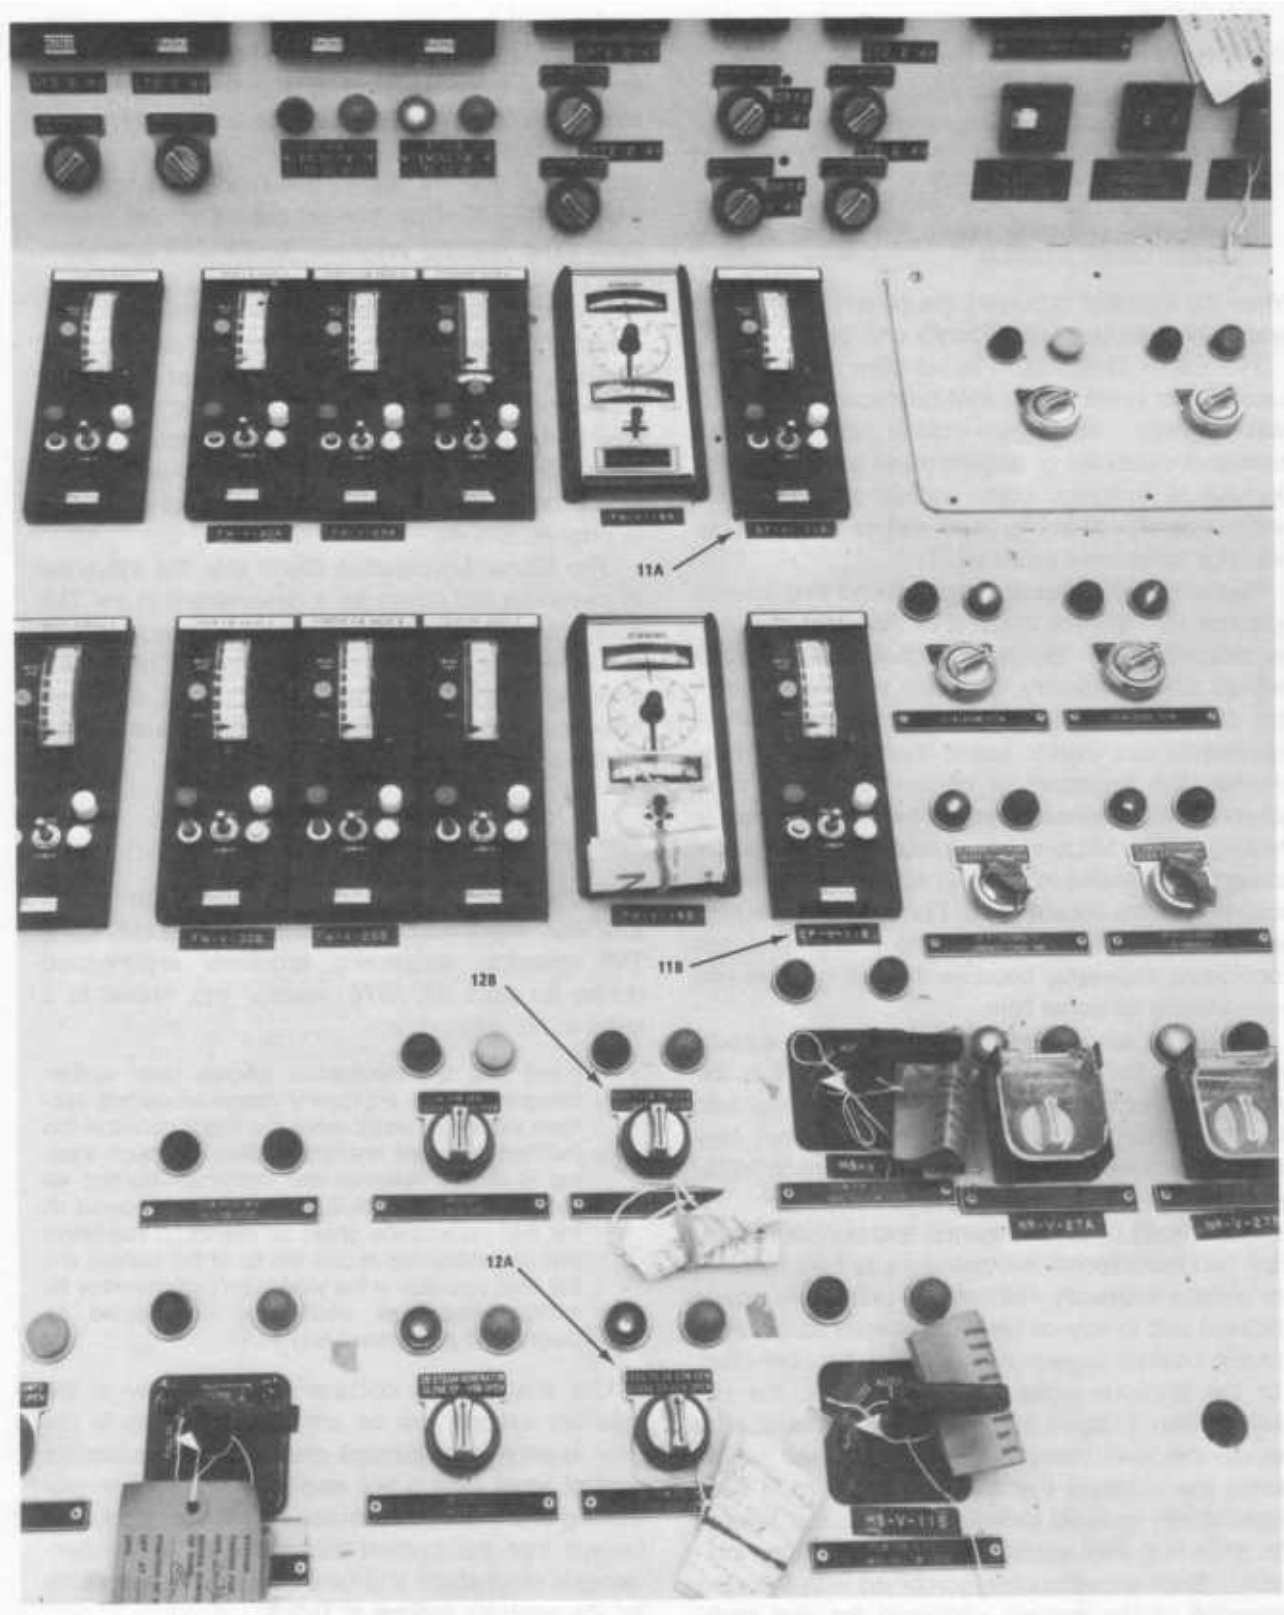
FIGURE 11-46. EFW Control Station Showing Block Valve (11A and B) and Control Valve (12A and B) Layout

4. The feedwater control panel is not laid out in a logical fashion. For example, control locations do not mimic actual valve and pump positions in the plant. In fact, the control and display placement on the emergency feedwater panel is inconsistent (Figure 11-46). The absence of any logical panel layout forced operators to rely on memory or random search to locate a particular control. This panel layout problem also existed elsewhere in the control room and increased operator workload and the probability for mistakes, particularly during emergency situations.

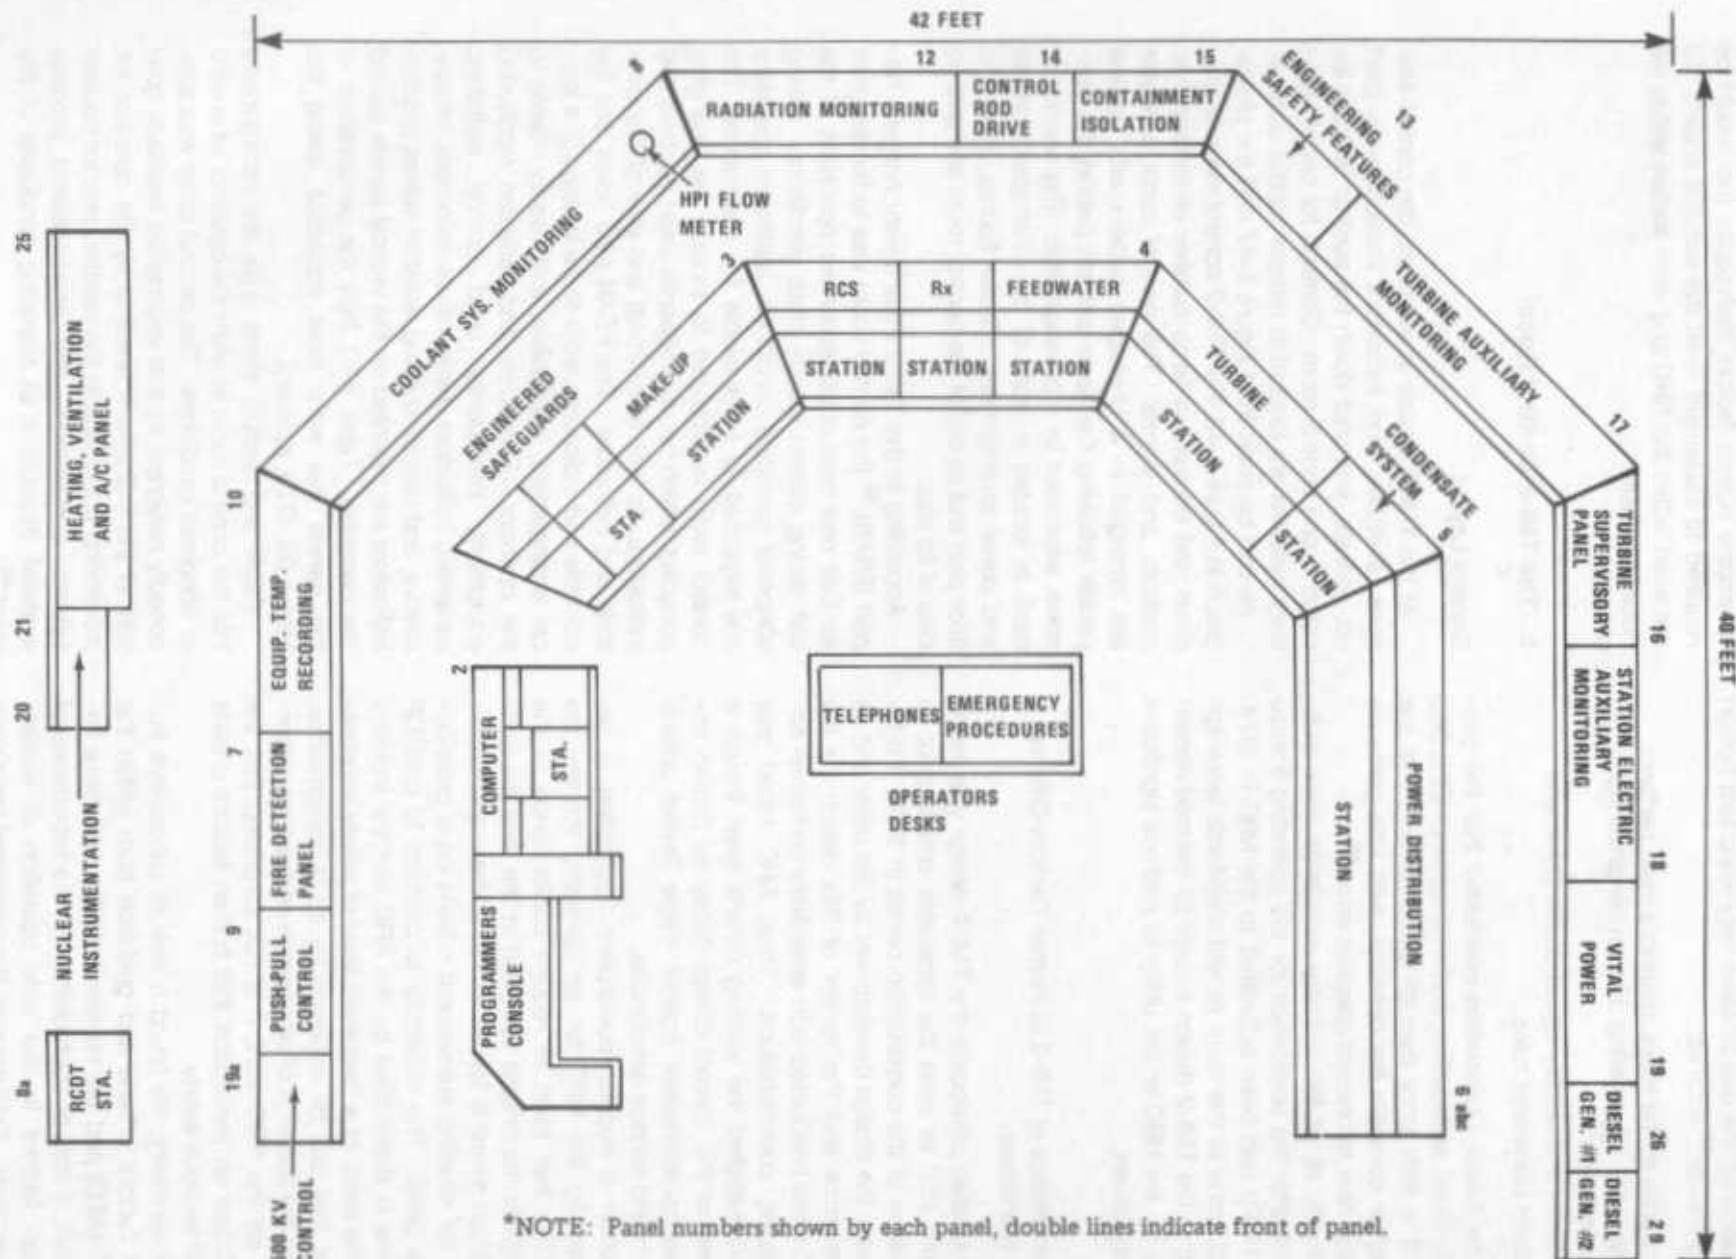
FIGURE II-47. TMI-2 Control Room Layout*

Moreover, the instrumentation for RCDT conditions and the corresponding alarms are behind the control panel and cannot be read unless the operator leaves his normal operating area in front of the control panel and walks about 50 feet (see Figure 11-47). To further compound the problem, the RCDT instrumentation on the back panel only gives instantaneous information. It does not record the parameters that indicate the previous conditions and thereby indicate trends in the RCDT temperature, level, and pressure. Consequently, when the operator went to check the RCDT status, he had difficulty telling whether the RCDT conditions were a result of an expected single opening and closing of the PORV at the beginning of the accident or whether they were a result of an unexpected longer, continuous leak from a stuck-open PORV.

- RCDT instrumentation is located on panel 8A, which is completely outside the main operating area. See Figure 11-47.

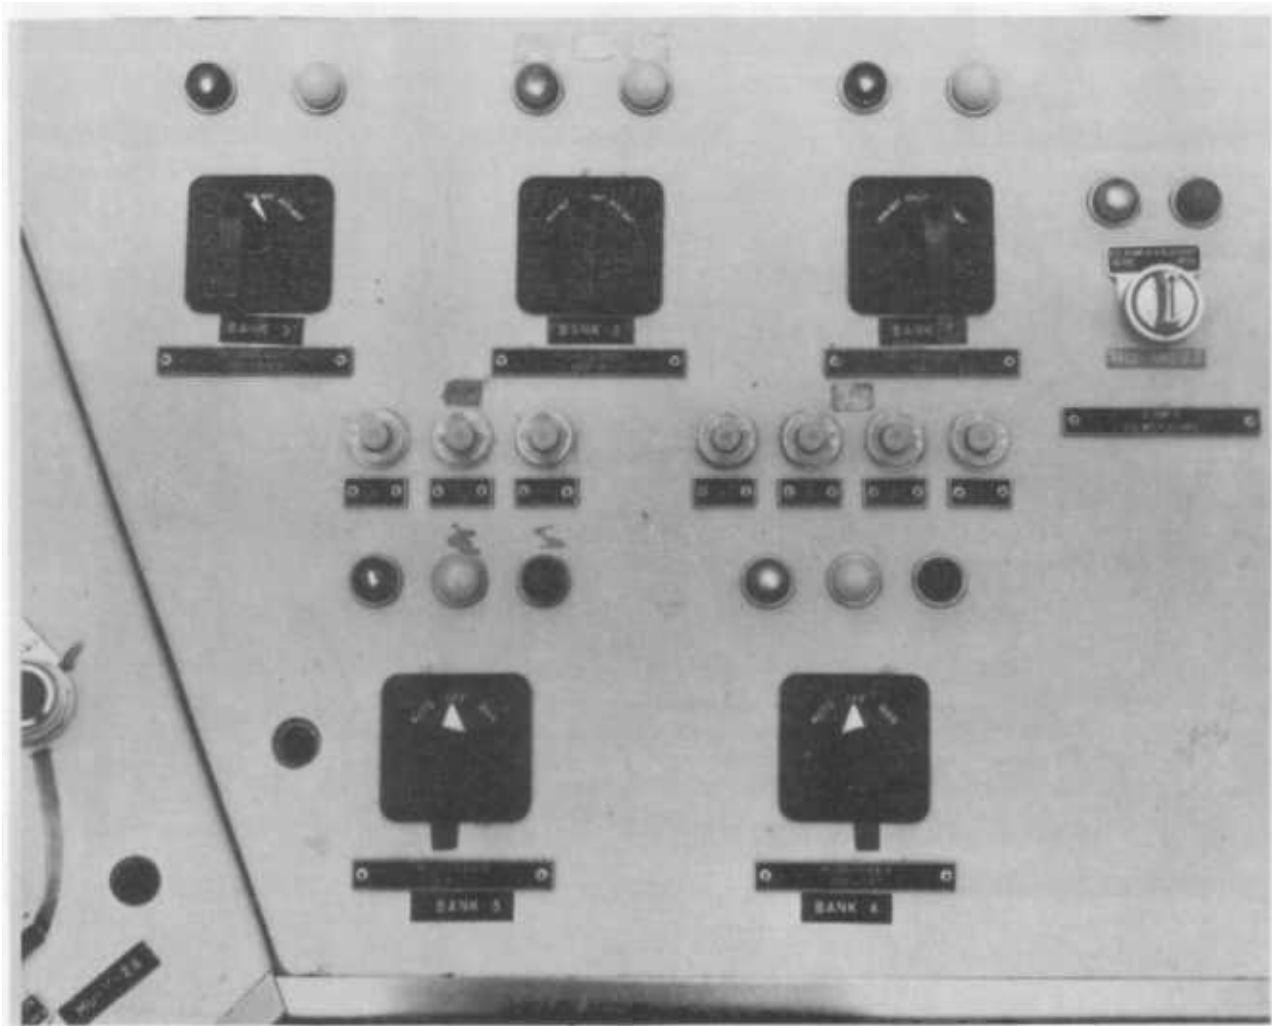
FIGURE 11-50. Pressurizer Heater Control*

- Auditory displays associated with annunciators are not prioritized to assist the operator in discriminating critical alarms.
- Controls having common operating modes (i.e., automatic and manual) are not designed so that mode selection is consistent between controls. In some cases, controls having similar functions are turned clockwise to place the system in manual, and in others, counterclockwise. See Figure 11-50.

*Note the right to left sequence and inconsistency of control movement to auto and manual.

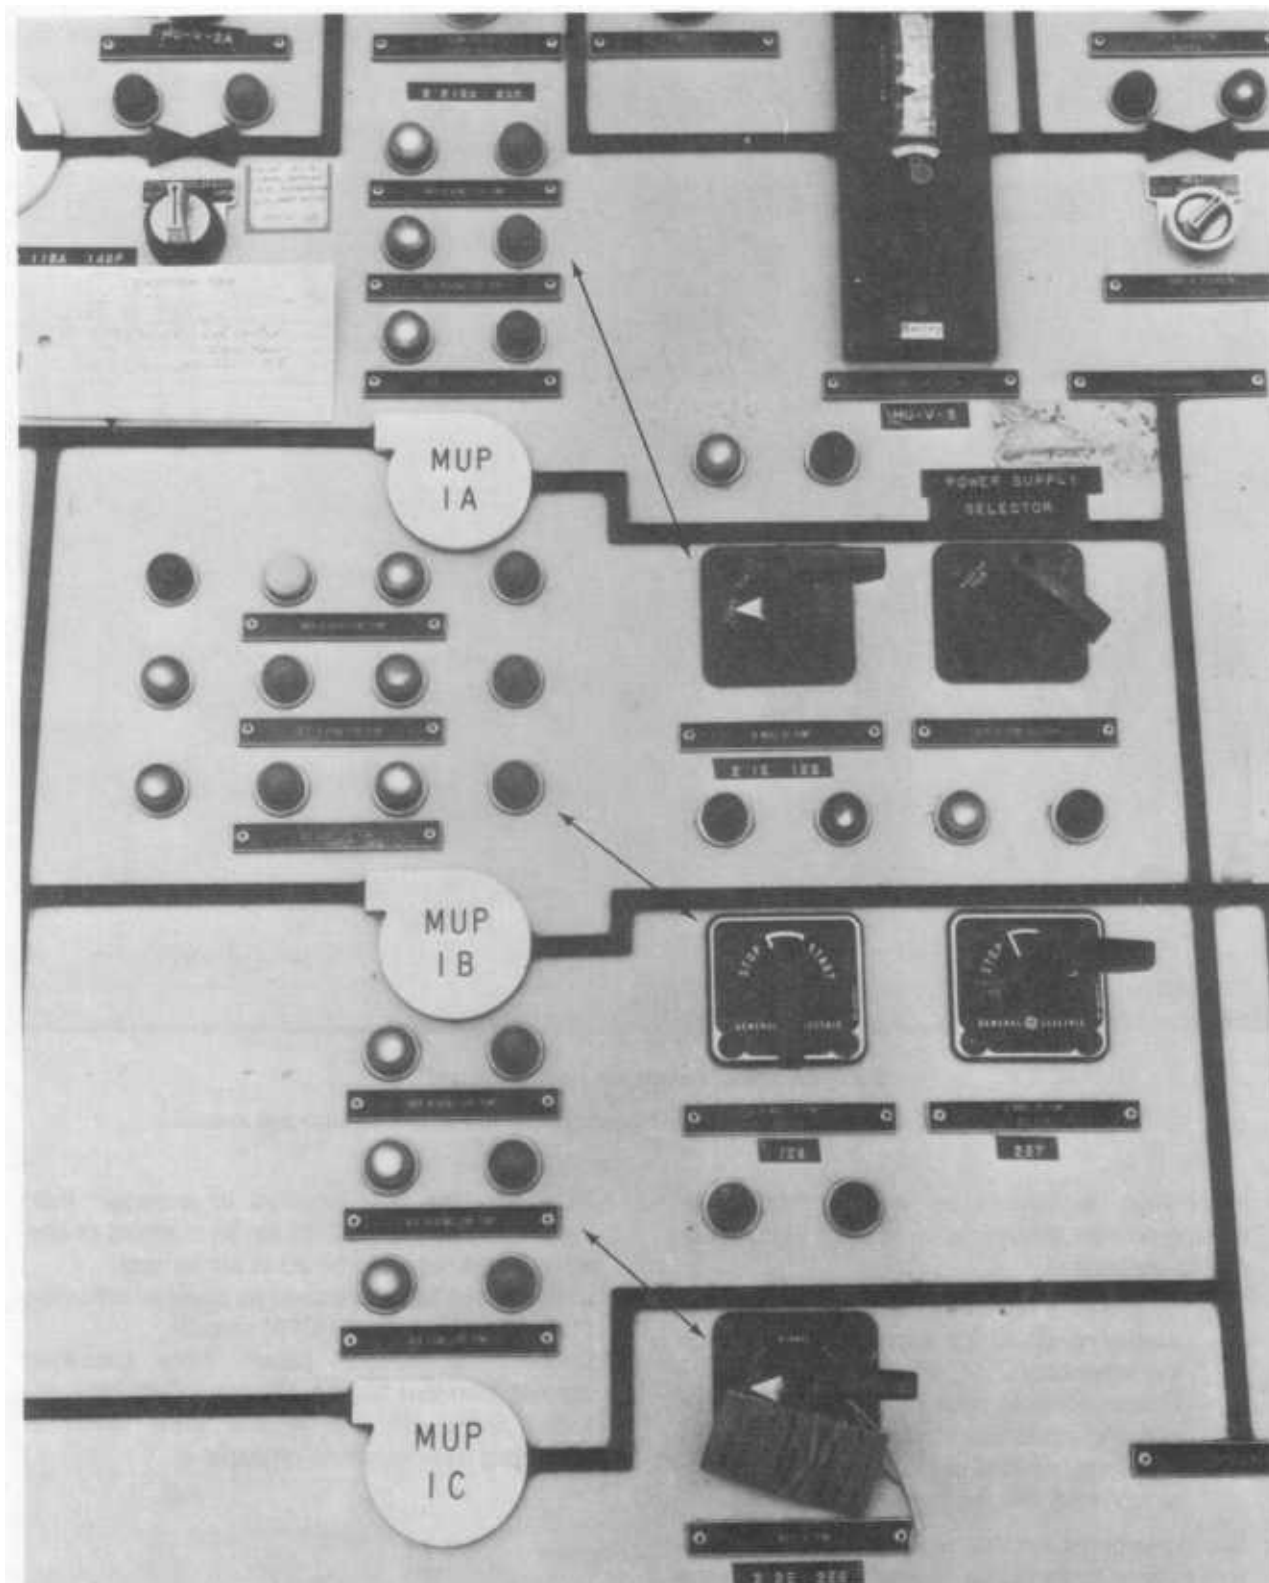
FIGURE 11-51. Relationship of Makeup Pump Controls and Indicator Lights

- In many cases, workstation design appears to maximize visual scan, reach, and walking requirements.
 - RC pump seal pressure is on panel 10, and seal temperature is on panel 8, but the pump controls are on panel 4.
 - Makeup control is on panel 3, but makeup flow indication is displayed on panel 8. See Figure 11-49.
- Controls and displays are not logically or consistently sequenced.
 - Pressurizer heater controls are sequenced from right to left rather than from left to right. See Figure 11-50.
 - Pressurizer narrow range indicators are B, A instead of A, B
- Indicator lights are inconsistently placed above, beside, or below their associated controls. See Figure 11-51.

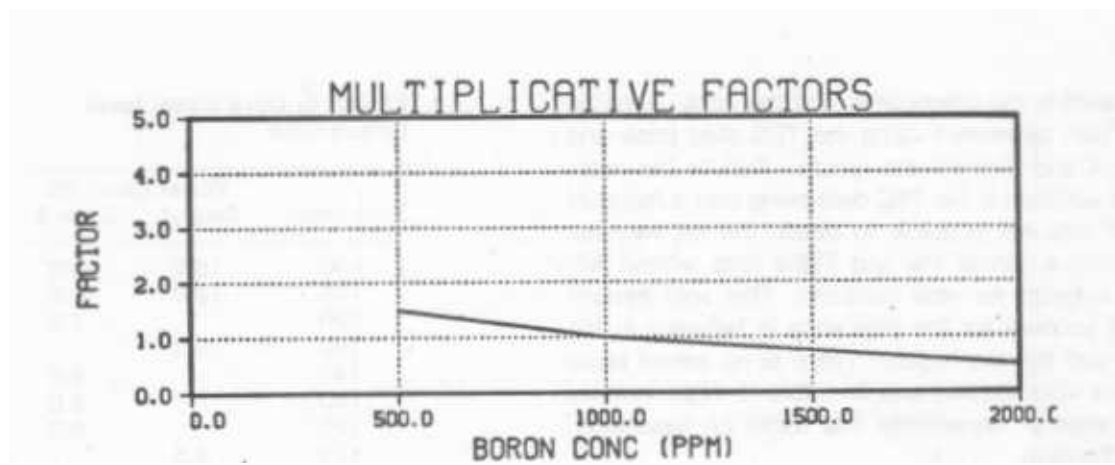
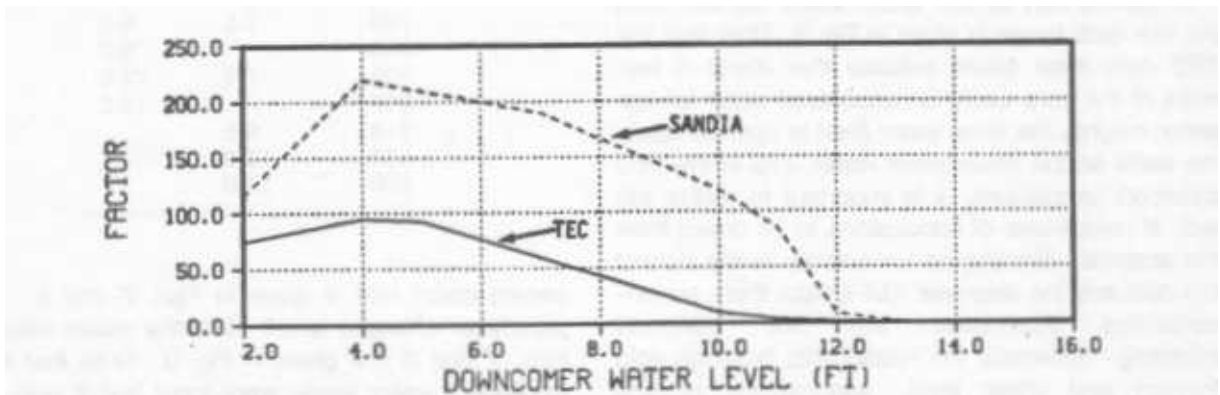
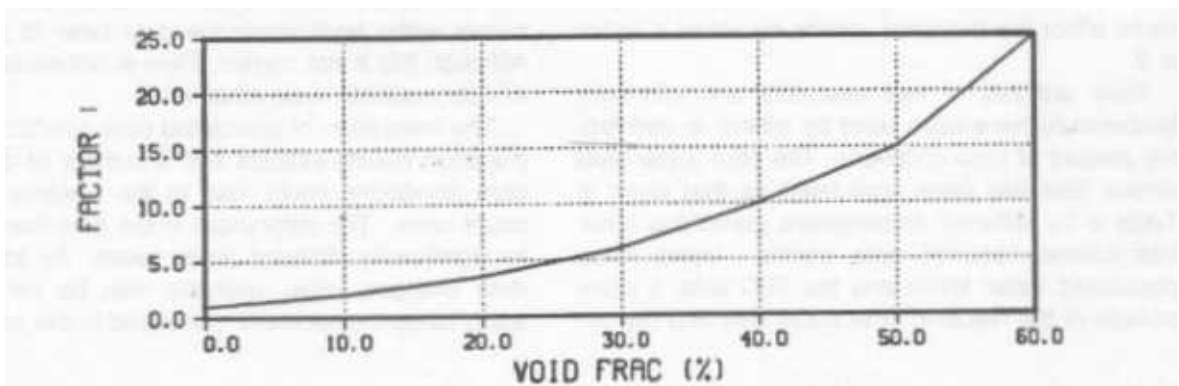
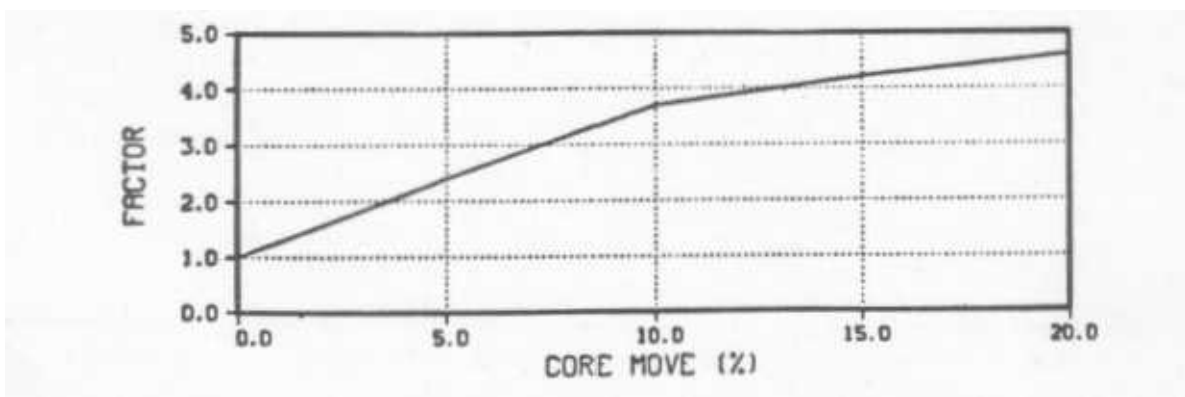
A99 FIGURE D-33 Plots of Input Data Base (Figure 1)

The analysis is separated into two parts. The first analysis was based on the trial and error choice of water level and void fraction versus time in order to obtain a reasonably good agreement with the observed count rate. Figure 1 shows the plots of the data base. Figure 2 shows the comparison between the observed (dashed curve) and calculated SRM count rate using the Sandia data base. The time dependent boron concentration, core condition, water level and void fraction are given in Fig. 3.

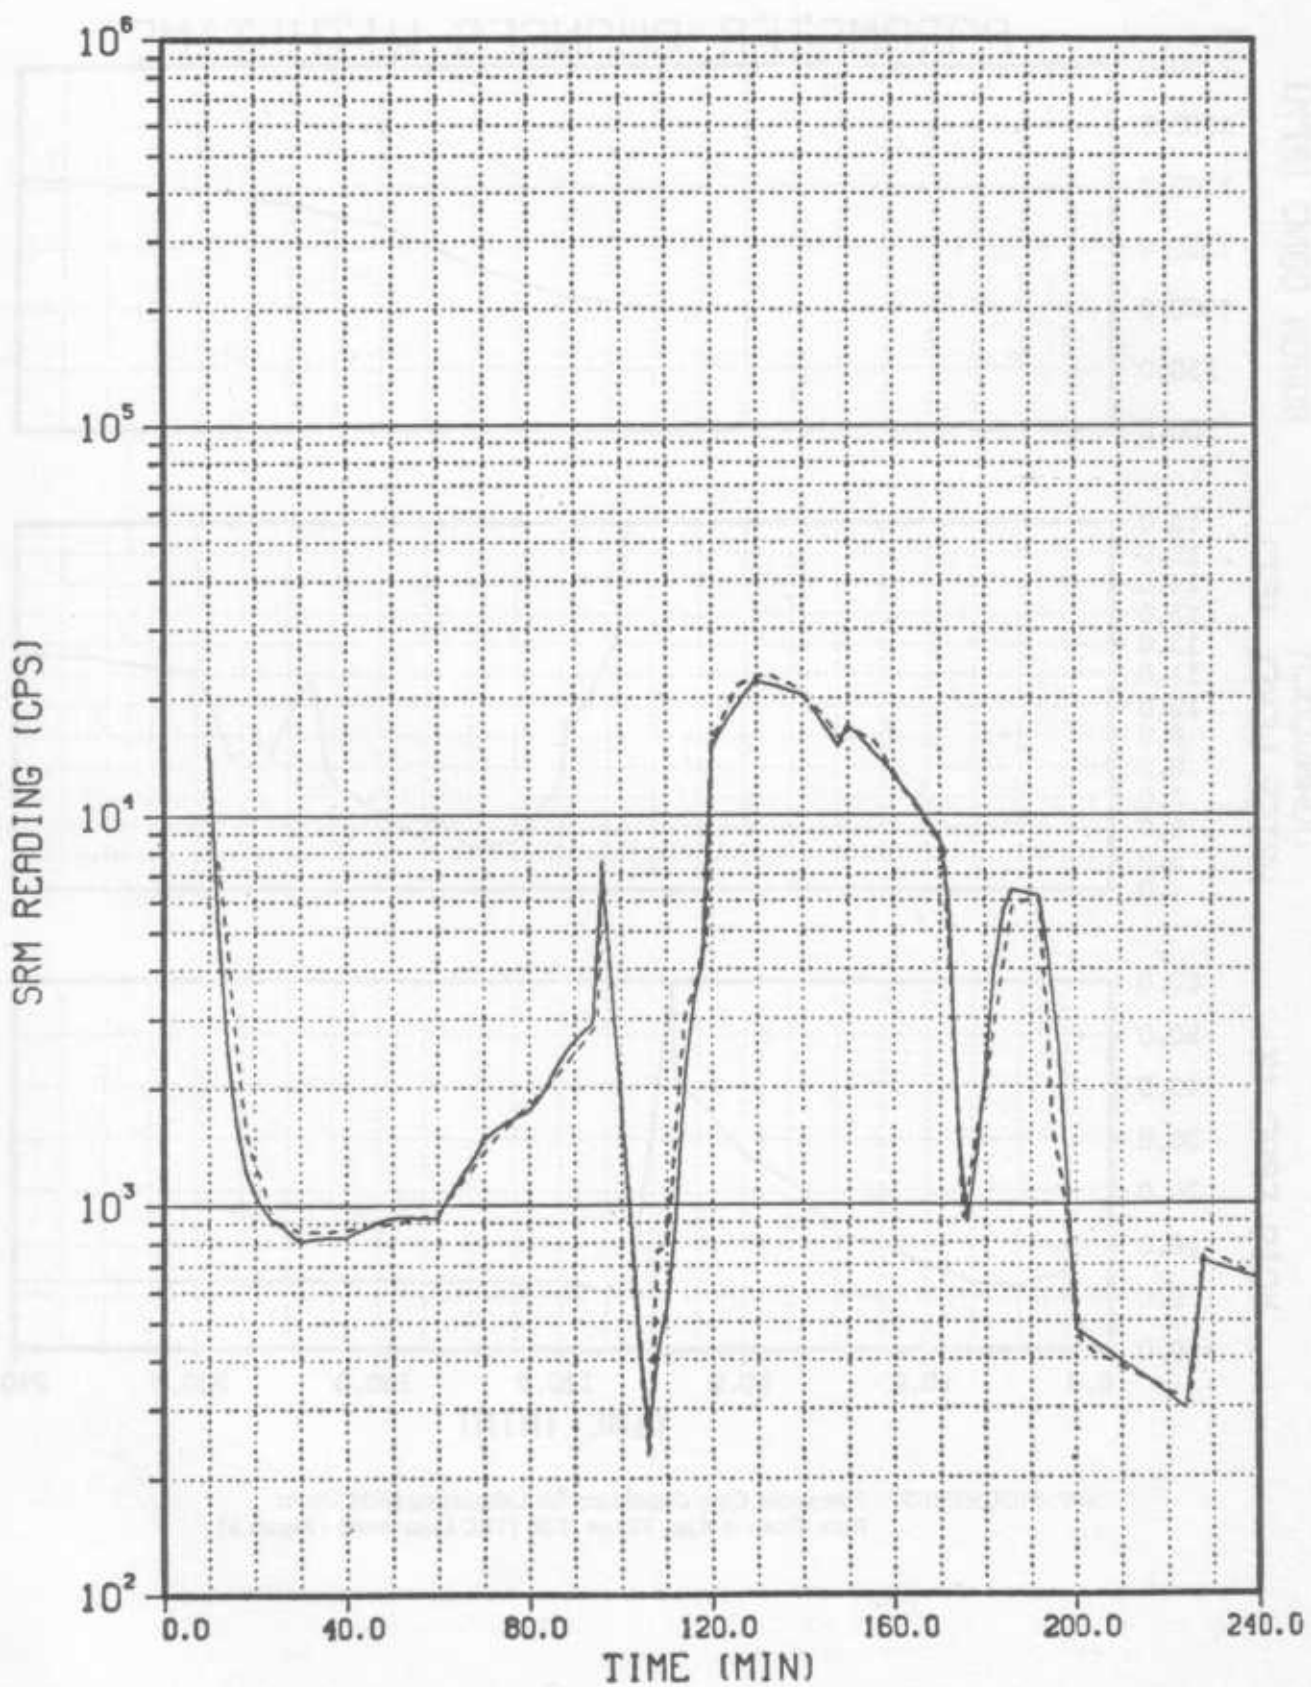
APP. FIGURE 11-36. SRM Reading Versus Time Using the TEC Data Base (Figure 4)

the same in the downcomer and the core. Analysis was also performed using the TEC data base and Figs. 4 and 5 show the results. Due to the maximum variation in the TEC data being only a factor of 95, it was not possible to obtain the full variation between a normal trip and TMI-II data without adding a factor for void fractions. This void fraction could account for the difference in behavior in the core and bypass region. There is no sound basis for the void fraction and therefore it might indicate the range of uncertainty that might be associated with the data.

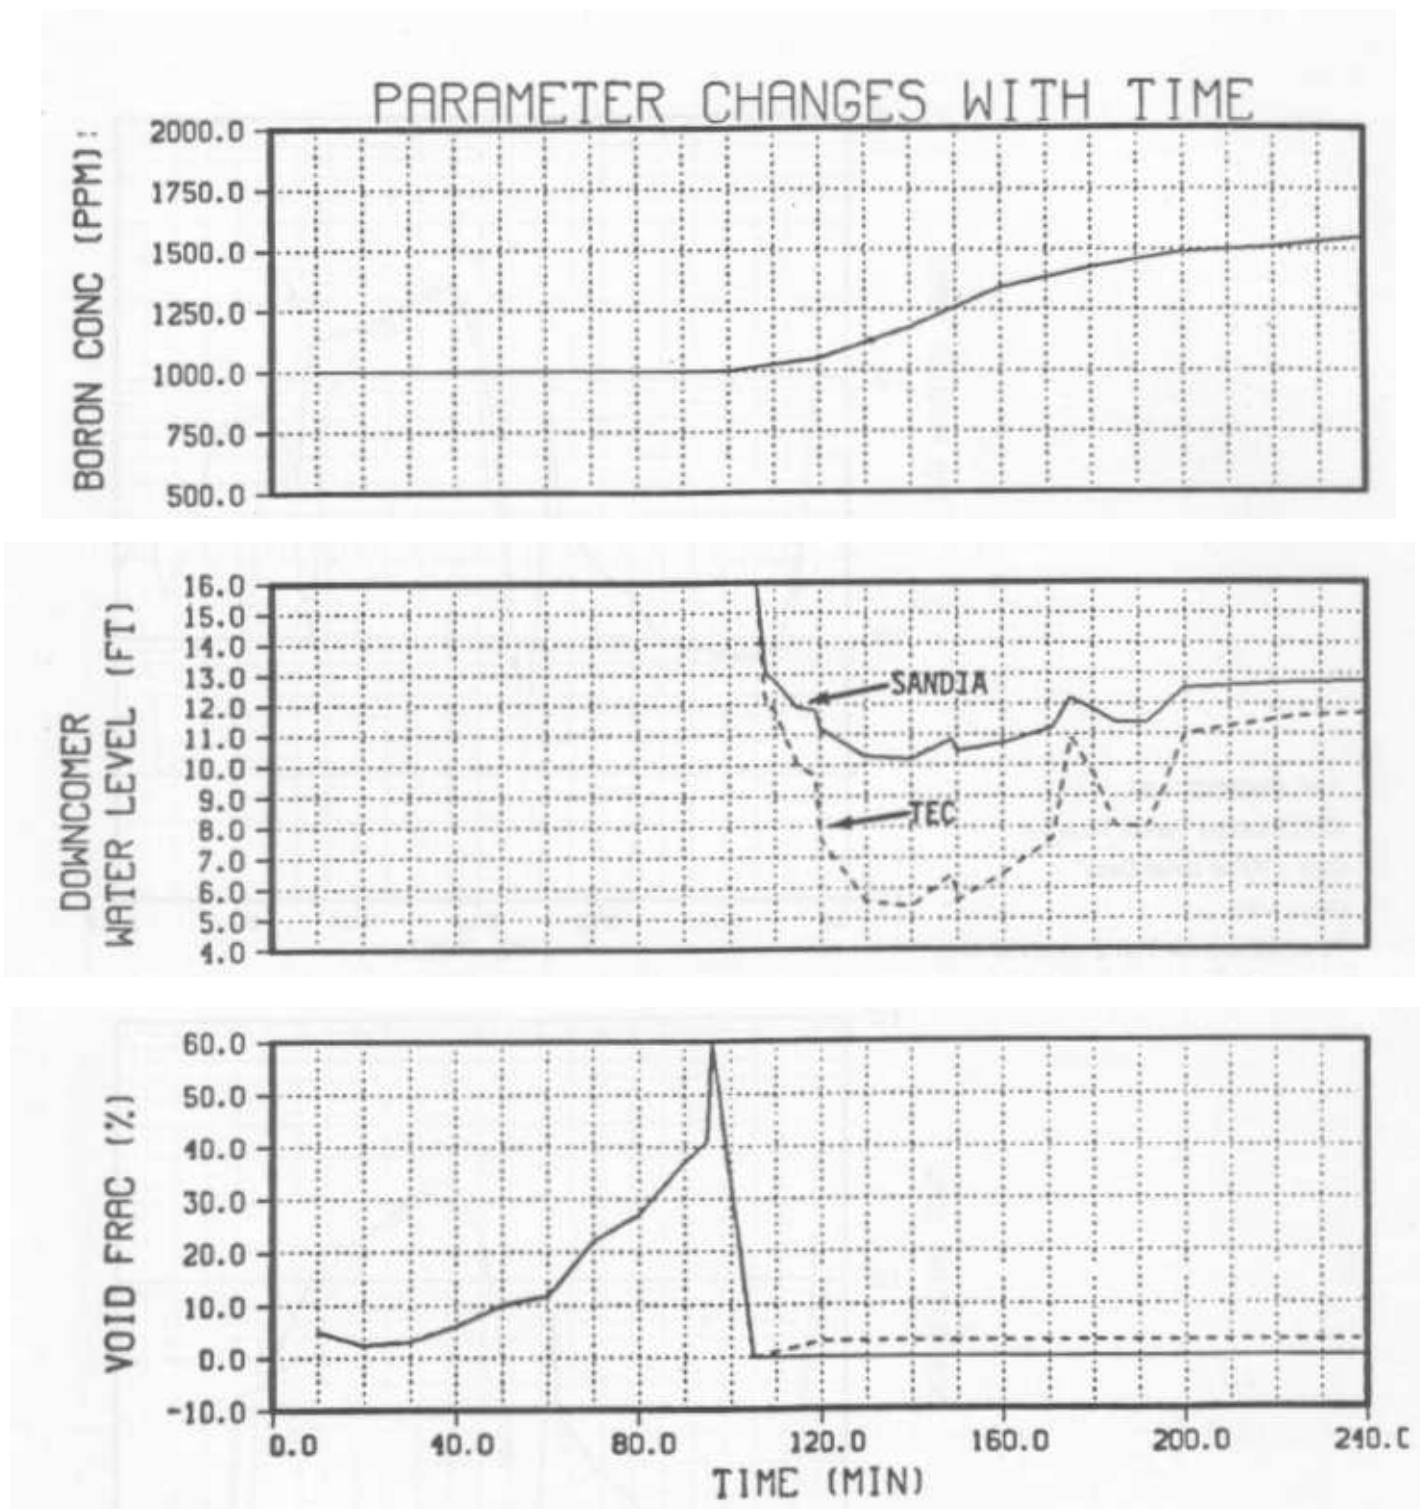
APP. FIGURE 11-38. Comparison of Parameter Inputs for SRM Count Rates
Shown in App. Figures 11-34 and 11-36 (Figure 6)

A comparison of the water levels derived from the two data bases is given in Fig. 6. Note that the TEC data base would indicate that about 5 feet more of the core would be uncovered since for low water heights the core water level is approximately the same as the downcomer water level in the TEC transport calculations. It is important to realize the lack of uniqueness of conclusions to be drawn from the analysis. Besides an uncertainty in the normal trip data and the observed TMI-II data, there are uncertainties associated with the transport modeling-especially the relationship between void fraction and water level. Assumptions on the characteristics of the water in the bypass region could affect the transport results by about a factor of 2.

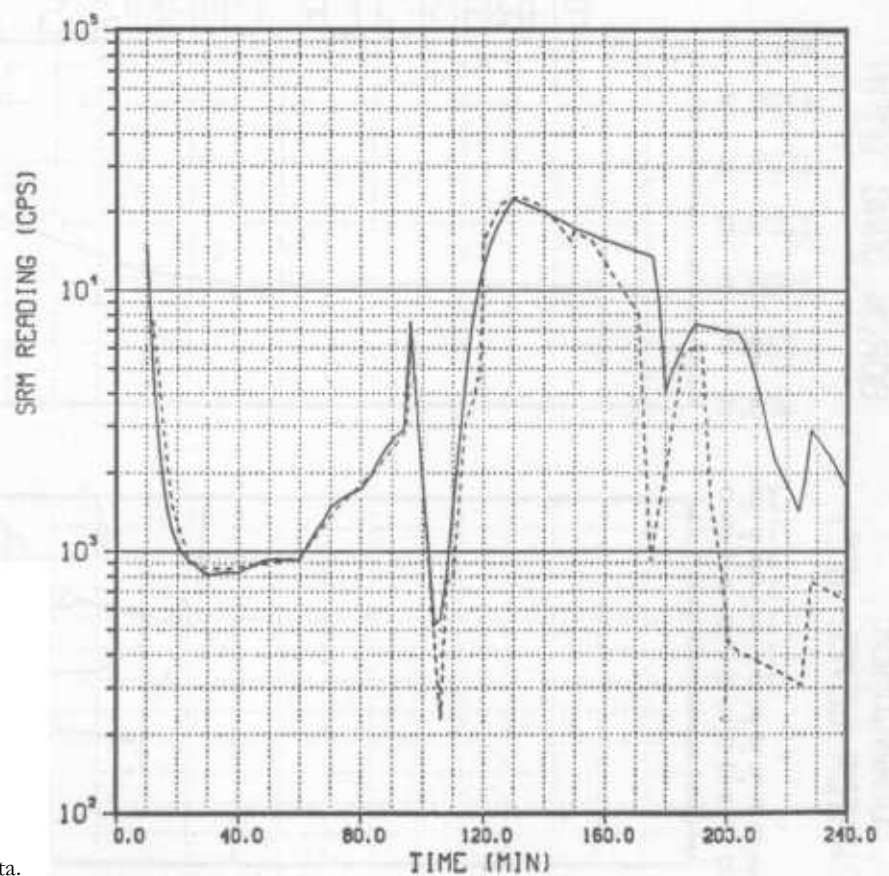
APP. FIGURE 11-39.
 SRM Reading Versus Time for
 Case 1 Water Level Data *
 (Figure 7)
 * Dashed curve is TMI-2 observed data.

served count rate is given in Figs. 7 and 8. The parameter changes which yield the count rates in Figs. 7 and 8 are given in Fig. 9. Note that time dependent water levels were input and it was assumed that core water level was the same as downcomer water level when the data base is utilized. Although this is not correct, there is not enough other data available to do otherwise.

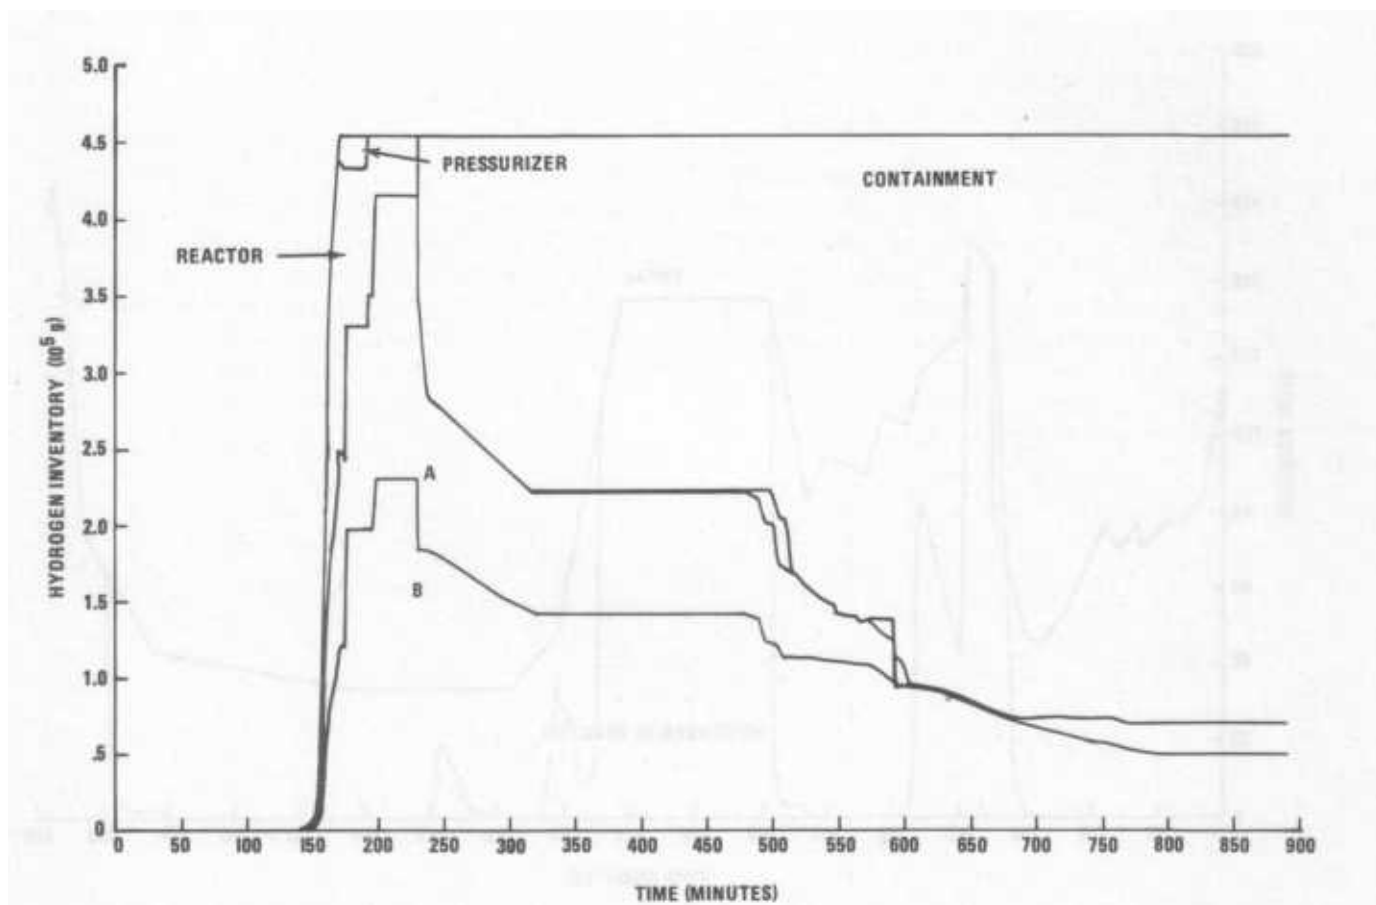
APP. FIGURE II-42. Hydrogen Inventory (Figure 1)

Hydrogen was generated over a short period of time (~ 150 - 175 minutes). The model had been "tuned" so that 4.5×10^5 g of hydrogen was produced. When the PORV was opened at ~ 220 minutes, hydrogen was rapidly vented from the reactor to containment. From ~ 220 to ~ 300 minutes the hydrogen venting continued from both A and B steam generators and hot legs. On opening of the PORV at ~ 450 minutes (system depressurization), the venting continued and resulted in a hydrogen deflagration in containment at ~ 600 minutes. About 6×10^4 g of hydrogen remained in the system after 900 minutes.
