VOLUME **II** Part 2

three mile island

A REPORT TO THE
COMMISSIONERS
AND TO THE
PUBLIC

NUCLEAR REGULATORY COMMISSION
SPECIAL INQUIRY GROUP

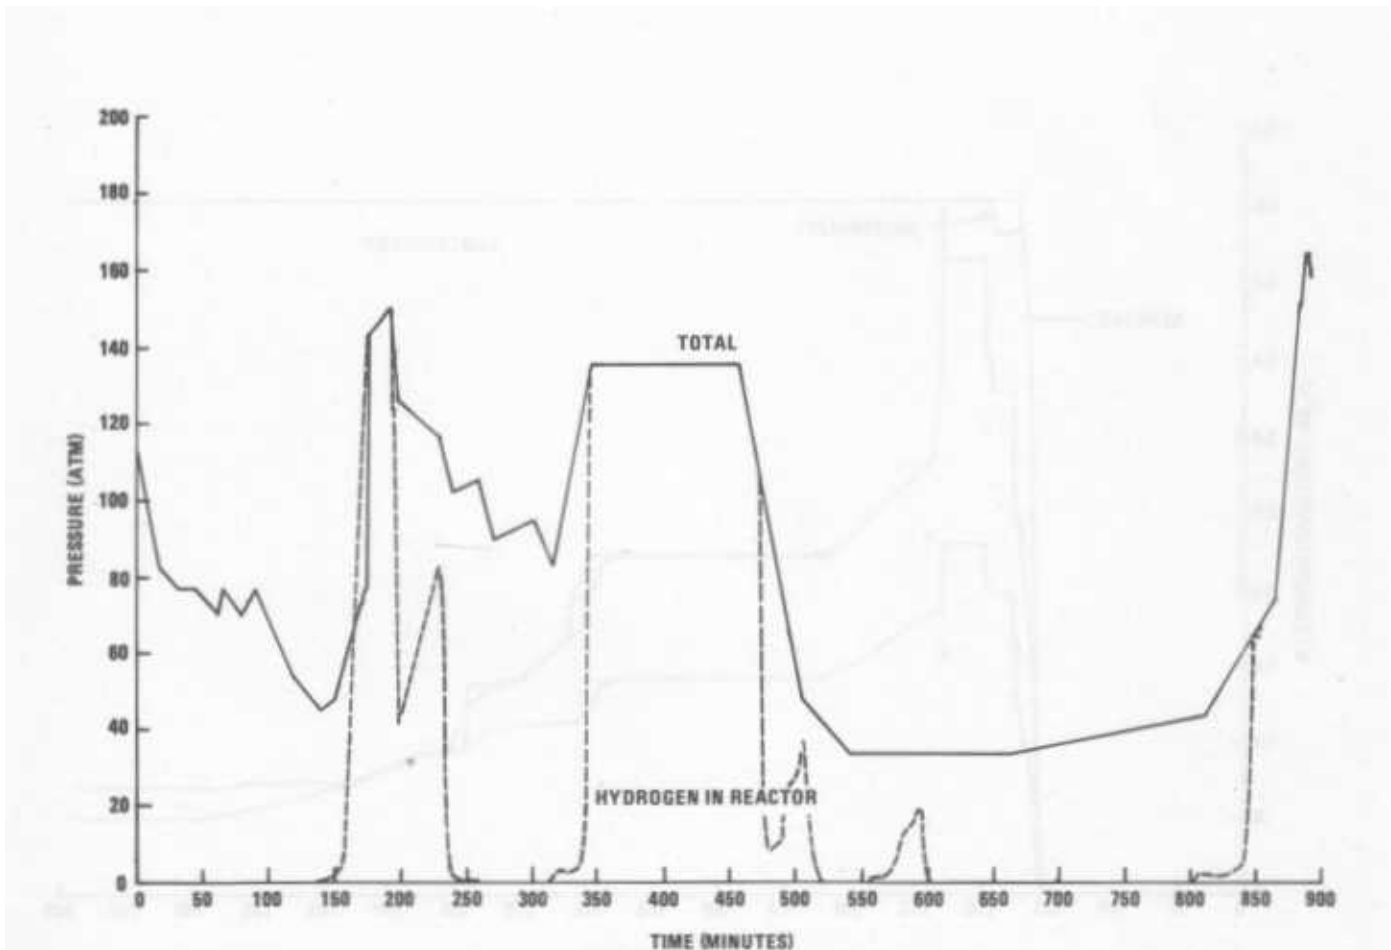
APP. FIGURE II-43. Hydrogen Pressure in Reactor Void Space (Figure 2)

From the onset of hydrogen generation (^150 minutes) to ^•240 minutes, a substantial amount of the reactor void space was filled with hydrogen gas. Hydrogen was vented rapidly through the open PORV at -200 minutes and again at -240 minutes. At ^•315 minutes when the PORV was closed and the system repressurized, hydrogen again occupied a substantial amount of the reactor void space. During the depressurization starting at -450 minutes, hydrogen was again vented rapidly through the open PORV. After the repressurization at ^800 minutes, hydrogen again occupied a substantial amount of the reactor void space.

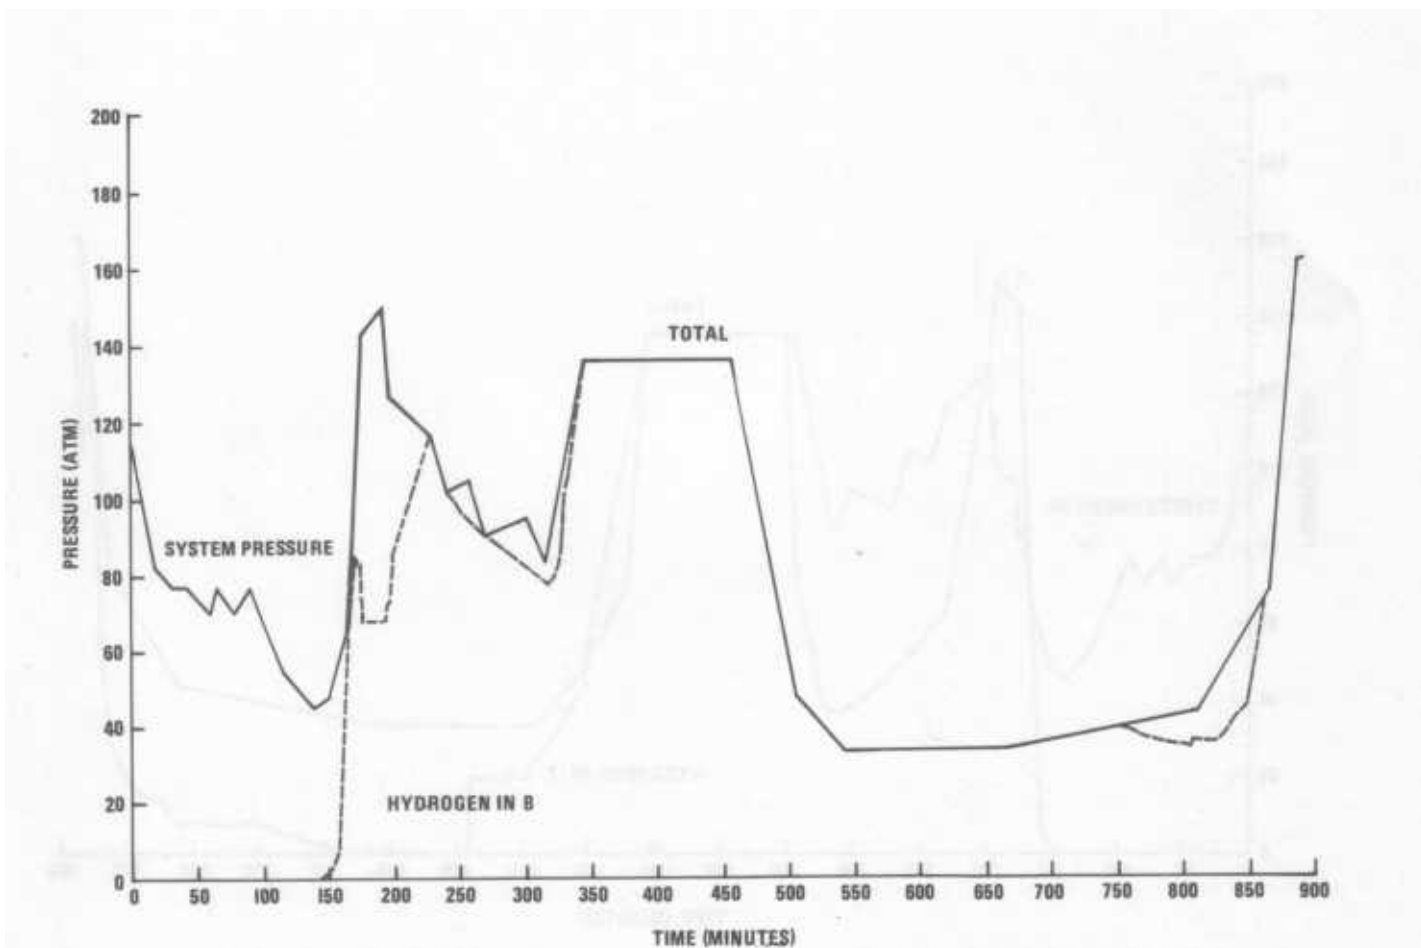
APP. FIGURE 11-44. Hydrogen Pressure in B Steam Generator and Hot Leg (Figure 3)

From the onset of hydrogen generation (~150 minutes) through ~900 minutes, hydrogen occupied a substantial amount of the void space in the B steam generator **and hot leg.**

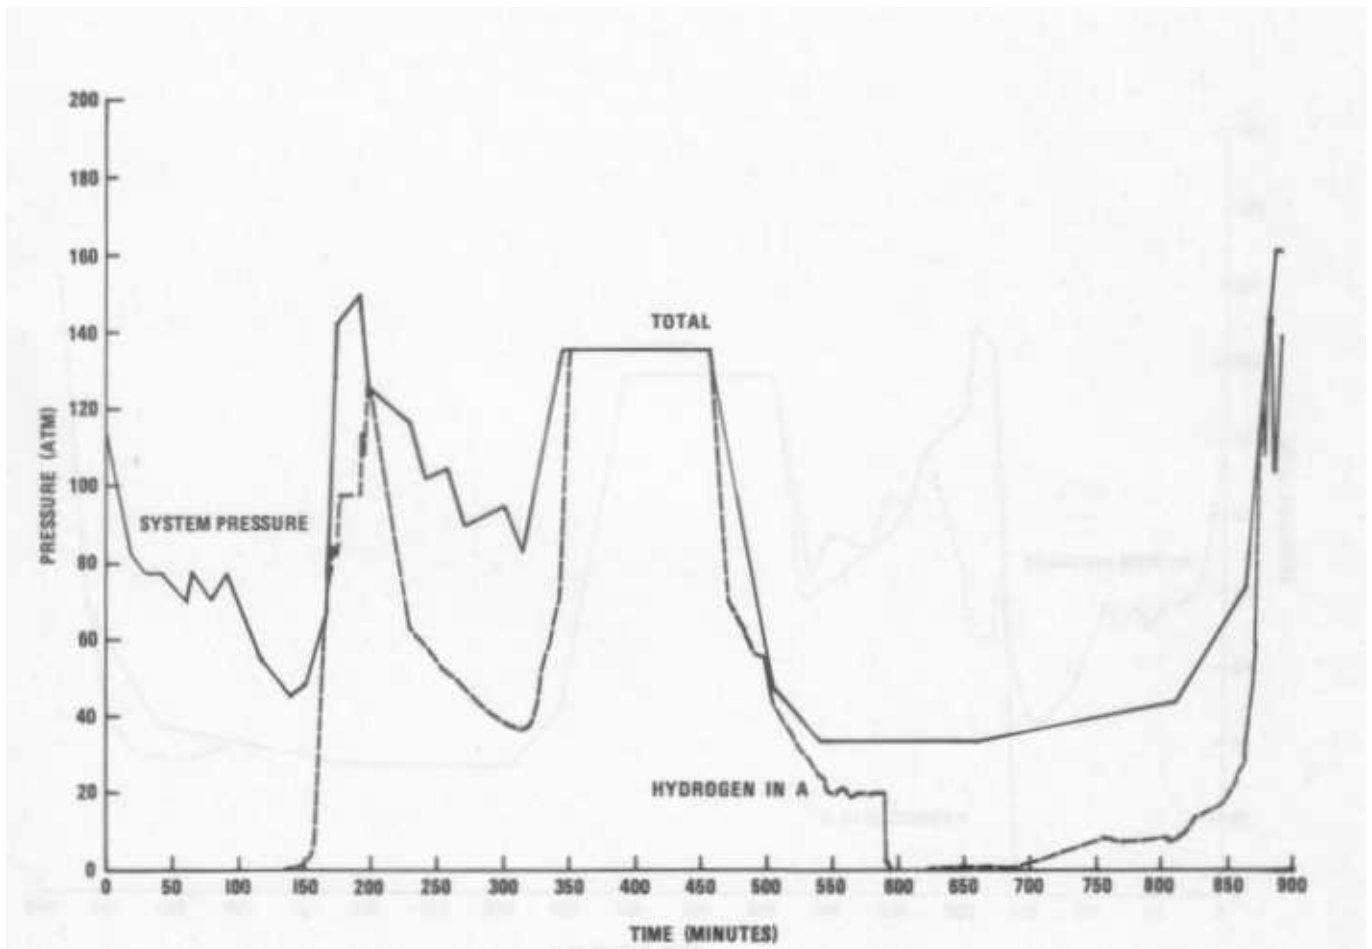
APP. FIGURE 11-45. Hydrogen Pressure in A Steam Generator and Hot Leg (Figure 4)

From the onset of hydrogen generation (~ 150 minutes) through ~ 600 minutes, hydrogen occupied a substantial amount of the void space in the A steam generator and hot leg. From ~ 600 to ~ 800 minutes, hydrogen partial pressure in the A steam generator and hot leg was small.

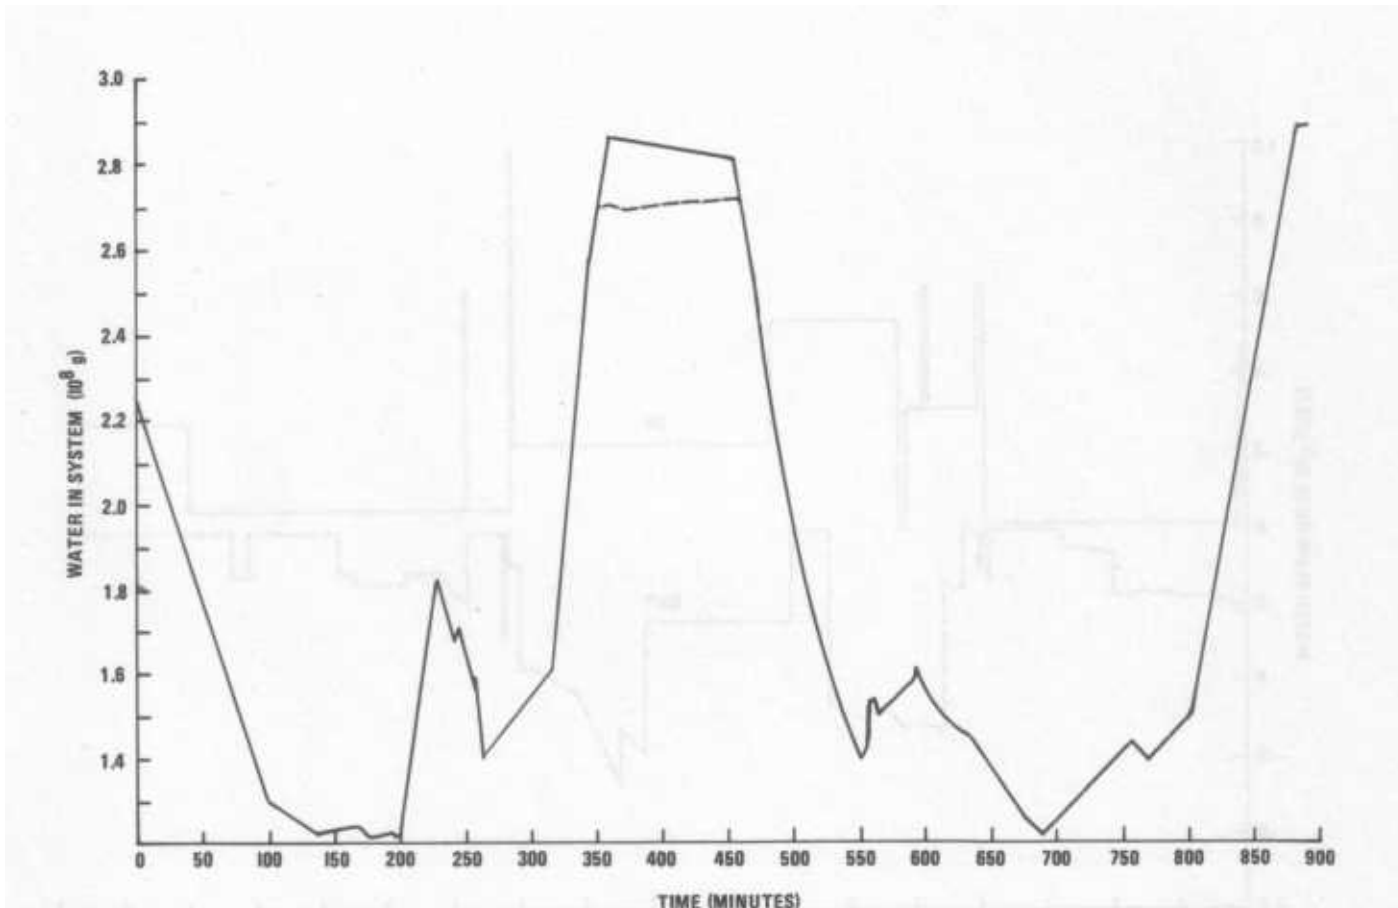
APP. FIGURE 11-46. Water Inventory in System (Figure 5)

The water inventory in the system was calculated assuming net makeup/letdown from BWST levels and flow through the PORV and vent valve. A saturated vapor model, a saturated liquid model, or a subcooled liquid model, depending on the recorded pressurizer level, temperature, and pressure was used. The system volume was large enough to contain this amount of water in addition to the calculated hydrogen (at 700 °K), except during the short period from 350 to 500 minutes. This excess water could have a number of explanations, for example, a net gain in the makeup tank, a lower average hydrogen temperature, a smaller amount of hydrogen generated, or a larger amount of hydrogen released to containment.

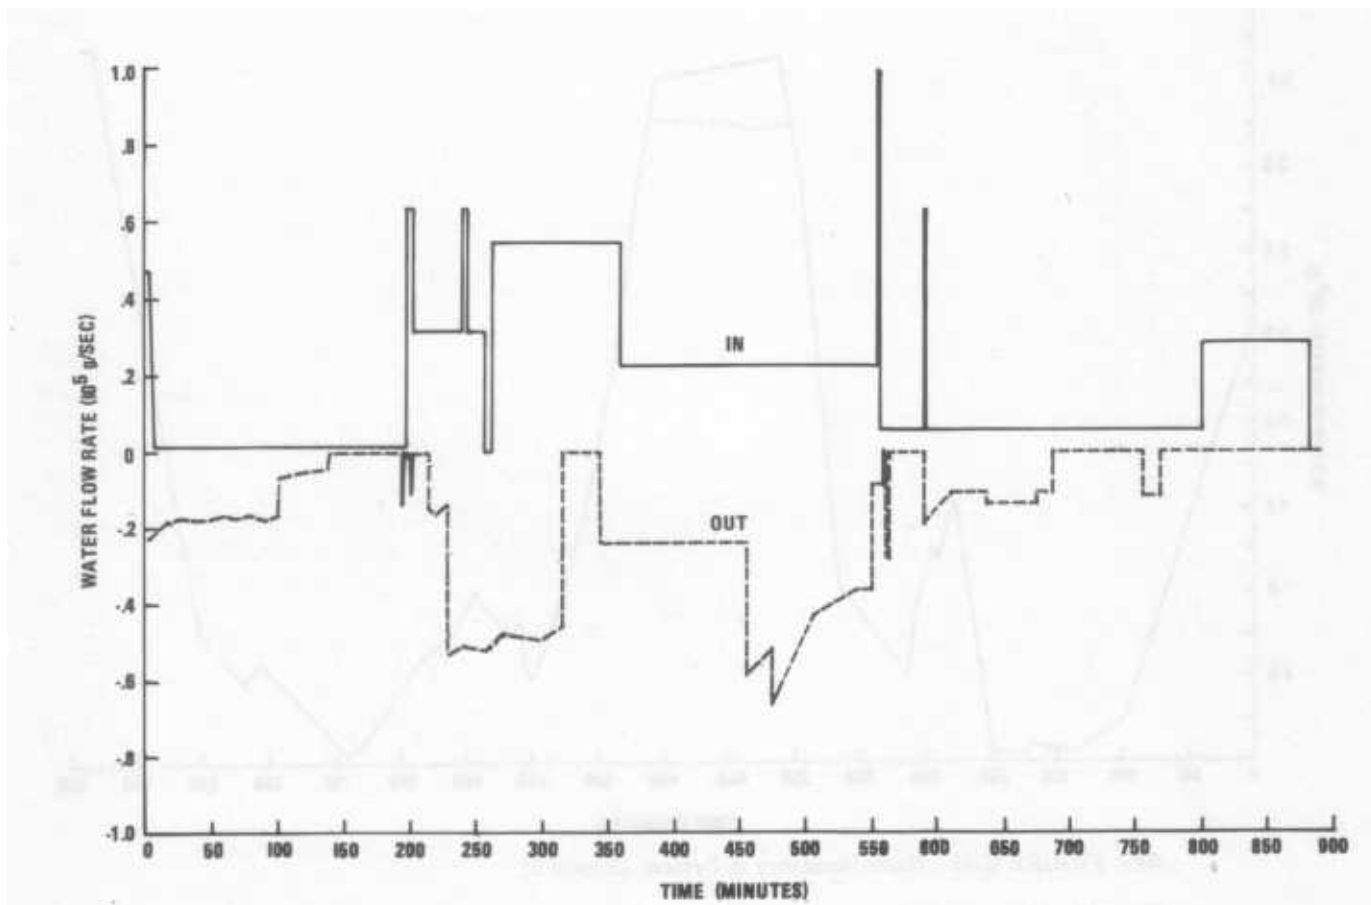
APP. FIGURE II-47. Water Flow Rates Used To Construct Water Inventory (App. Figure 11-46) (Figure 6)

"IN" represents the net makeup/letdown flow from the BWST, and "OUT" represents flow out the pressurizer PORV and vent valve.

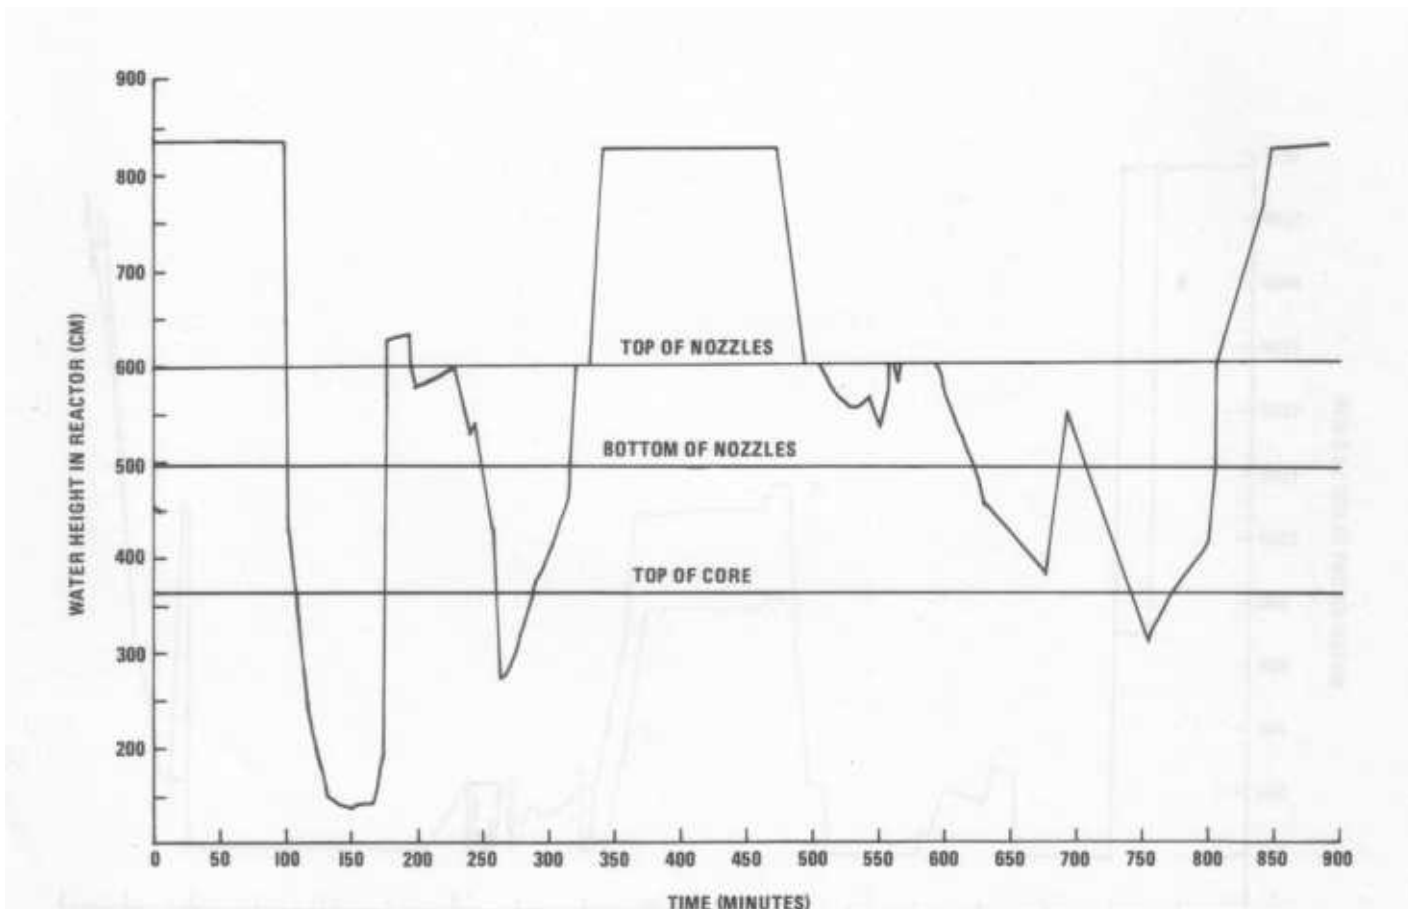
APP. FIGURE 11-48. Water Height in Reactor (Figure 7)

The water level in the reactor fell rapidly at ^100 minutes when the steam generator A RCP was turned off and the voids collapsed. Boiloff then reduced the level to ^-150 cm above the bottom of the core. The top of the core was uncovered at ^108 minutes. The starting of the steam generator B RCP and the subsequent HPI recovered the core rapidly. A slight uncover occurred at ^250 minutes; however the makeup/letdown details could easily have resulted in the core not being uncovered. The reactor was filled at -350 minutes and remained filled until -475 minutes when the system was depressurized. The level slowly rose until ^750 minutes when the core was again uncovered. As shown above, makeup/letdown details could easily have resulted in the core not being uncovered. The level rose rapidly as the system was repressurized at ^-800 minutes.

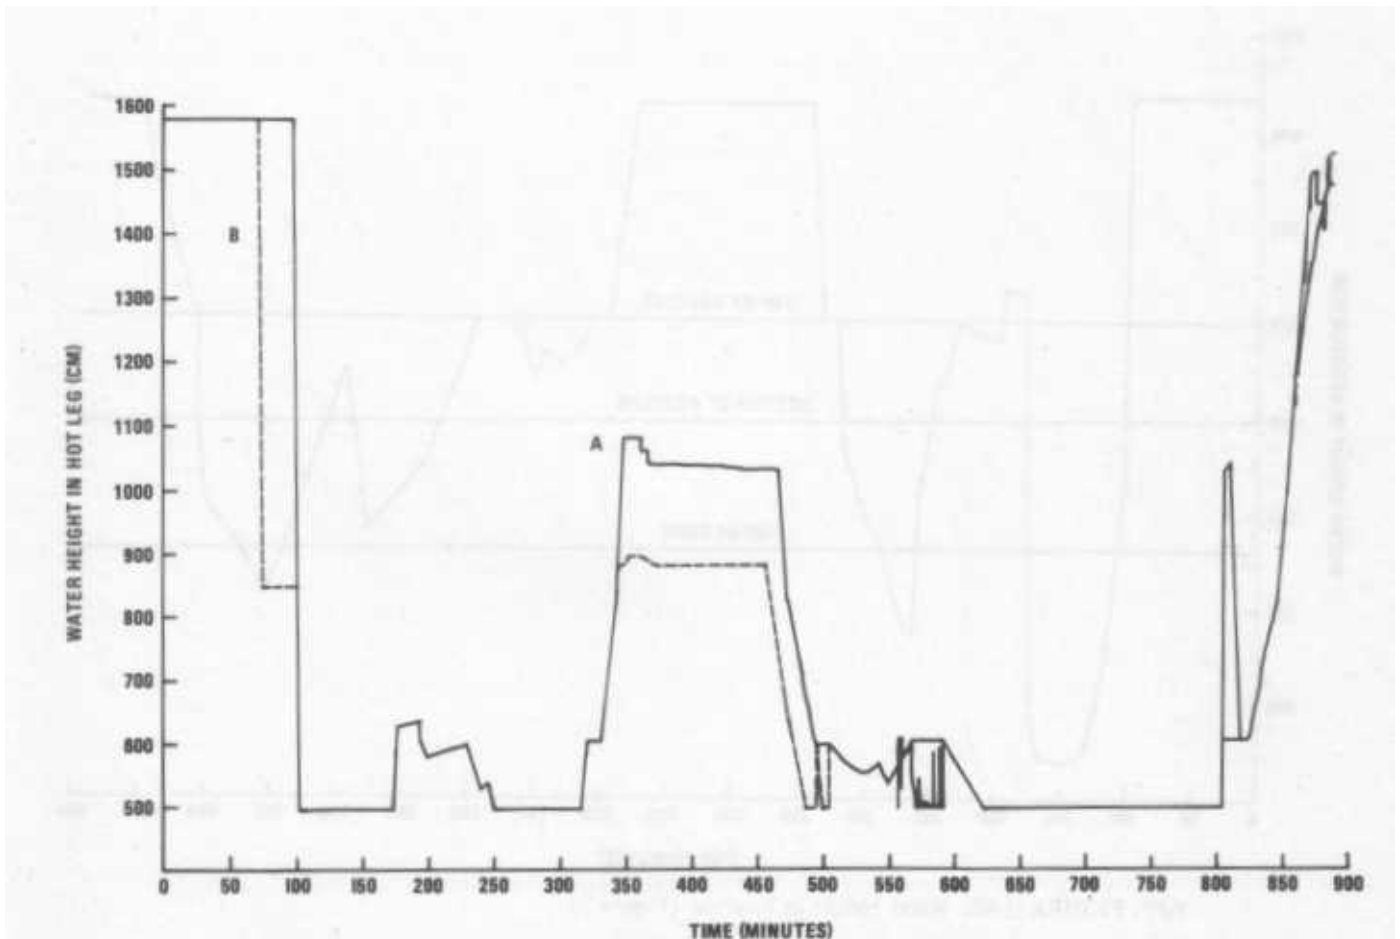
APP. FIGURE 11-49. Water Height in Hot Leg (Figure 8)

The hot legs filled with water above nozzle elevation prevented the flow of hydrogen gas for most of the accident. However, from ^-200 to ^'300 minutes the water level in the hot legs allowed gas flow. In addition, the depressurization at -500 to ^'800 minutes emptied the hot legs and allowed hydrogen redistribution and flow to containment.

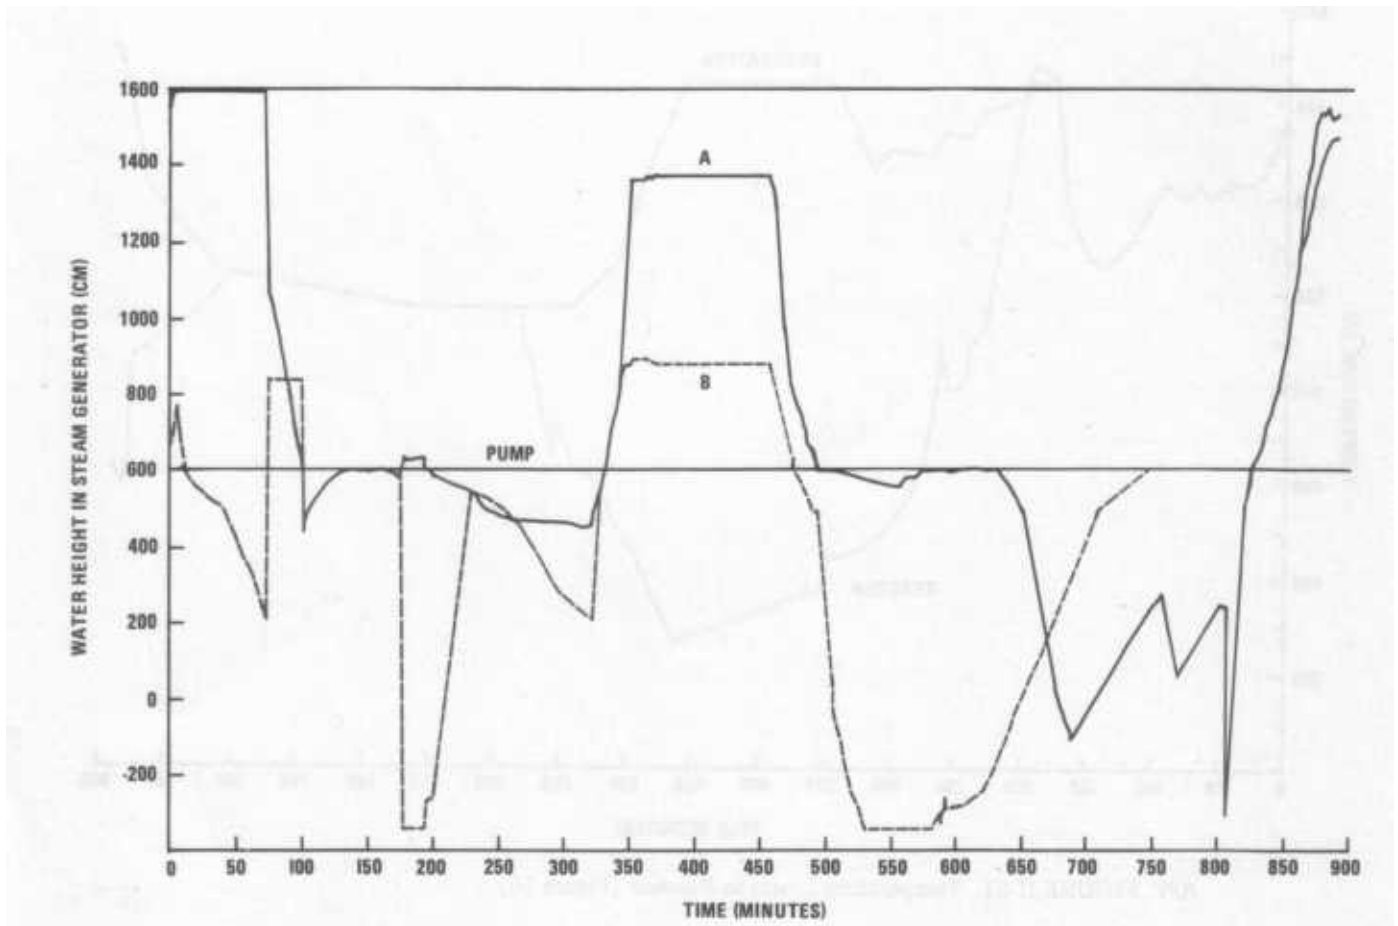
APP. FIGURE 11-50. Water Height in Steam Generator (Figure 9)

Steam generator water levels generally fluctuated about the pump elevation. An exception occurred at -175 to -200 minutes when the steam generator B RCP emptied the B steam generator. It appears that a calculational error emptied the B steam generator rather than the A steam generator during the depressurization at ^500 minutes. When the water level in the reactor was below pump elevation, the A steam generator emptied due to letdown (^600 to -800 minutes).

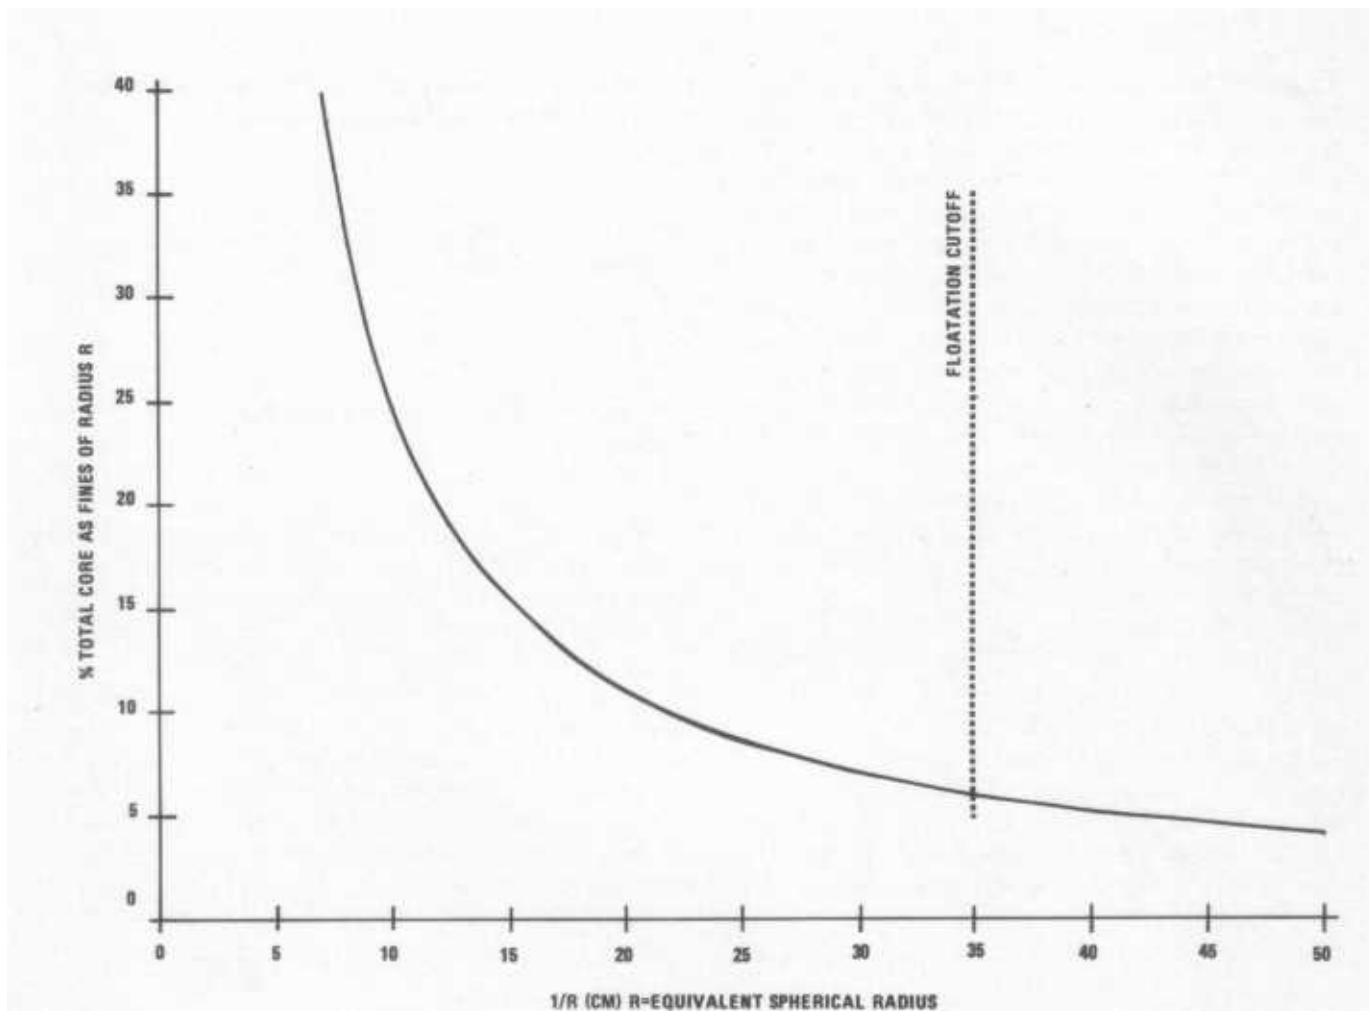
APP. FIGURE 11-53. Percent of Total Core as Fines of Radius (Figure 2)

If it is assumed that the core debris is made up of intact pellets and fuel fragments of a particular size, an estimate of the volumetric fraction of fine fragments in the core may be made. The volume fraction of the core that could have a size r is plotted versus r in Figure 2. Very fine fragments are not likely to have developed. Fine materials would be levitated by the coolant flow and would have escaped the reactor coolant system to a much greater extent than observed. Consequently, a cut-off in the possible size of the fines of about 0.03 cm is shown in Figure 2.
